Town of Pelham

Effingham Street  
In Service Road Safety Review

January 2019

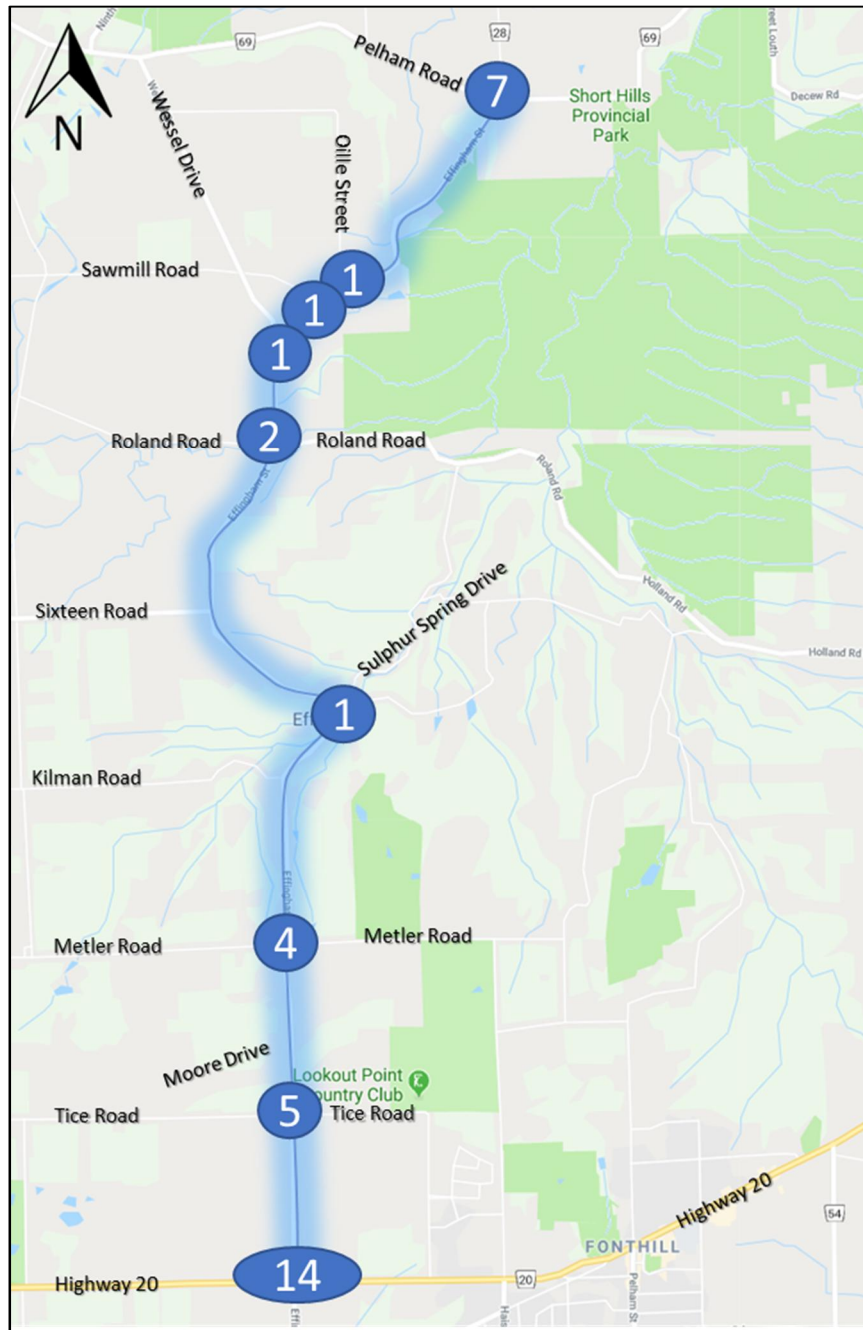
Figure 2-1  
Collisions at Intersections

**Figure 2-1** shows the collisions that occurred at intersections within the study area for the period reviewed. There is a total of 36 collisions within the study area (which includes intersections at either end of the study area). Twenty-three (23 or 64%) of the collisions were property damage only with a smaller number (7 or 19%) resulting in an injury. The remaining collisions were classified as ‘unknown’ or ‘non-reportable’.

Both intersections either end of the study area were noted as having the highest frequency of collisions. Regional Road 20 (Highway 20) at Effingham Street had 14 collisions over the period reviewed. Regional Road 69 (Pelham Road) at Effingham Street at 7 collisions over the period reviewed. As both locations experience significantly, higher traffic volumes than the other intersections in the study area (being Regional Roads meant to serve intra-municipal traffic), a higher collision frequency is expected. Moreover, these intersections are under the jurisdiction of the Region of Niagara. Two intersections under the jurisdiction of the Town of Pelham were noted as having a modest number of collisions over the period reviewed. Tice Road at Effingham Street had 5 collisions while Metler Road had 4 collisions. The remaining locations either had one or zero collisions over the period reviewed.

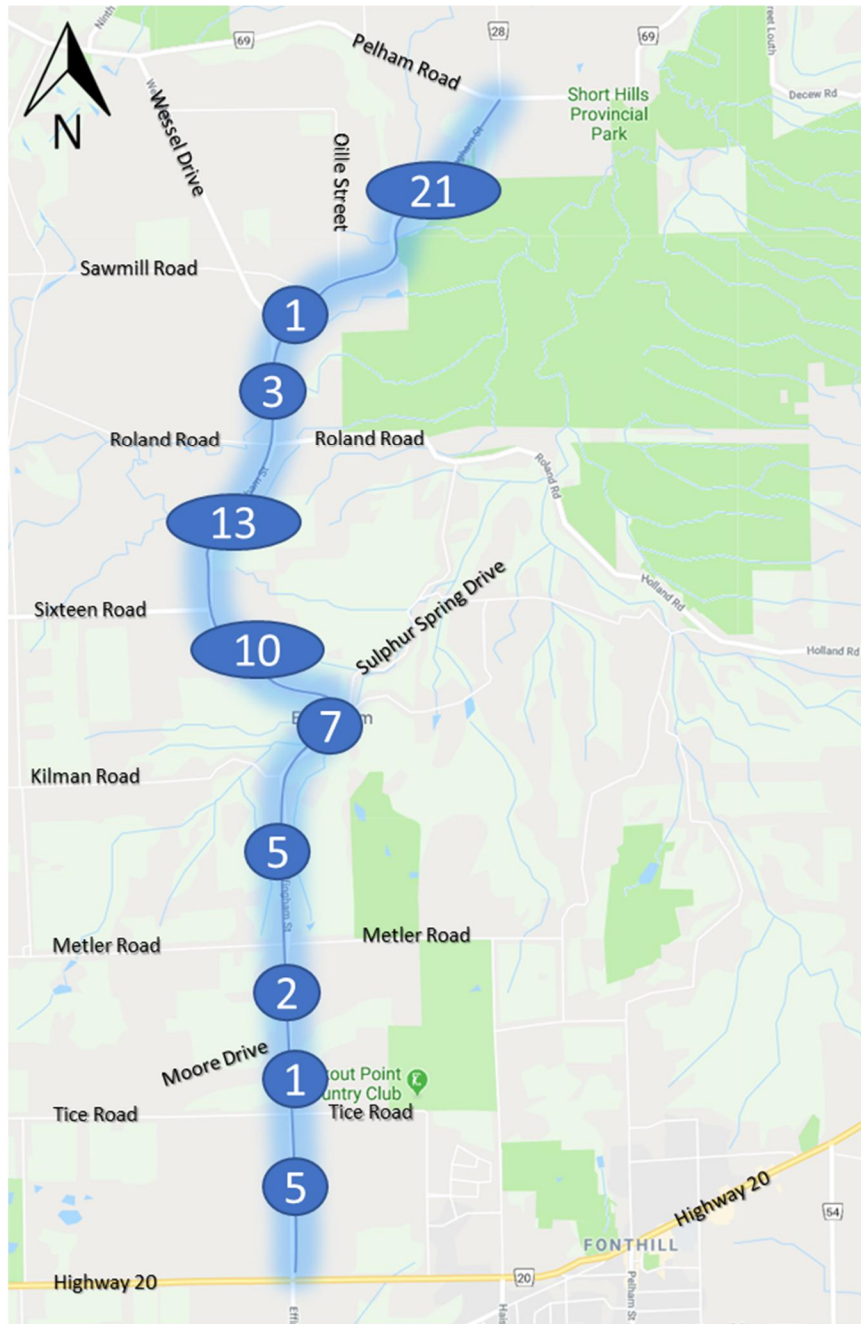
**Figure 2-2**  
**Collisions at Midblock Locations**

**Figure 2-2** shows the collisions located at mid-block locations within the study area. A total of 68 collisions were reported to have occurred at a mid-block location. Of the 68 collisions, 50 (or 74%) were property damage only, 5 (or 7%) resulted in an injury and 1 (1%) resulted in a fatality. The circumstances of the fatal collision are discussed in further detail below.

The locations with the highest frequency of mid-block collisions were the section of Effingham Street between Oille Street and Pelham Road, with a total of 21 collisions. This section was reviewed in further detail to determine the details and circumstances associated with the collisions. The following was noted:

- Of the 21 collisions, 18 were reported as 'property damage only', with other three being 'personal injury', 'other' or 'fatal';
- The 21 collisions were noted as being primarily single motor vehicle collisions – 17 or 81 percent of the collisions with the remaining 4 collisions being noted as approaching (vehicles moving in opposite direction striking each other);
- More than half (12 or 57 percent) of the collisions occurred on a slippery road surface (wet/loose snow, packed snow);
- Common events reported were 'ran off road', 'skidding/sliding', and 'striking a wild animal'; and
- 'Speed too fast for conditions' or 'lost control' were reported as a driver action for 12 or 57 percent of the collisions

Of particular note, a fatal collision occurred on September 23<sup>rd</sup>, 2014 within this section. The collision involved a northbound motorcycle striking a southbound pick-up truck. Conditions were clear (daytime) and the roadway was dry. According to the homeowner at 2796 Effingham Street, the fatal collision occurred in front of their property, the same curve reviewed in the 2008 Synectics report.
