APPENDIX A – SITE PHOTOGRAPHS SULPHUR SPRINGS DRIVE EMERGENCY REPAIR

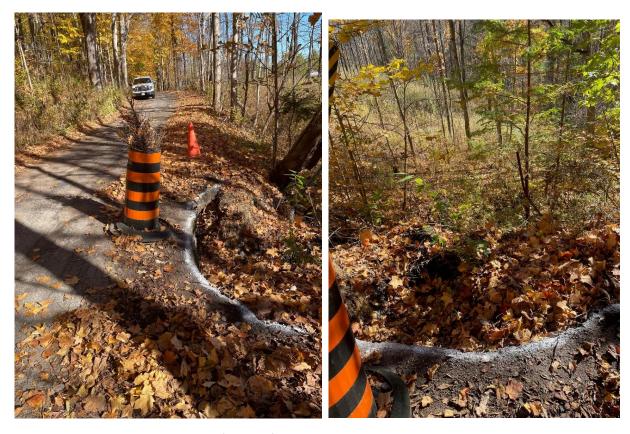
Photographs showing erosion and failure of the existing roadway.
