In-Service Road Safety Review (ISRSR) Study

Canboro Road between Effingham Street and Vinemount Drive

Final

January 22, 2024

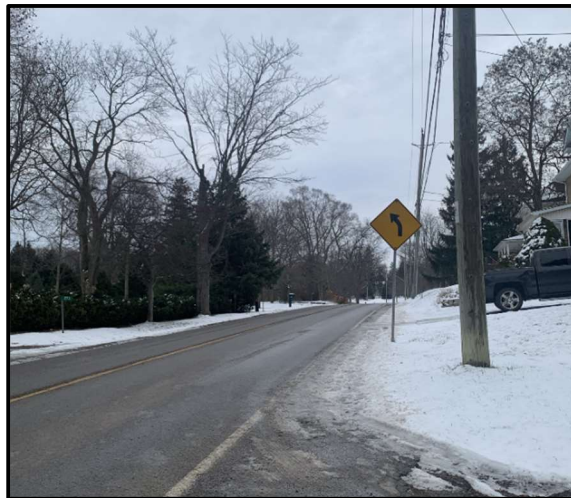
Figure 3.1 – Wa-3L Signage

As seen in the aerial images presented in the foregoing sections, the corridor exhibits a moderate curve for a short segment of the corridor. Drivers are notified of this curvature through Wa-3L (curve) signage on either end of the segment, as shown in **Figure 3.1**. Furthermore, the rumble strips on the south side of the roadway notify eastbound drivers if they are veering out of the vehicular travel lanes.

Advisory speed tabs could be used to encourage drivers to operate at a reduced speed along this curve. However, the field investigation documented that the curvature can be safely navigated when travelling at the posted speed of 50km/hr without noticeable impacts from centrifugal forces.

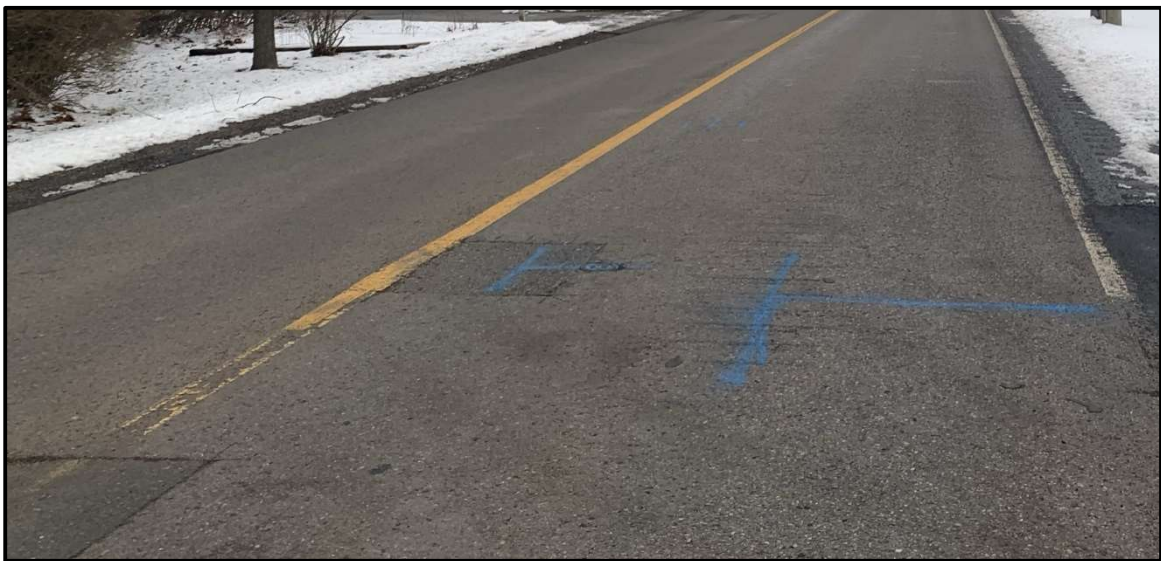
Figure 3.2 – Lane Markings

The field investigation documented that the existing pavement markings are largely apparent during the day, although some sections are completely faded or beginning to fade; this can be seen in **Figure 3.2**.

In the nighttime period, the lane markings are still visible due to the streetlights; however, the retroreflectivity of these lane markings have faded significantly. This makes the lane delineation markings more difficult to see in sections with a lesser degree of illumination.

- In the interim, it is also recommended that Wc-19 and Wc-19t signage be implemented along the corridor to increase driver awareness of on-road cyclists. Furthermore, it is recommended that sharrow pavement markings be implemented in the middle of vehicle travel lanes throughout the entire corridor to designate the roadway more formally as a shared facility, and lane pavement markings should be repainted to provide enhanced retroreflectivity.

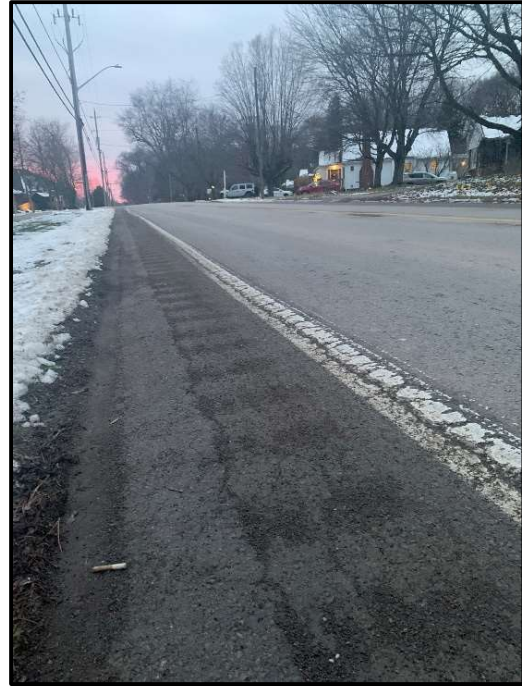
Figure 3.4 – Eroded Rumble Strips

The rumble strips along the south side of the corridor have experienced significant wear-and-tear in many areas which has hindered their effectiveness. In fact, vehicles were observed driving over the rumble strips, to which it appeared to have nominal impacts on their driver behaviour. Surveyors also indicated that the rumble strips were not producing the desired humming sound when vehicles were traversing them. An example of the eroded rumble strips can be seen in **Figure 3.4** where the rumble strips have transitioned into a gravel-like sediment. In these areas where the rumble strips are eroding, they are still substantial enough to cause significant discomfort for cyclists that wish to use the shoulder yet have little-to-no impact on driver behaviour.

- The rumble strips were constructed in 2023-2024 and have eroded substantially since, assumed to be result of age and overuse.
- The field investigation observed vehicles driving at perceivably high operating speeds, with some vehicles regularly traversing the rumble strips.

- In the interim, it is recommended that the rumble strips be reinstated, as their presence has a benefit on overall road safety. This conclusion is based on the findings of the field investigation, narrow lane widths, and the lack of clear zone width between the EOP and roadside hazards (e.g., hydro poles). It is important to note that converting the existing rumble strips to a paved shoulder would result in a substandard cycling facility, and therefore reduce the safety performance of the corridor.
