2024 BRIDGE AND CULVERT INSPECTION PROGRAM

REHABILITATION/REPLACEMENT NEEDS

June 2024

TOWN OF PELHAM

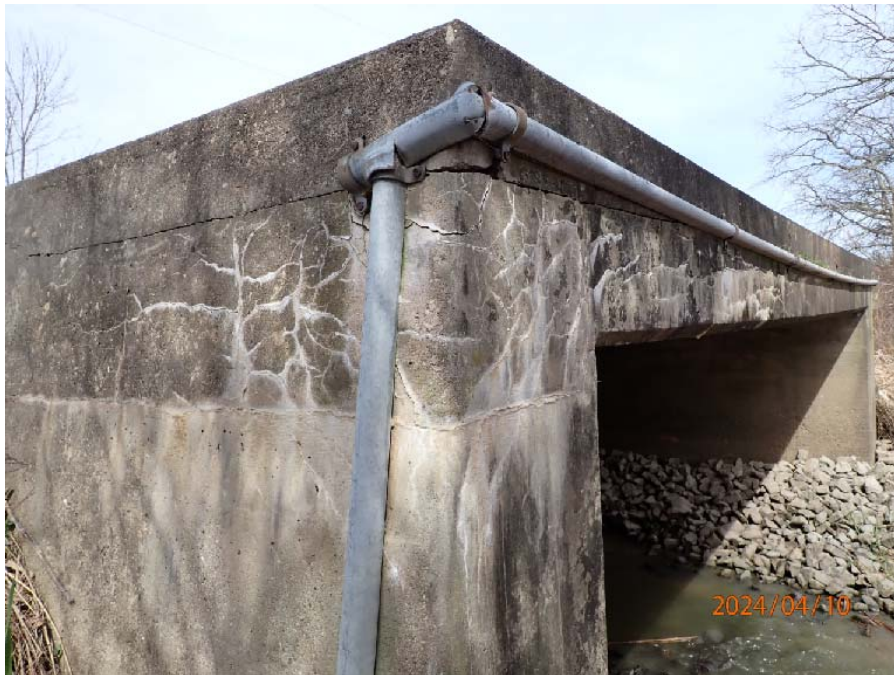
Photograph No. 4: 0374: Cracking and efflorescent staining at southeast corner.

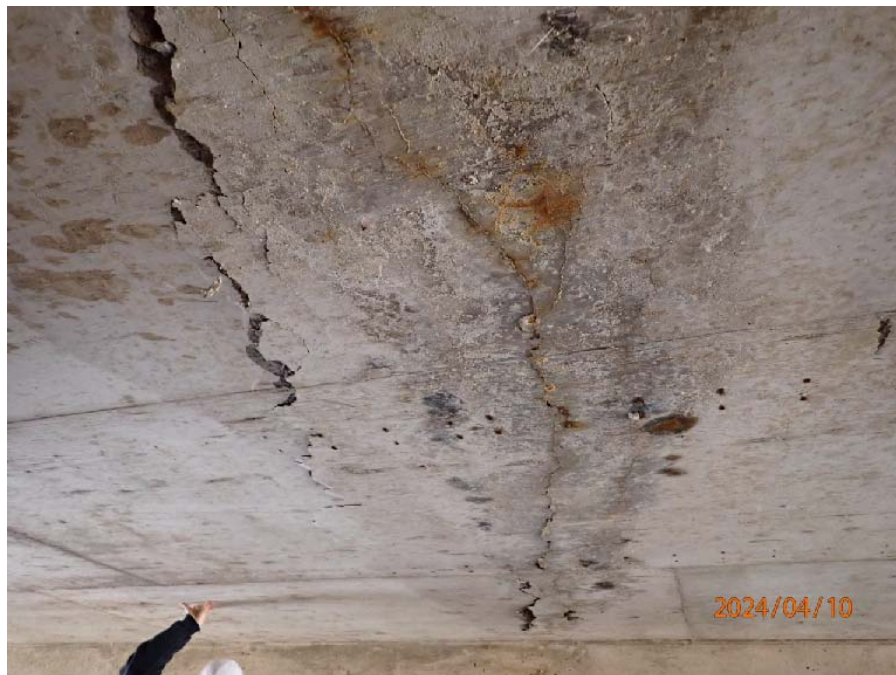
Photograph No. 4: 0307: Area of delamination and spalling 2m west of center.

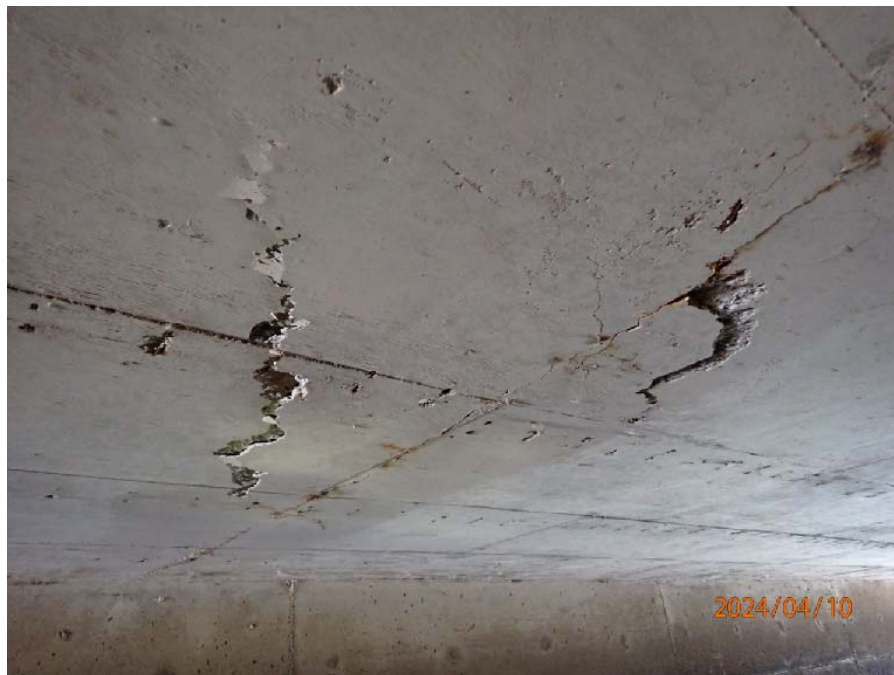
Photograph No. 4: 0259: Delamination at midspan.

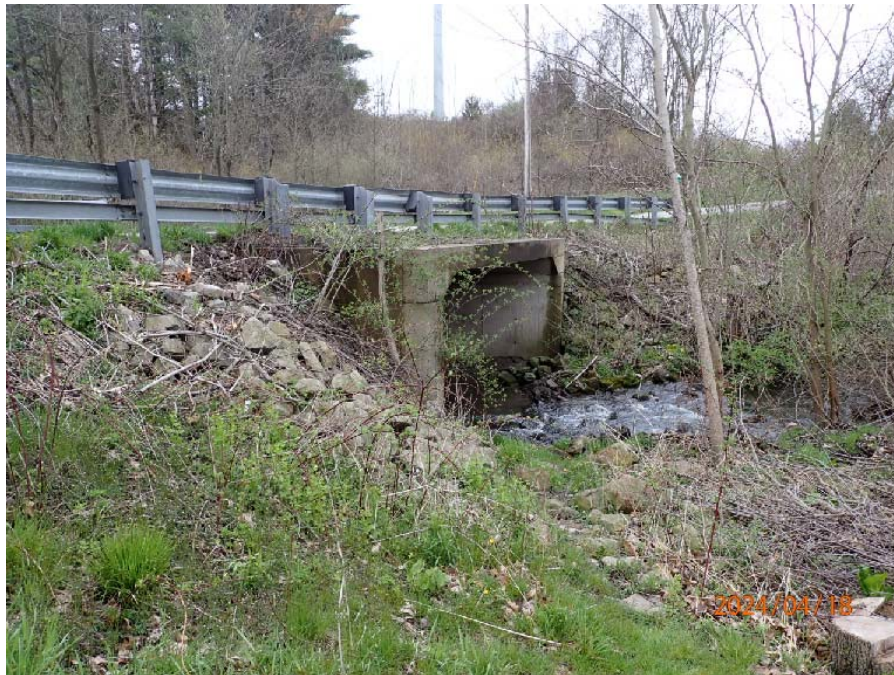
Photograph No. 2: 0214: South elevation and erosion at southwest corner.

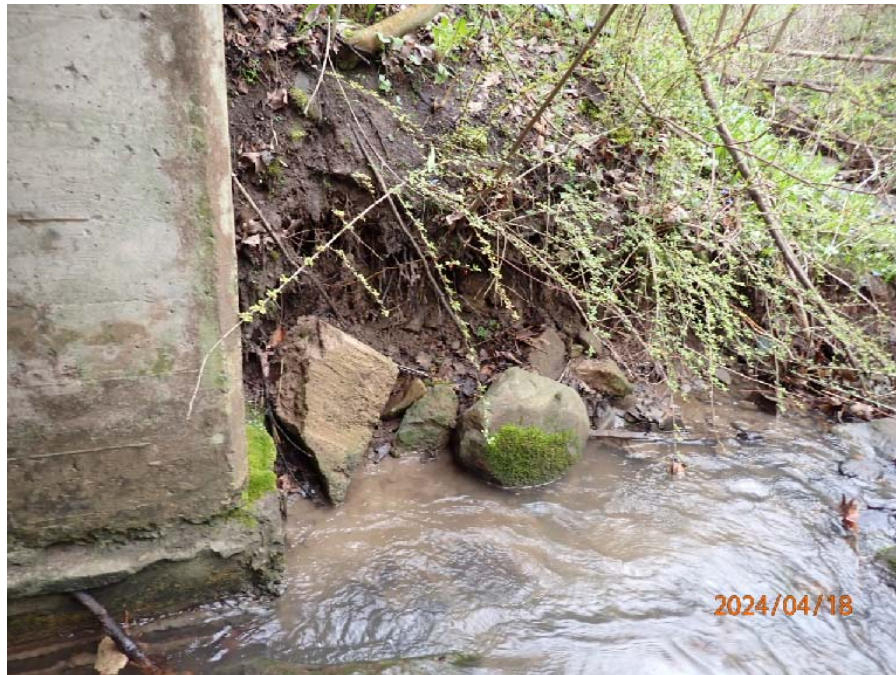
Photograph No. 4: 0405: Erosion at northwest corner.

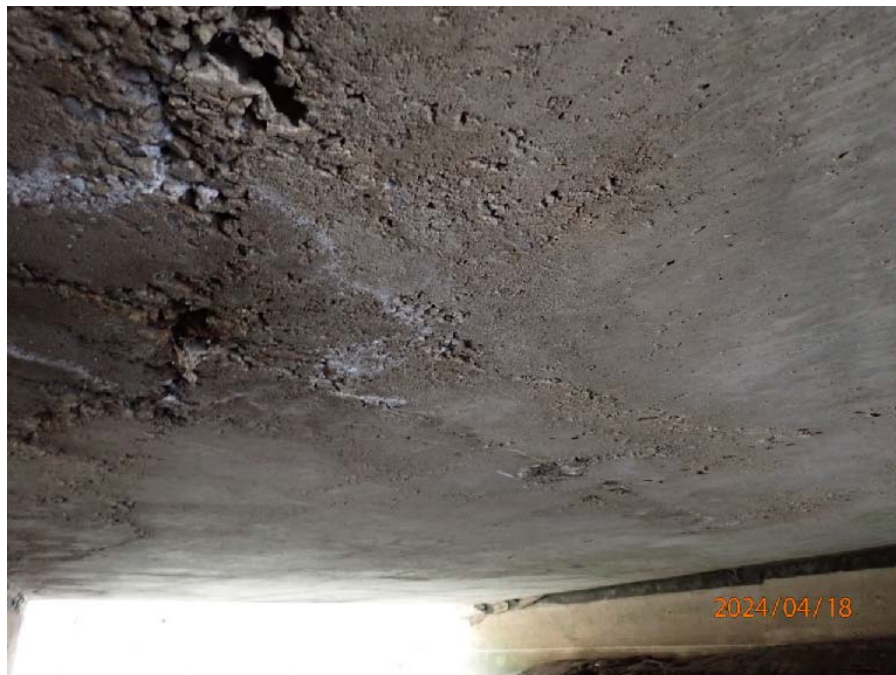
Photograph No. 4: 0493: Area of delamination in the soffit at centre span.

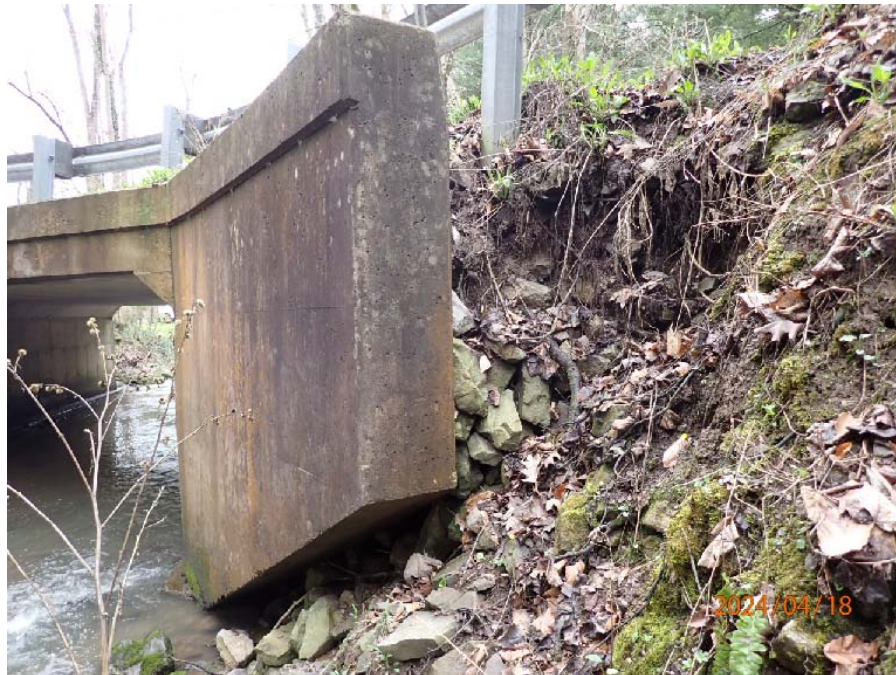
Photograph No. 4: 0571: Erosion at northwest wingwall.

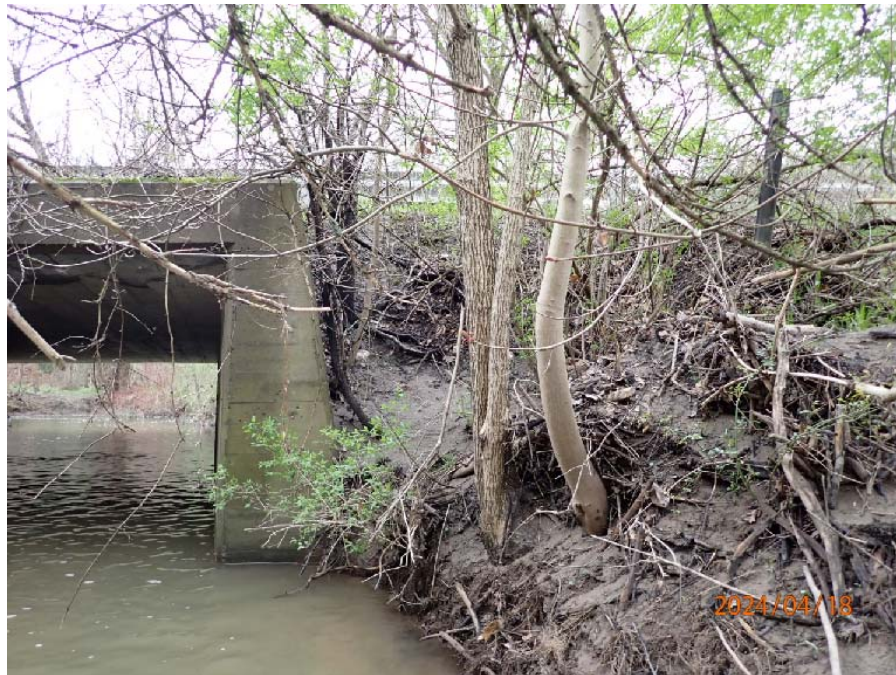
Photograph No. 4: 0690: Area of erosion at northeast corner.

| ID Number | Structure Name | Priority Rating | Recommendation | Cost |
|---|---|---|--|---|
| 09 | Roland Road | NOW | Replace damaged section of guiderail. | \$17,250 |

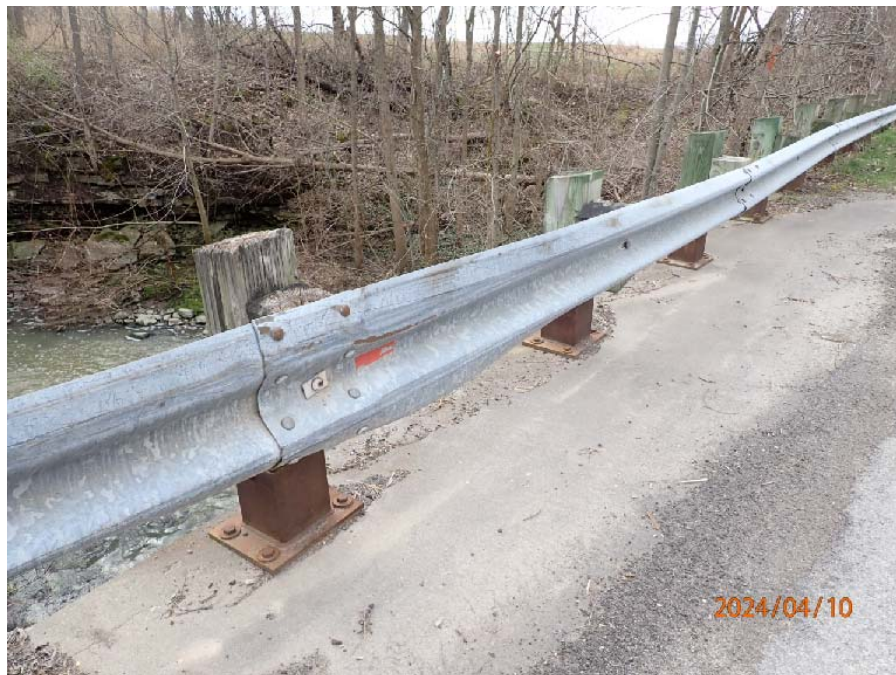
Photograph No. 4: 0142: Damaged guiderail over east side of the structure.

| ID Number | Structure Name | Priority Rating | Recommendation | Cost |
|---|---|---|--|---|
| 11 | Centre Street | 6-10 Years | Replace steel beam guiderail. | \$80,500 |

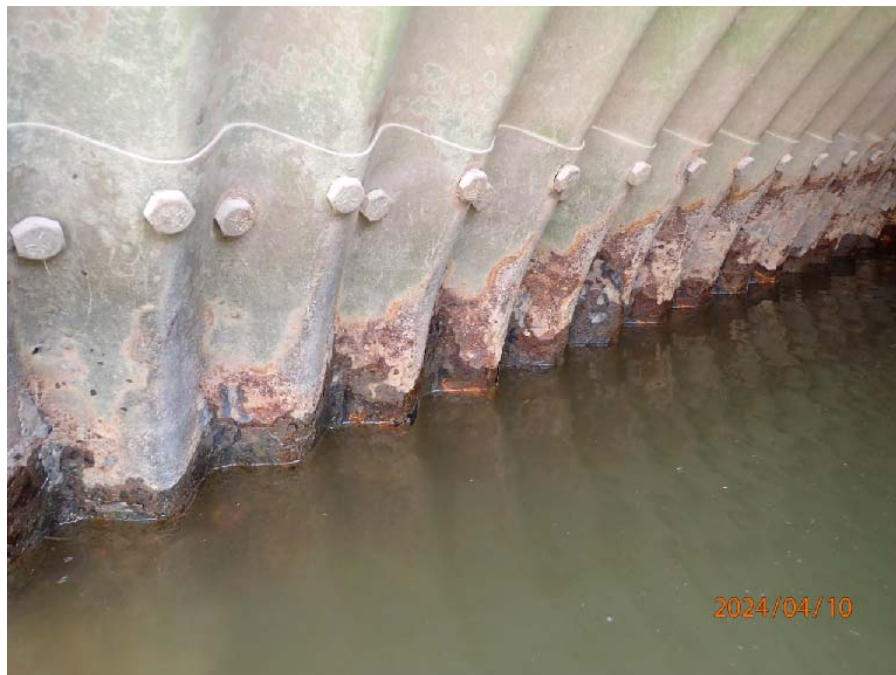
Photograph No. 4: 0797: Severe corrosion along the waterline (typical).

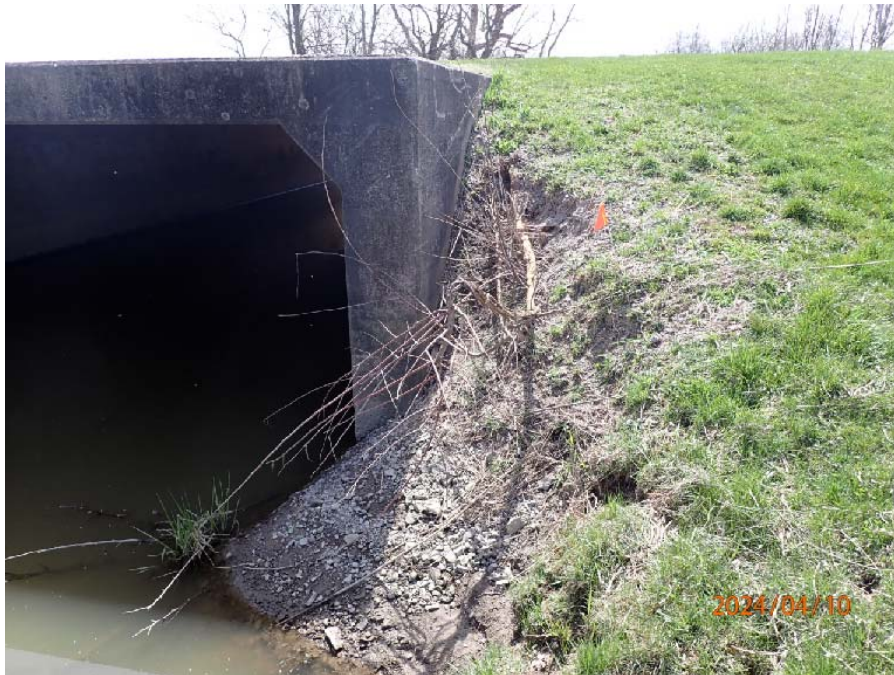
Photograph No. 4: 0523: Erosion at northwest corner.

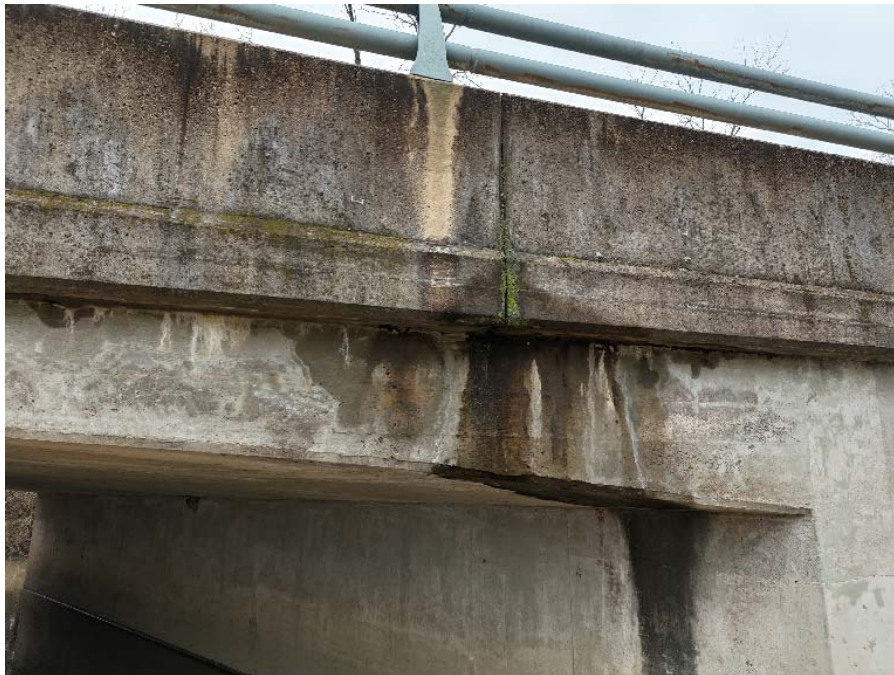
Photograph No. 4: DJI_0009: Leakage in west fascia looking northeast.

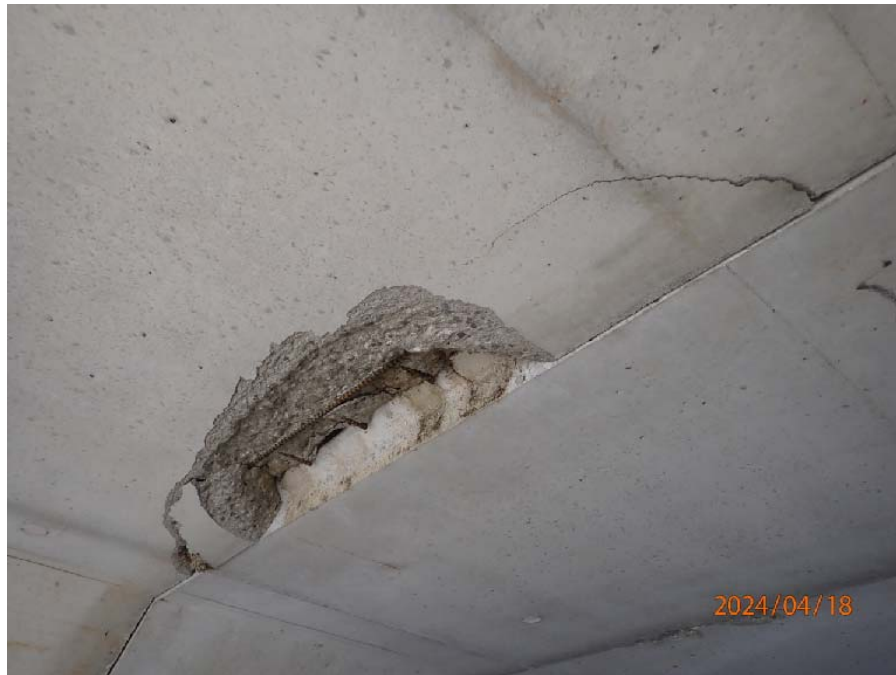
Photograph No. 4: 0034: Spall in precast unit at east end.

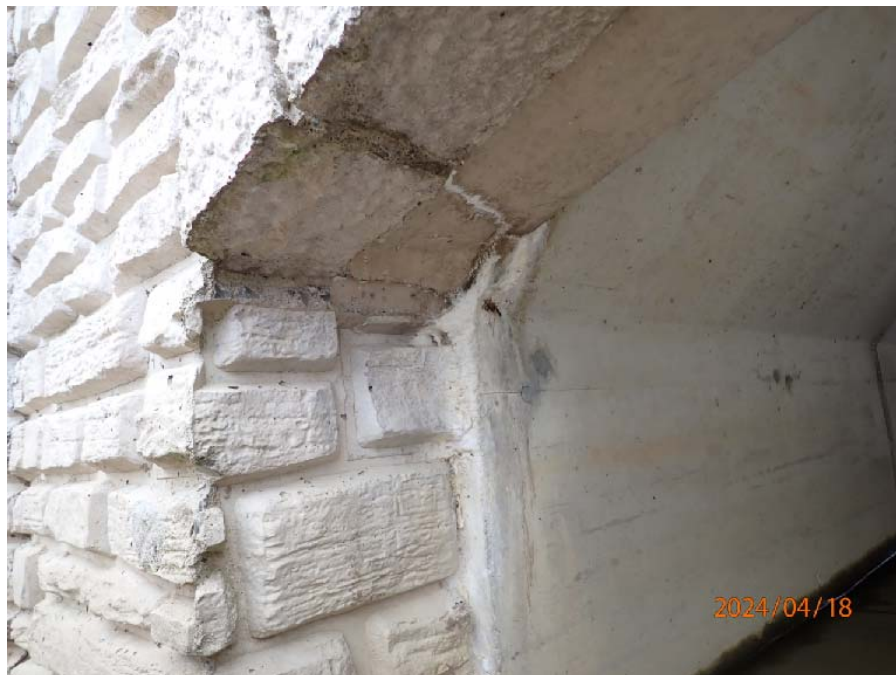
Photograph No. 4: 0113: Leakage and efflorescent staining at southwest corner.

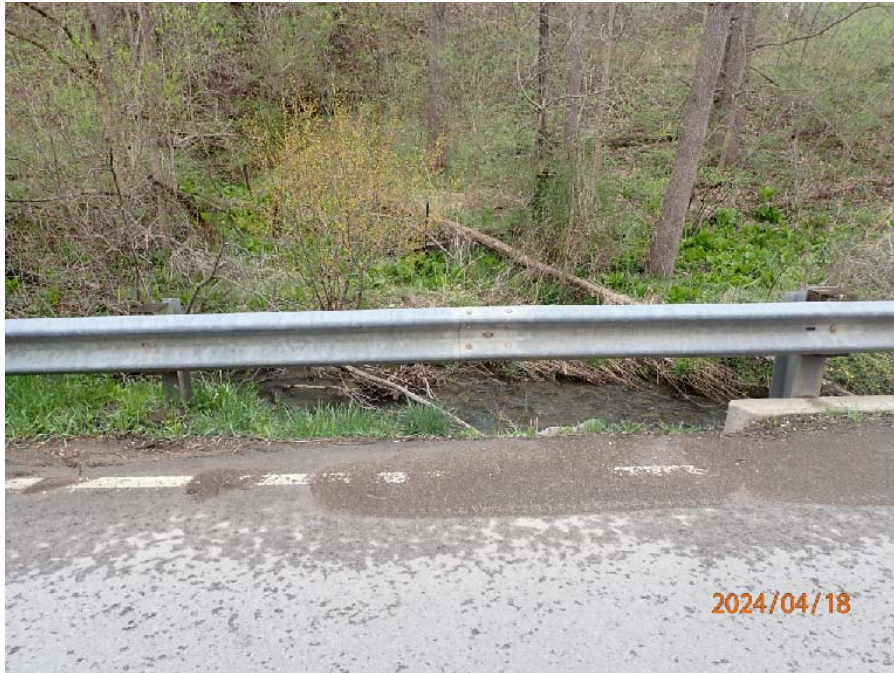
Photograph No. 4: 0286: Missing guiderail post at southwest corner.

| ID Number | Structure Name | Priority Rating | Recommendation | Cost |
|---|---|---|--|---|
| 21 | Effingham Street | NOW | Replace missing guiderail post. | \$1,500 |

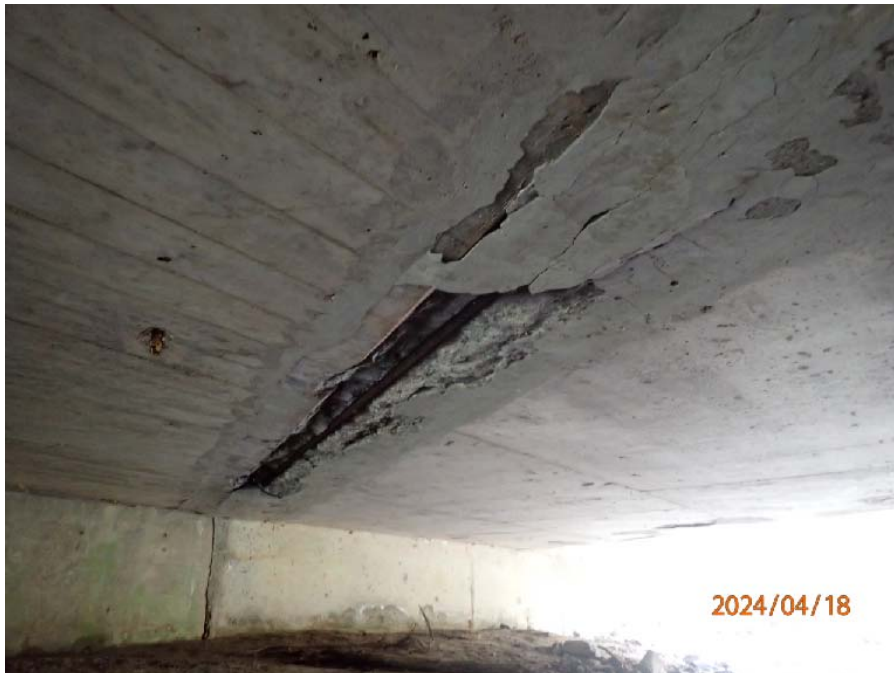
Photograph No. 4: 0326: Area of spalling and delamination at centre span, looking south.

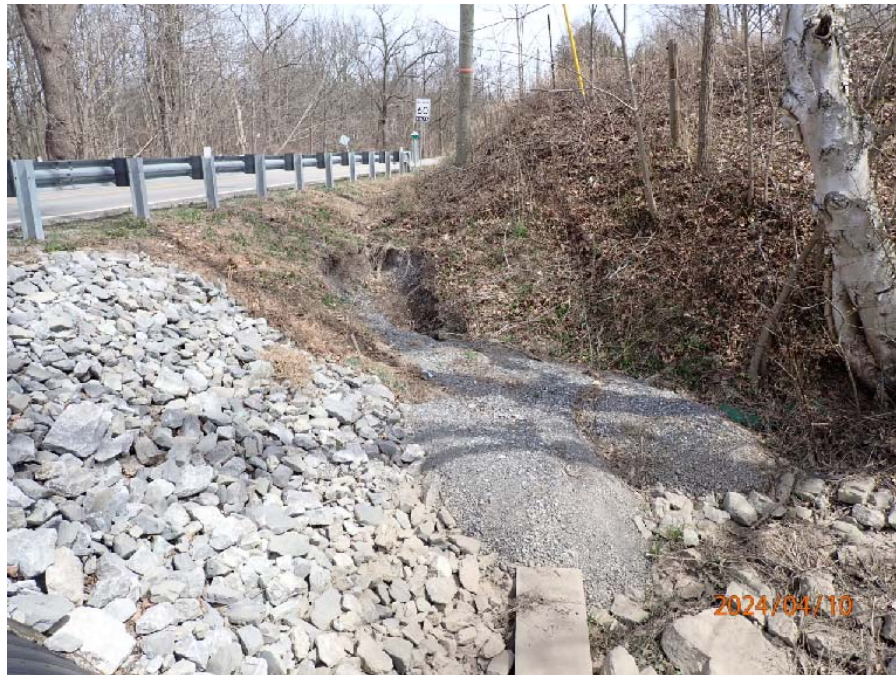
Photograph No. 4: 0677: Area of granular washout at southeast corner.

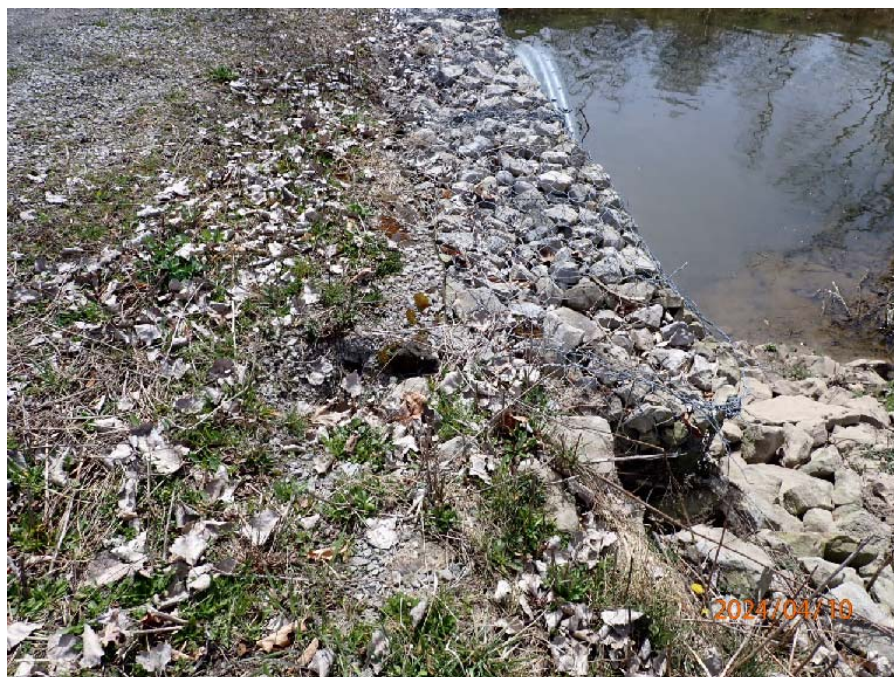
Photograph No. 4: 0611: Gabion basket at northwest corner with loss of stone.
