Date: February 27, 2019 **File:** 2018-5290

Project: Traffic Studies

Subject: Review of Intersection Pedestrian Signals

MEMO

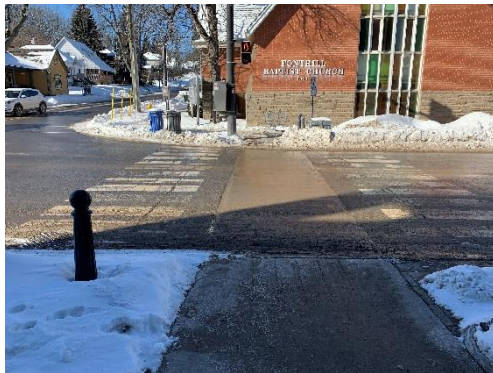
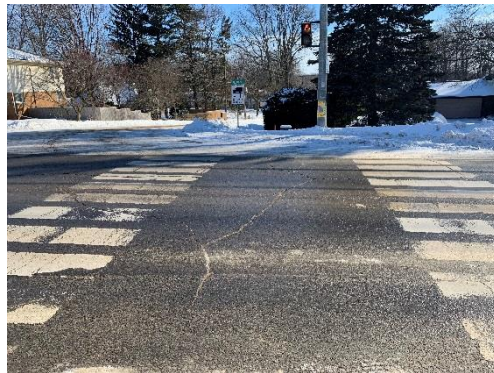
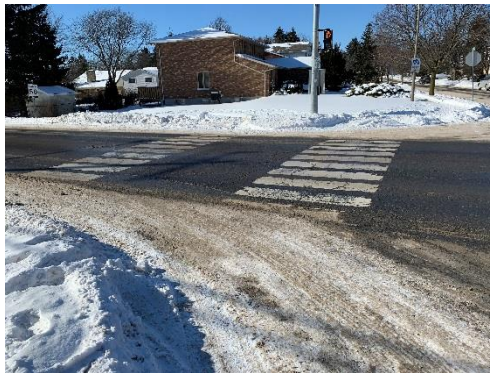
Figure 2-1 Views of Crosswalks

Pelham Street and Church Hill

Pelham Street and Pancake Lane/John Street

Pelham Street and Bacon Lane/Spruceside Crescent

Observations during the field visit on February 1st reaffirm that visibility for pedestrians and vehicles at Pelham Street and Church Hill was obscured as documented in our previous study. This is due to the presence of legally parked vehicles (2-hour parking permitted) within the functional area of the intersection on the Pelham Street approaches. Visibility was adequate at the intersections of Pelham Street and Pancake Lane/John Street and Pelham Street and Bacon Lane/Spruceside Crescent on the north and south approaches to the intersection pedestrian signals.

1. Prohibit vehicle parking on both sides of Pelham Street within 30 metres of the crossing and install the corresponding parking prohibition signs;
2. Remove existing crosswalk markings and replace with markings specified in Section 6.2.4.4 of Book 15 (the existing crosswalk surface is textured so ladder markings are not recommended);

1. Consider installing parking prohibition signs on both sides of Pelham Street within 30 metres of the crossing;
2. Remove the existing crosswalk markings and replace with markings specified in Section 6.2.4.5, Figure 12 of Book 15 (ladder markings for increased awareness).
3. Install Ra-9a signs on the north side of the intersection as specified in Table 9 of Book 15 under "Optional Components".

1. Consider installing parking prohibition signs on both sides of Pelham Street within 30 metres of the crossing;
2. Remove the existing crosswalk markings and replace with markings specified in Section 6.2.4.5, Figure 12 of Book 15 (ladder markings for increased awareness);
3. Install Ra-9a signs on the north side of the intersection as specified in Table 9 of Book 15 under "Optional Components".

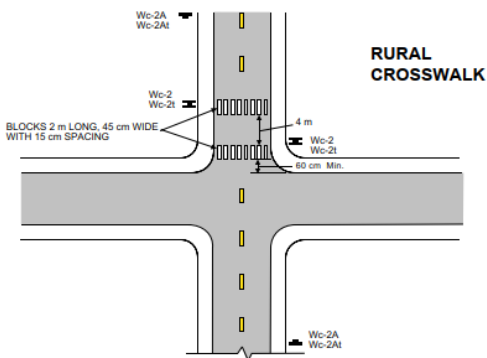
Figure 2-3

The existing crosswalk pavement markings are not appropriate and are for those used at rural supervised school crosswalks as shown in Figure 45 of *Ontario Traffic Manual Book 11: Markings and Delineation* (Book 11). The appropriate markings are specified in Section 6.2.4.4 of Book 15 and consist of solid white lines spaced a minimum of 2.5 metres apart. As an option and for enhancement purposes, ladder crosswalk markings can be utilized as specified in section 6.2.4.5, Figure 12 of Book 15. The Ontario Traffic Manual illustrations are provided in **Figures 2-3 and 2-4**.

Figure 45 – School Crosswalks for Supervised Crossing

Book 11 Markings for Rural Supervised Crossings

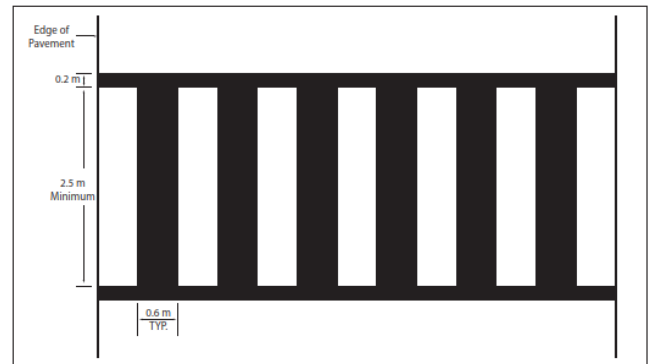
Figure 2-4

Figure 12: Pavement Markings for Ladder Crosswalk

Book 15 Ladder Crosswalk Markings

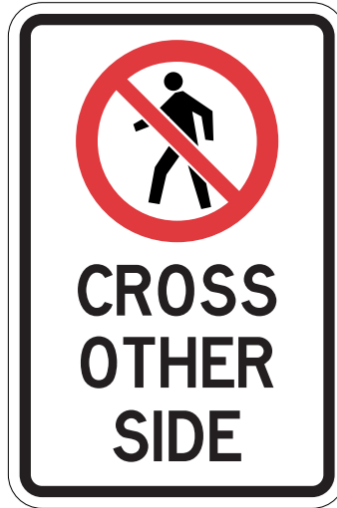
Figure 2-5
Ra-9a “Cross Other Side” Sign

There are no signs that reinforce to pedestrians the appropriate side to cross (i.e., the Ra-9a), given that the proportion of non-compliance is high (observations from the gap studies). An illustration of the Ra-9a “Cross Other Side” sign is provided in **Figure 2-5**.

3. Install Ra-9a signs on the south side of the intersection as specified in Table 9 of Book 15 under "Optional Components".

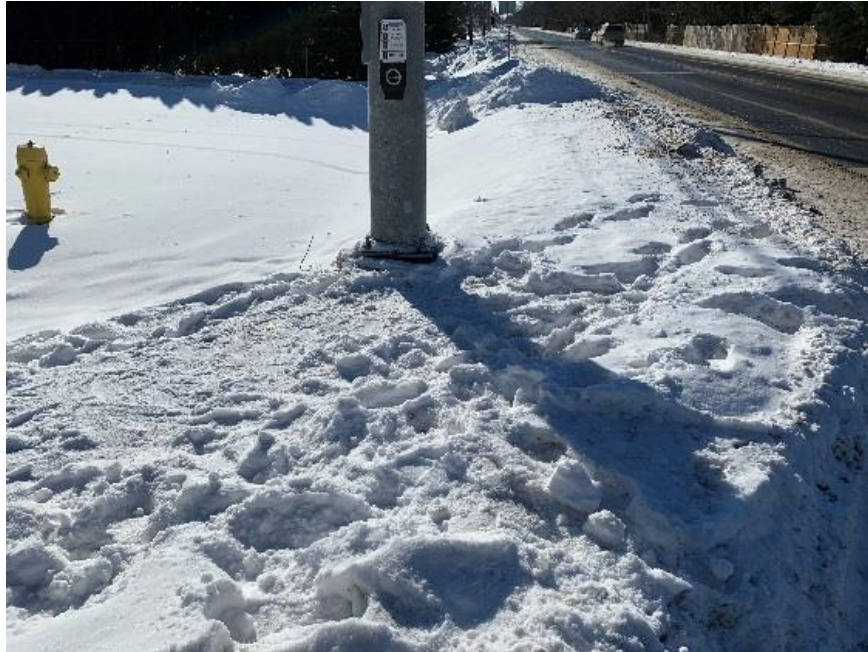
Figure 2-6

- Short-term parking (2 hours) permitted on both sides of Pelham Street within the 30 metre approaches to the crosswalk at Church Hill as documented earlier in this report and;
- Accessibility issues at Pelham Street and Bacon Lane/Spruceside Crescent with respect to the push-button location. It was noted at the time of the site visit that snow had not been cleared near the steel pole to which the push-button was installed (south-east corner) which made access difficult. A picture is provided in **Figure 2-6**.

Push-Button Accessibility south-east corner of Pelham Street and Bacon Lane/Spruceside Crescent

1. Ensure that during snow clearing operations, the area around the pedestrian push-button poles is cleared adequately to remain accessible to all users;
2. Develop an education program or initiative that teaches the proper use of intersection pedestrian signals. This can be achieved through the production and distribution of brochures or other media and/or delivery of presentations to the public.

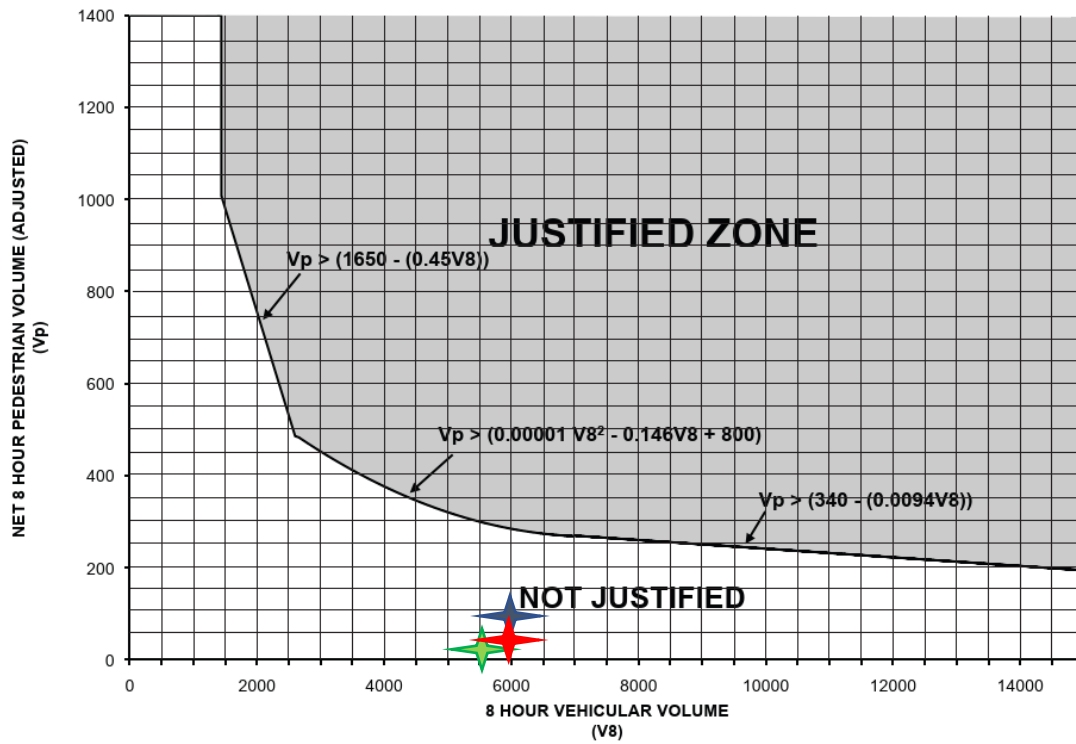
Figure 22 – Justification 6 – Pedestrian Volume

According to *Ontario Traffic Manual Book 12– Traffic Signals* (Book 12)¹, the need for an Intersection Pedestrian Signal is determined based on the traffic volume on the road, pedestrian volumes and the amount of pedestrian delay (inability for pedestrians to find safe gaps - Justification 6), as presented in Figures 22 and Figure 23 of Book 12. Higher traffic volumes will result in a reduction in gap availability, making it more difficult for a pedestrian to safely cross the roadway. A review of Figure 22 provided in Book 12 indicate the warranting conditions for an Intersection Pedestrian Signal are not met, based on the traffic counts undertaken in November 2018, as there is insufficient pedestrian volume, as shown in **Appendix A**. While not formally evaluated, it was also noted that there are insufficient pedestrian crossing volumes for an intersection pedestrian signal to be justified (based on Figure 23), as pedestrian volumes fall well below the minimum threshold (200 pedestrians crossing in an eight-hour period).

Pelham Street and Church Hill
-

Pelham Street and Pancake Lane/John Street
-

Pelham Street and Bacon Lane/Spruceside Crescent
