Traffic & Safety Review of Pedestrian Priority Signal

Pelham Street and Church Hill
Fonthill, Ontario

Prepared for Town of Pelham

March 2018

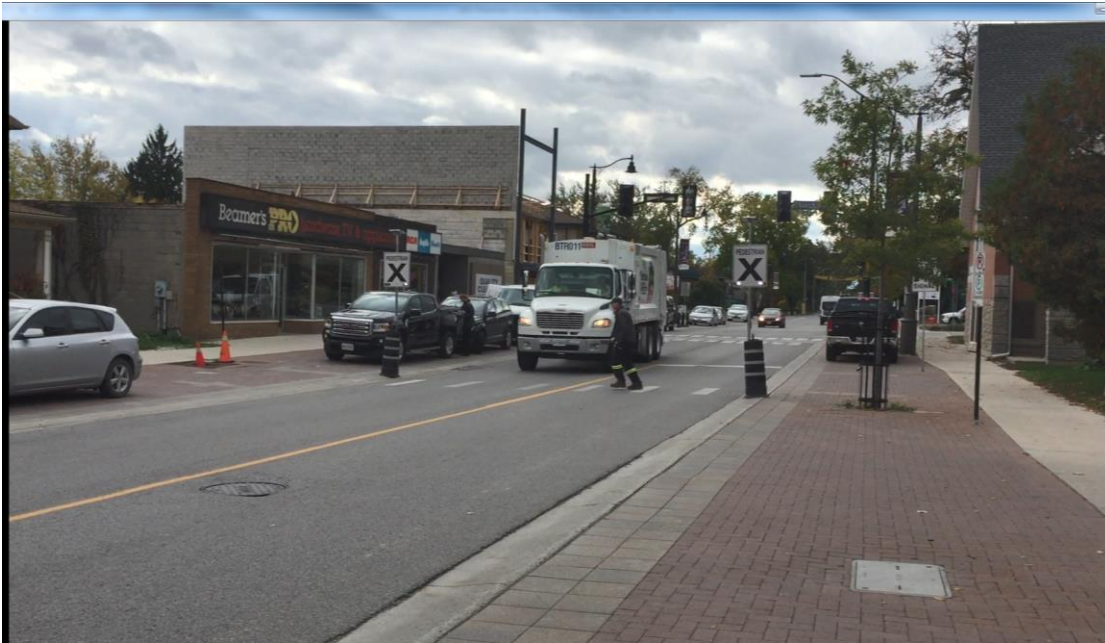
Figure 2 Pilot crossing October 2016

Pilot PXO observations:

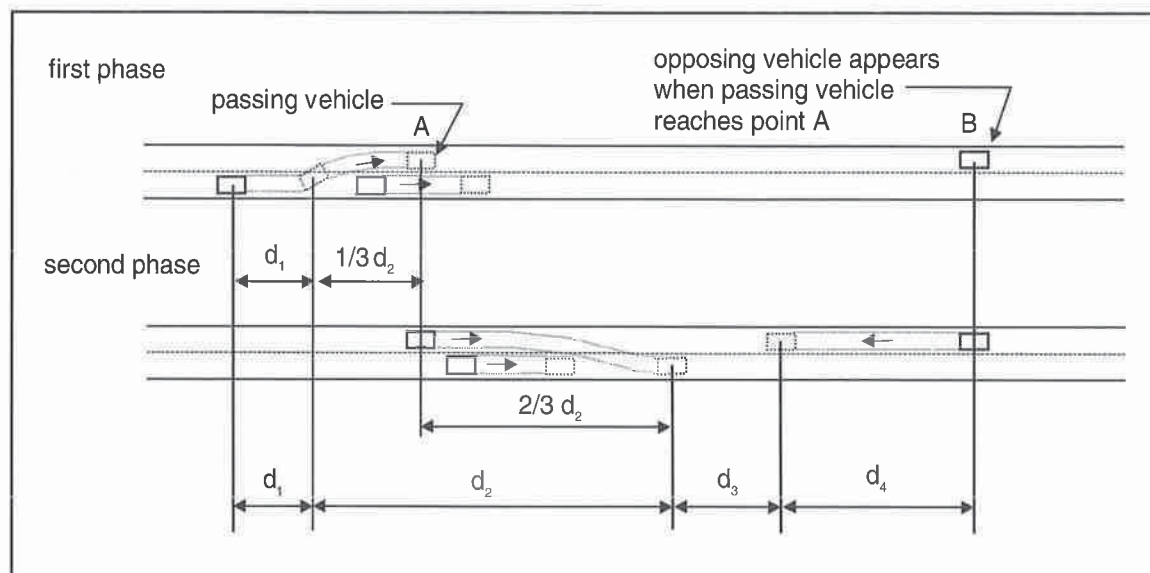
Figure 1.2.5.1 Elements of Passing Sight Distance²¹

Minimum passing sight distance equals the addition of d_1 through d_4 . Table 1.2.5.5 shows the minimum passing sight distances for various design speeds.
