Town of Pelham

Effingham Street  
In Service Road Safety Review

January 2019

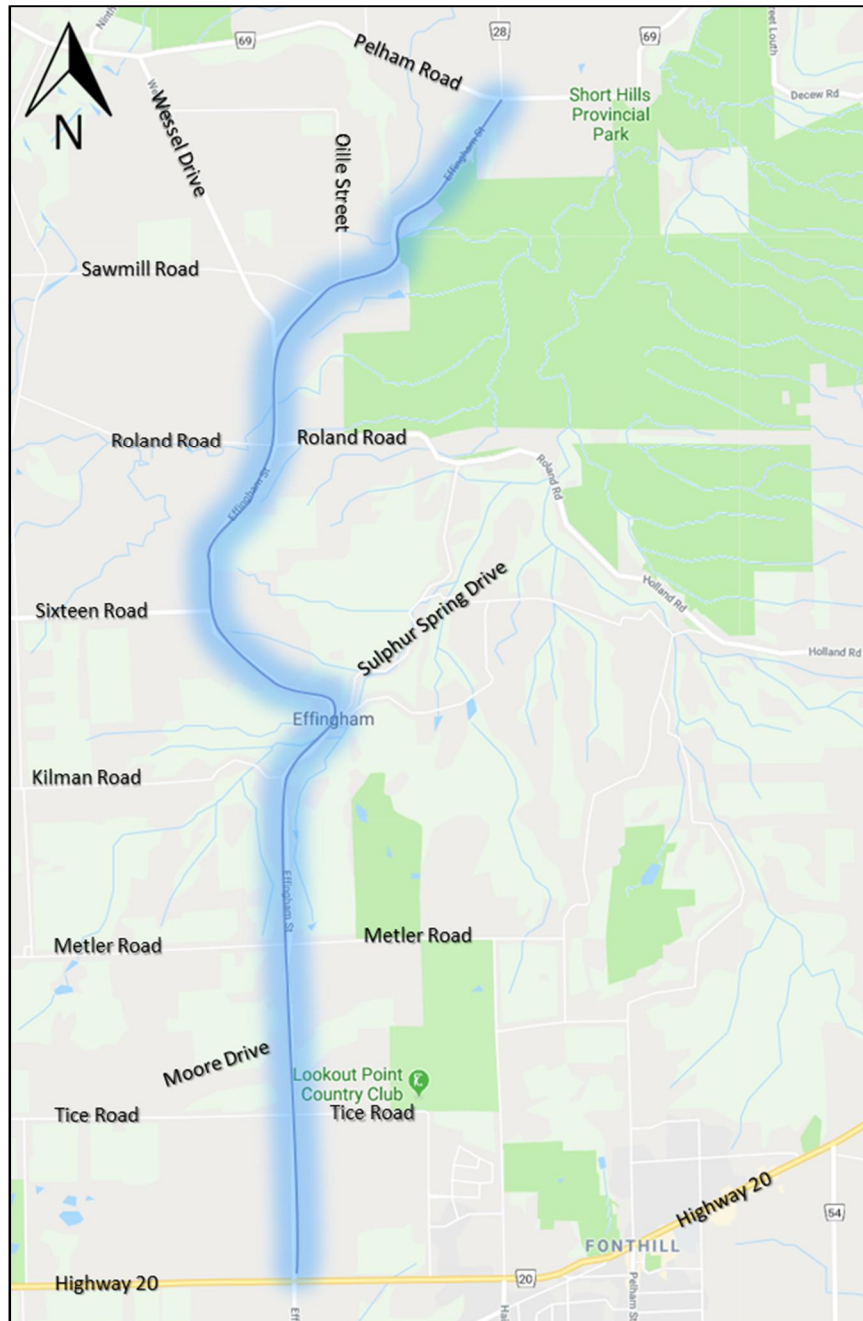
**Figure 1-1  
Study Area**

The study area encompasses all of Effingham Street between Highway 20 (Regional Road 20) and Pelham Road (Regional Road 69), consisting of 8.6 kilometres of roadway. Effingham Street is a rural paved two-lane roadway characterized as having a number of tight radius horizontal curves. Towards the south end, the roadway has a steep grade where the road climbs the Niagara Escarpment (at Moore Drive). Towards the north end, Effingham Street passes just to the west of Short Hill Provincial Park. The corridor is popular with motorcyclists and cyclists due to the scenic nature of the roadway. **Figure 1-1** shows the study area and all roadways that intersect with Effingham Street.
