**Reference: 2020 Bridge and Culvert Inspection Program,
Rehabilitation/Replacement Needs
ELLIS File No.: 922**

We are pleased to submit one (1) copy of the 2020 Pelham Bridge and Culvert Inspection Program, Rehabilitation/ Replacement Needs ring binder, which contains inspection reports for twenty-three (23) of the Town of Pelham's bridges and culverts.

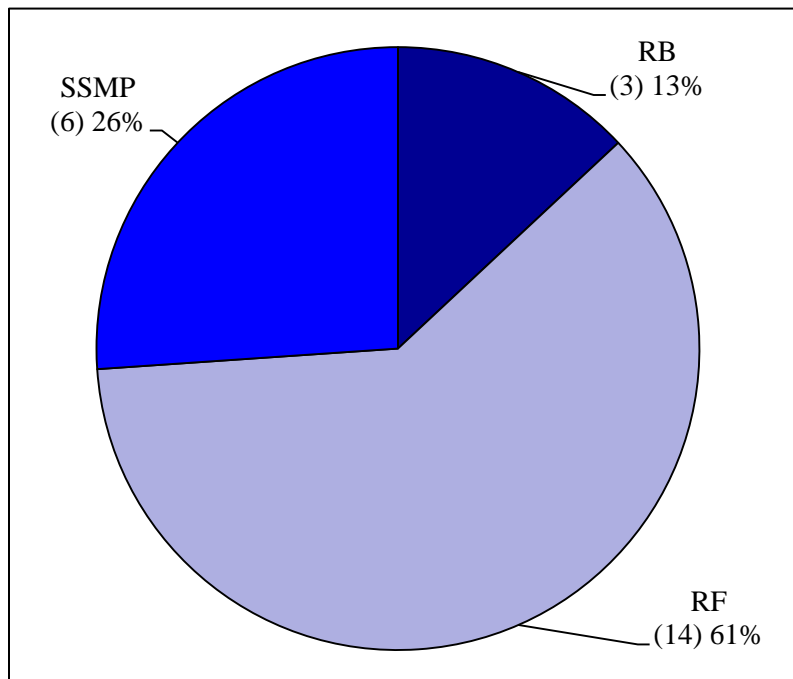
Each of the structures inspected has been classified by structure type. Structure types include Rigid Frame (RF), Rigid Frame Box (RB) and Soil Steel Multi Plate (SSMP).

Figure 1, below, shows the percentage of structures classified under each type.

Figure 1: Structures Classified by Structure Type

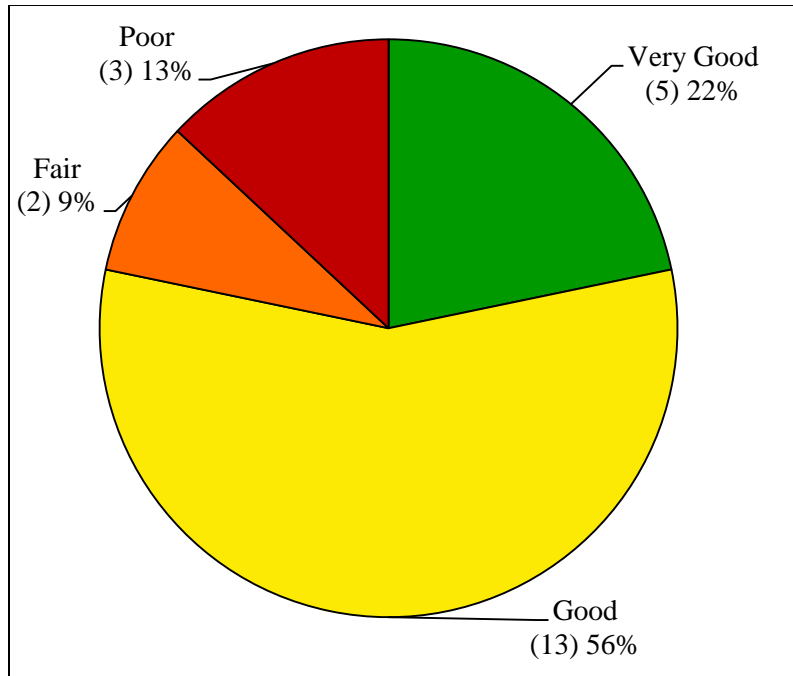
Figure 2, on the following page, shows the percentage of structures inspected in 2020 in each General Overall Condition category.

Figure 2: Structures Classified by General Overall Condition

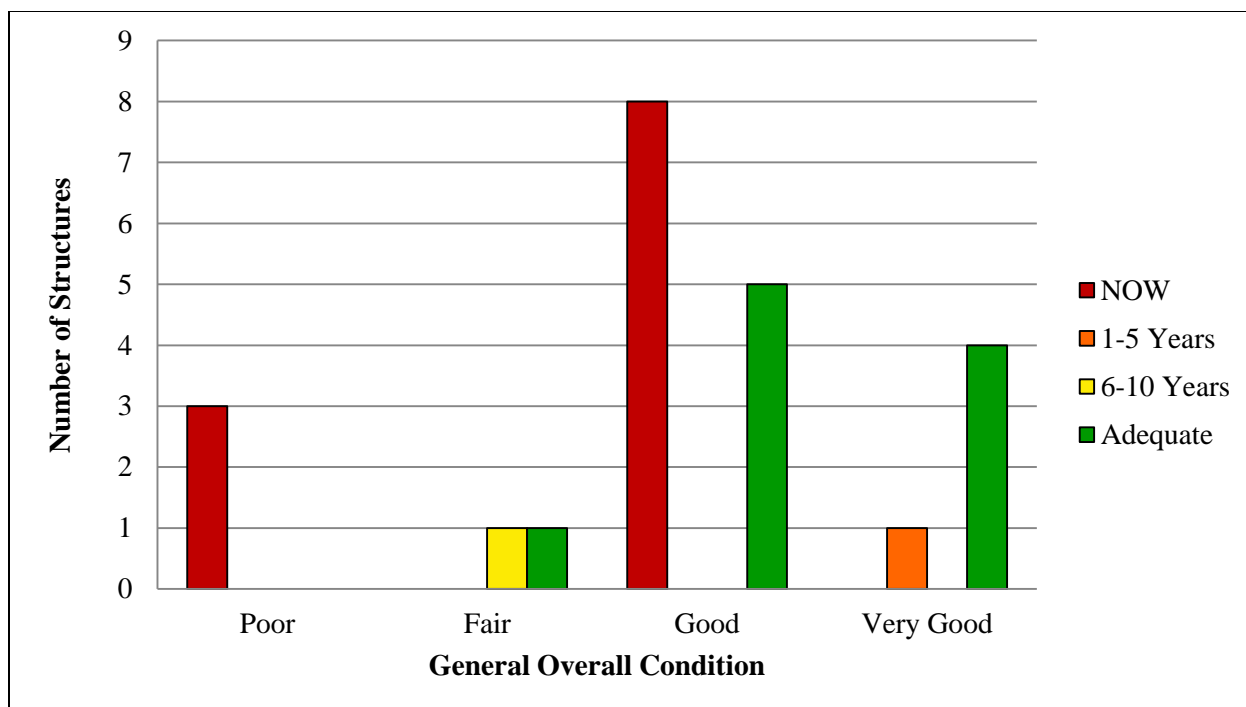
Table 4, below, and Figure 3, on the following page, summarize the relationship between the general overall condition and priority rating of the structures inspected.

Figure 3: Number of Structures for Each General Overall Condition Category by Priority Rating

General Overall Condition									
		Very Good		Good		Fair		Poor		Total	
Priority Rating	Adequate	4	18%	5	21%	1	4%	0	0%	10	43%
	6-10 Years	0	0%	0	0%	1	4%	0	0%	1	4%
	1-5 Years	1	4%	0	0%	0	0%	0	0%	1	4%
	NOW	0	0%	8	35%	0	0%	3	13%	11	48%
	Total	5	22%	13	56%	2	9%	3	13%	23	100%

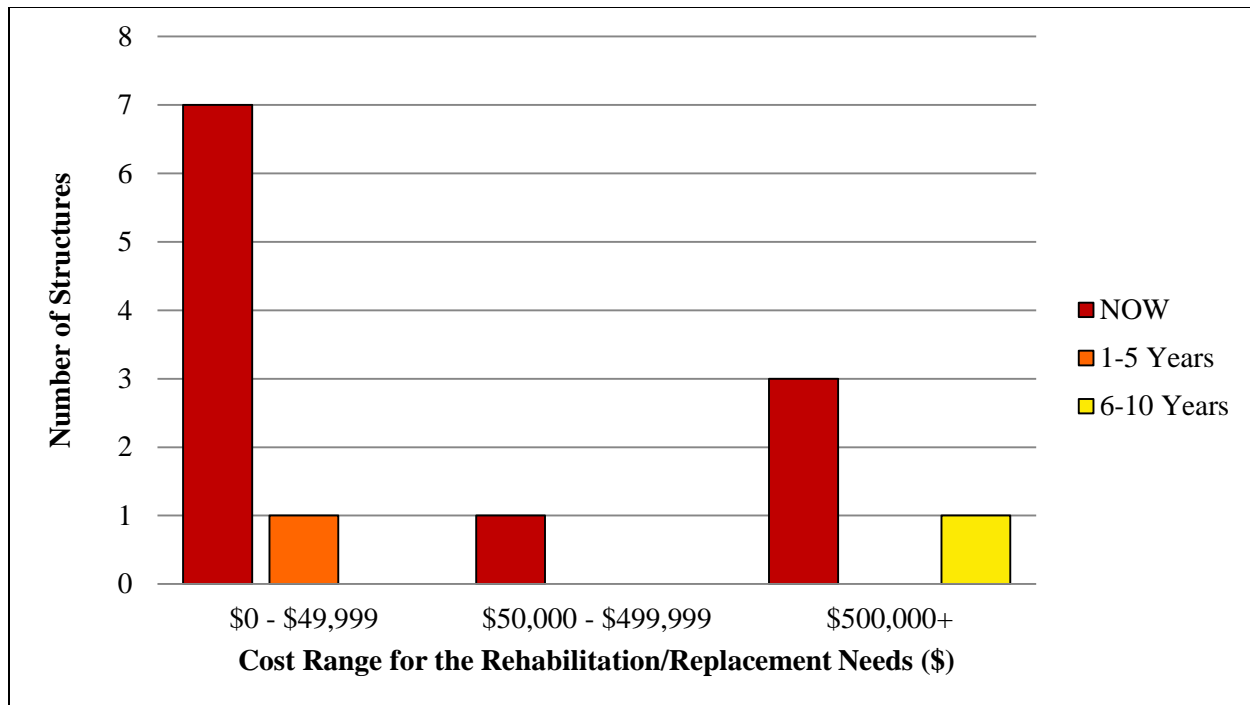
Table 5, below, and Figure 4, on the following page, summarize the relationship between the priority ratings of the structures inspected in 2020 relative to the estimated cost range for the rehabilitation/replacement needs.

Figure 4: Number of Structures in the Rehabilitation/Replacement Cost Range by Priority Rating
