ELLIS
Engineering Inc.

Reference: 2022 Bridge and Culvert Inspection Program, Rehabilitation/Replacement Needs
ELLIS File No.: 1070

We are pleased to submit one (1) copy of the 2022 Pelham Bridge and Culvert Inspection Program, Rehabilitation/ Replacement Needs ring binder, which contains inspection reports for twenty-three (23) of the Town of Pelham's bridges and culverts.

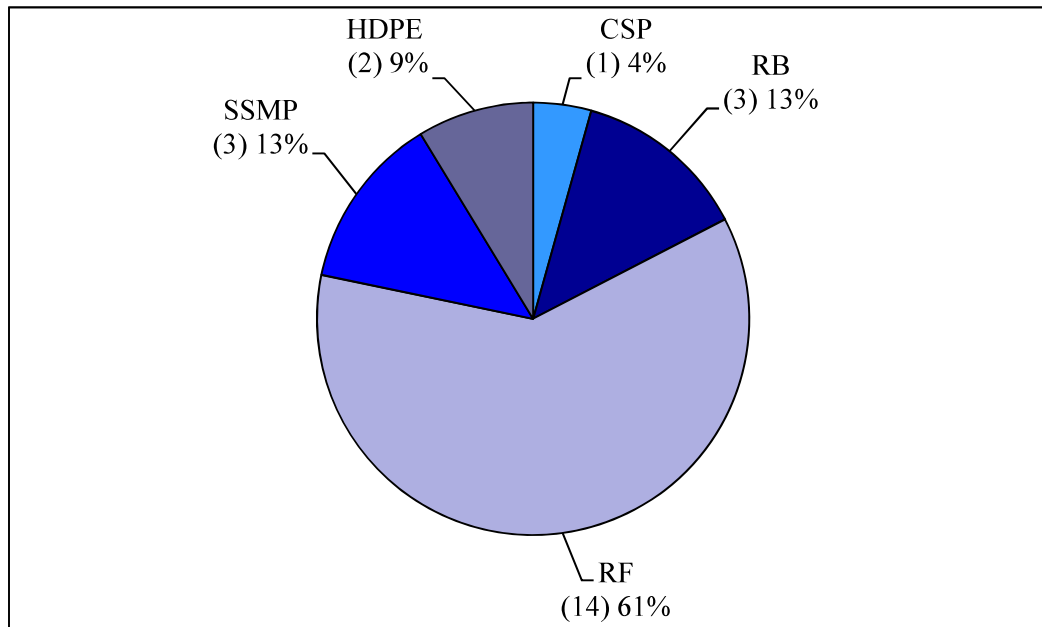
Figure 1: Structures Classified by Structure Type

Each of the structures inspected has been classified by structure type. Structure types include Rigid Frame (RF), Rigid Frame Box (RB), High Density Polyethylene Pipe (HDPE), Corrugated Steel Pipe (CSP), and Soil Steel Multi Plate (SSMP).

Figure 1, below, shows the percentage of structures classified under each type.

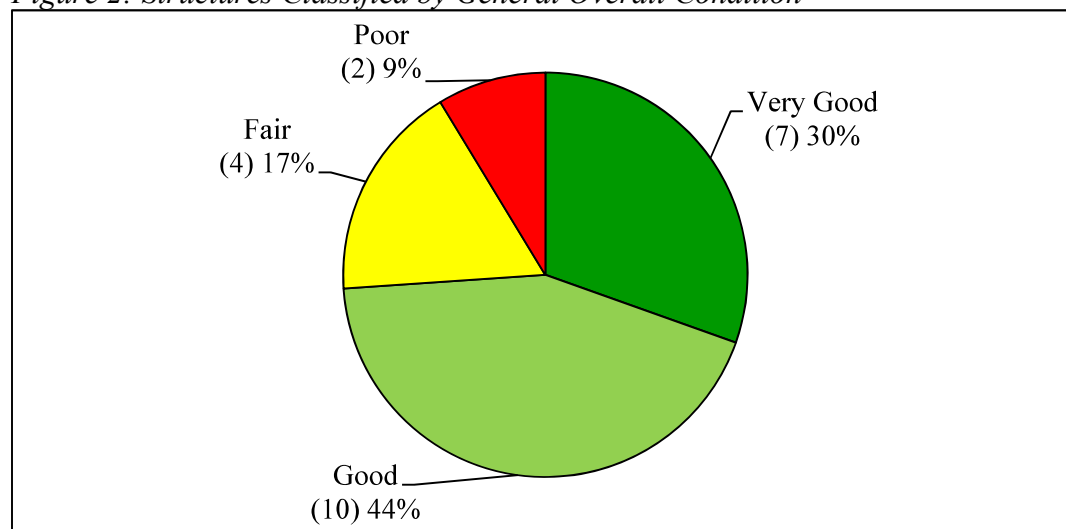
Figure 2: Structures Classified by General Overall Condition

Figure 2, below, shows the percentage of structures inspected in 2022 in each General Overall Condition category.

In addition to the priority rankings, the structures are classified with a General Overall Condition Rating and a corresponding Bridge Condition Index (BCI) value. The categories summarized in Table 1, below, were used to classify the structures.

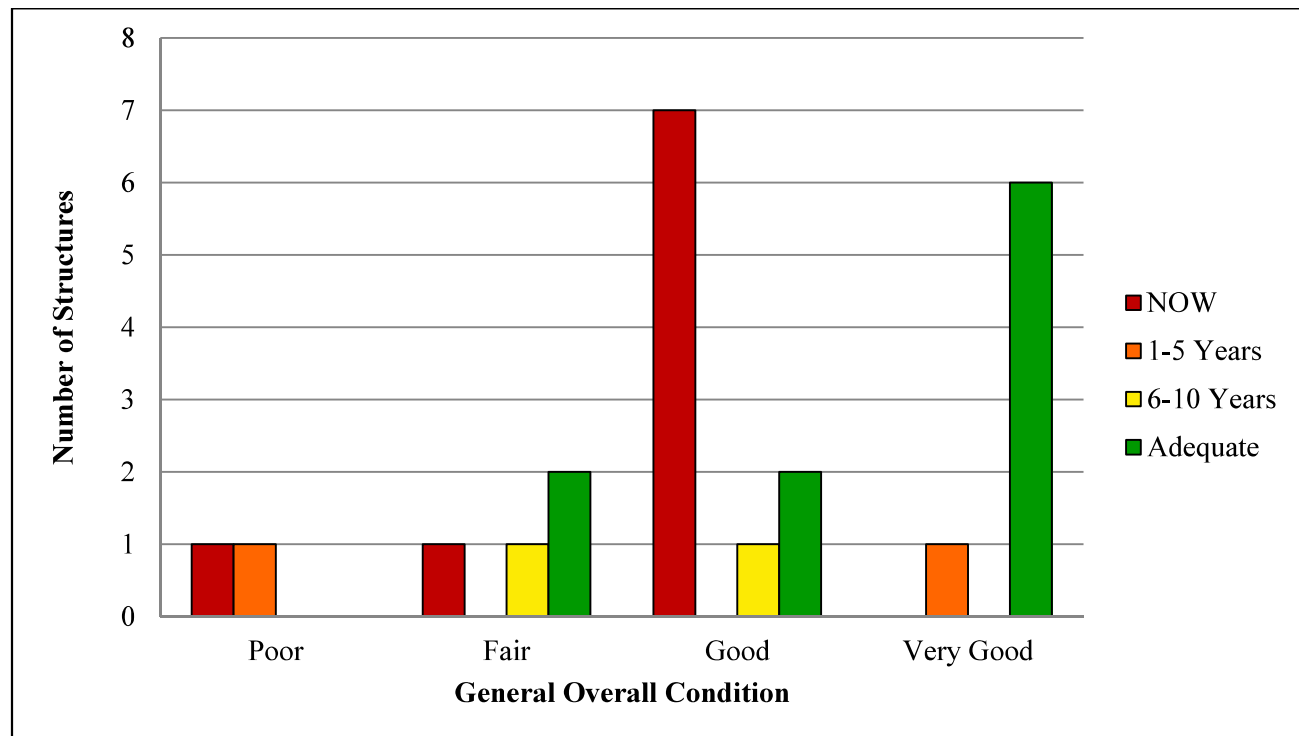
Figure 3: Number of Structures for Each General Overall Condition Category by Priority Rating

Table 4 and Figure 3, below, summarize the relationship between the general overall condition and priority rating of the structures inspected.

General Overall Condition									
		Very Good		Good		Fair		Poor		Total	
Priority Rating	Adequate	6	26%	2	9%	2	9%	0	0%	10	43%
	6–10 Years	0	0%	1	4%	1	4%	0	0%	2	9%
	1–5 Years	1	4%	0	0%	0	0%	1	4%	2	9%
	NOW	0	0%	7	30%	1	4%	1	4%	9	39%
	Total	7	30%	10	43%	4	17%	2	9%	23	100%

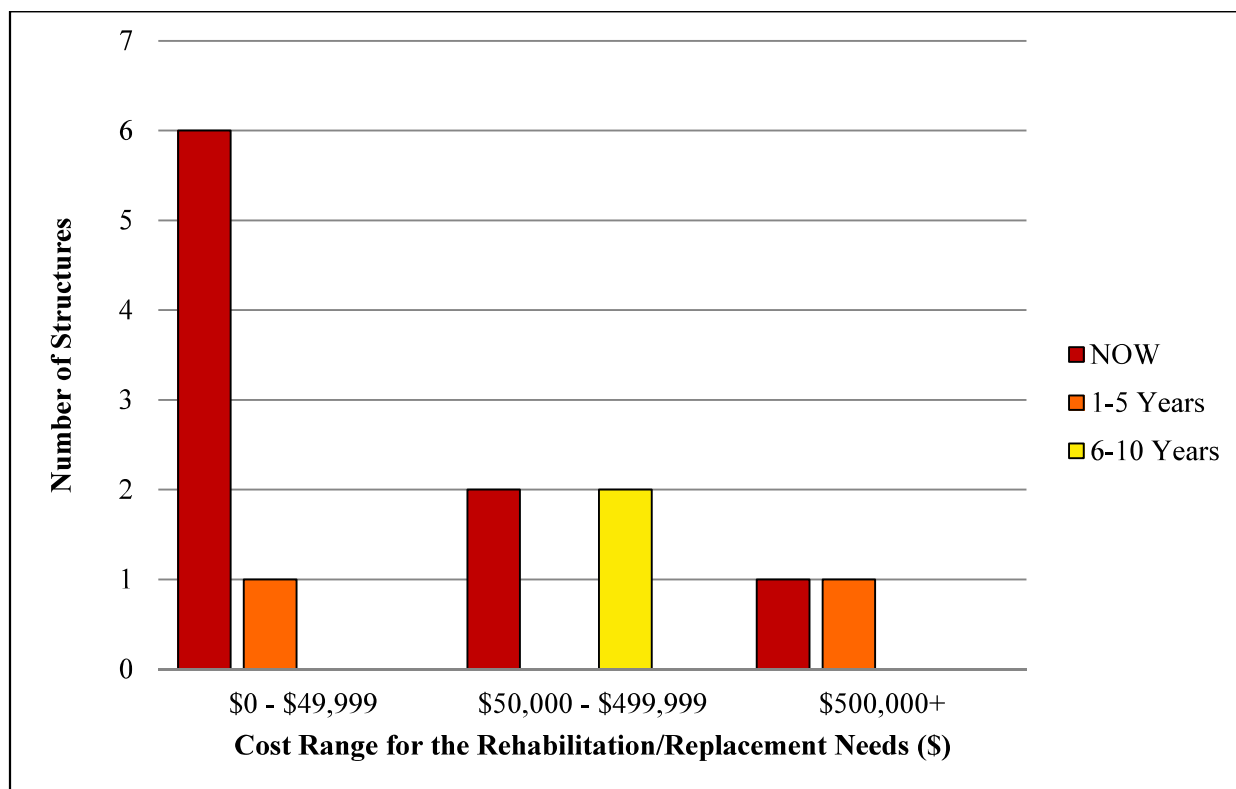
Figure 4: Number of Structures in the Rehabilitation/Replacement Cost Range by Priority Rating

Table 5 and Figure 4, below, summarize the relationship between the priority ratings of the structures inspected in 2022 relative to the estimated cost range for the rehabilitation/replacement needs.
