Drainage Study of the Farr, Webber and River Road Area

Town of Pelham Council Meeting

April 19, 2023

Presented by: Dr. Bahar SM

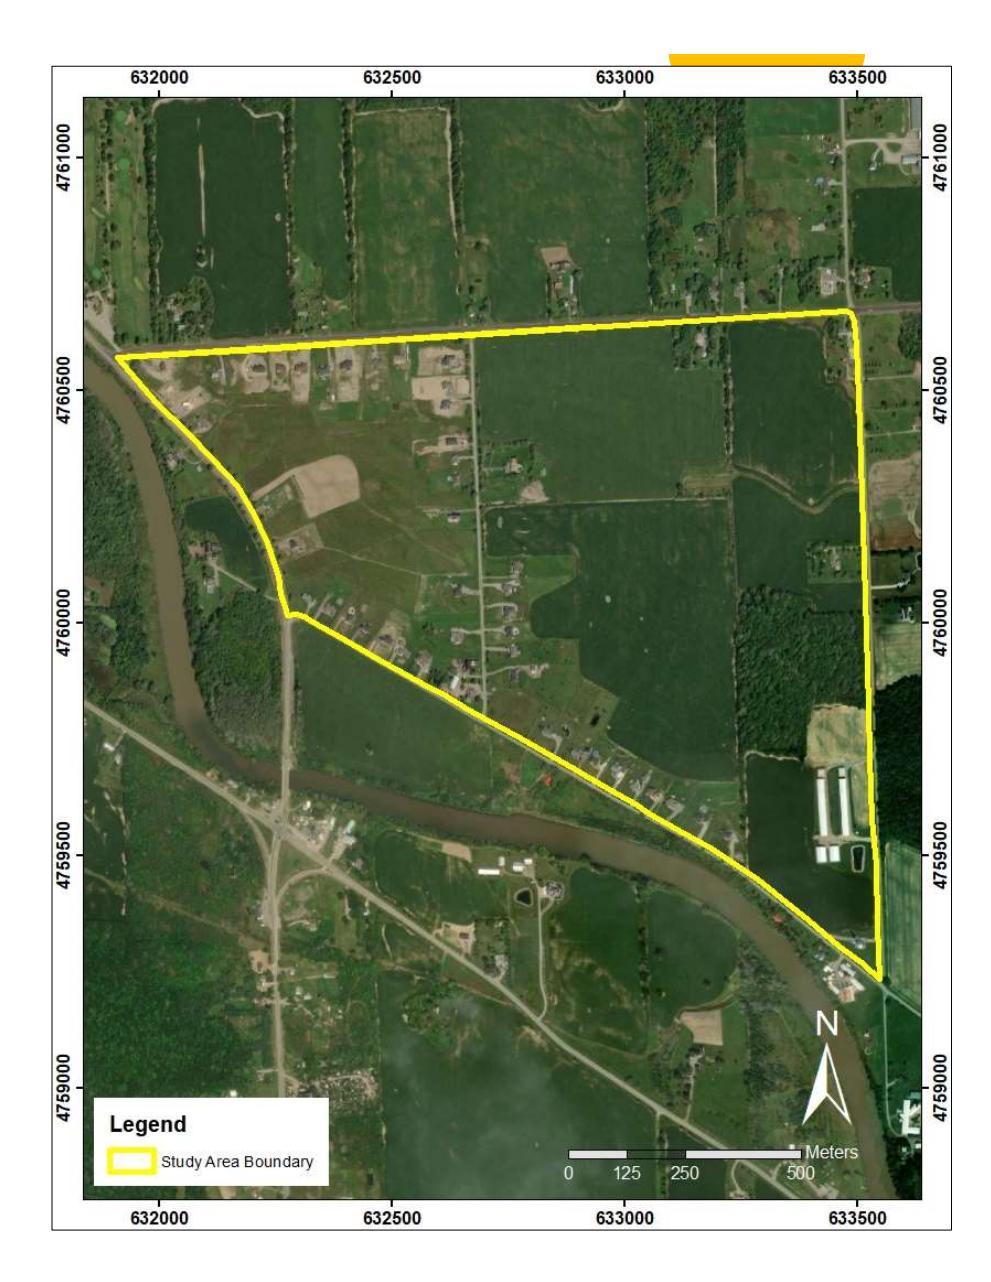
- The Farr, Webber and River Road area in the Town of Pelham encompasses an area of approximately **1.27 sq.km**
- **Extent of Study Area:** Victoria Avenue in the West and Church Street in the East. The Area is bounded Webber Road in the north and River Road in the South •
- Types of Data Used for analysis:
 - Hydrometeorological data of the study area (i.e., Rainfall Data using the Ministry of Transportation IDF Curve Lookup Table)
 - Hydrogeology of the study area (i.e., Soil Data)
 - Land Use of the study area (i.e., Land-use and Land-cover Data)
 - Topographic data (Field survey and Hydraulic structure survey)
 - Historical Aerial Images
- Drainage Area after delineation of watershed : 2.74 sq.km
 Number of Delineated Subbasins: 21 ٠

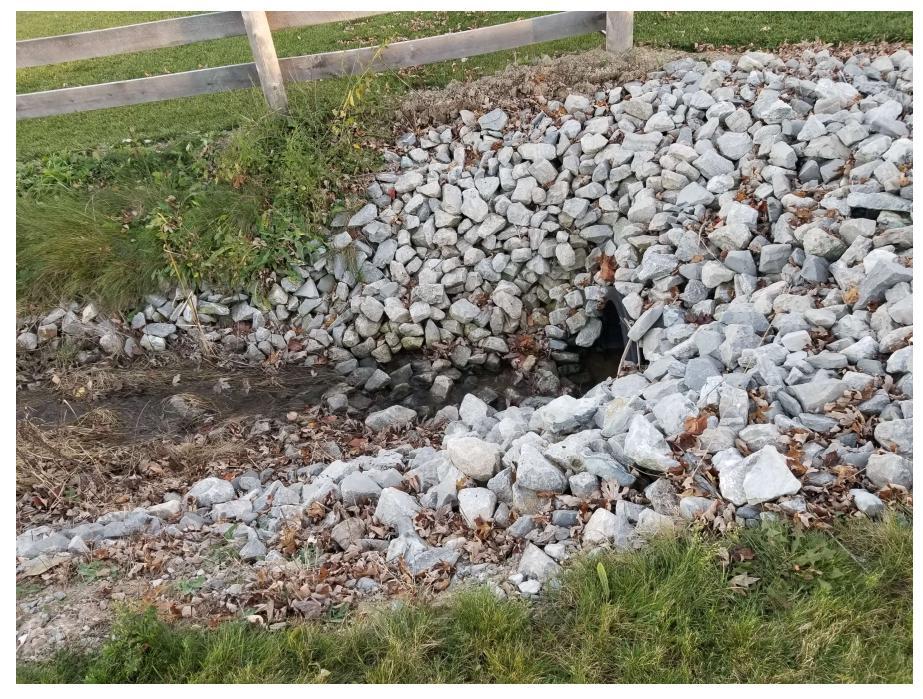
Culvert at 275-285 Victoria Avenue Property

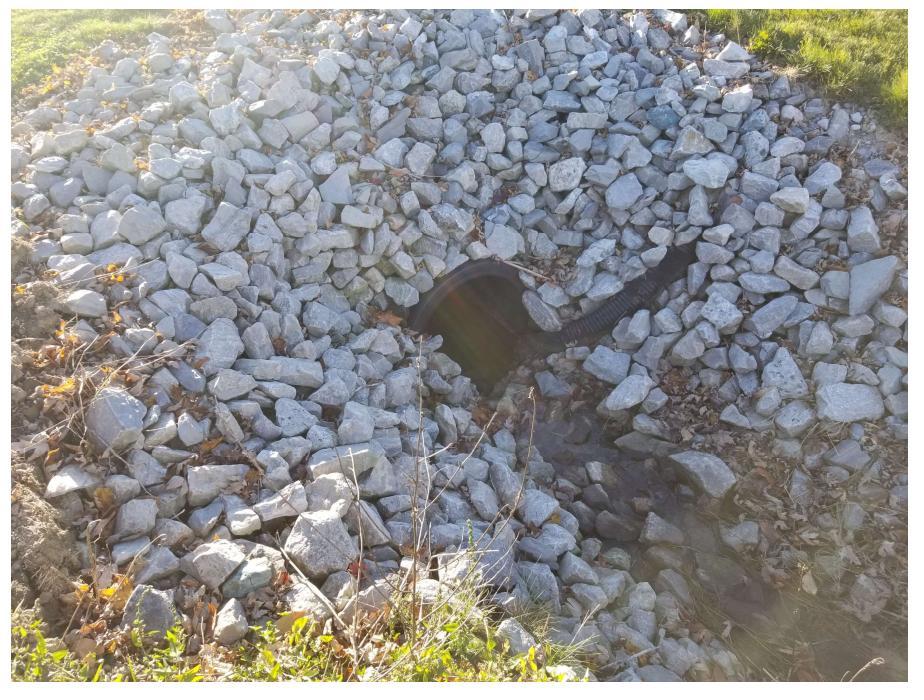
Culvert Inlet near 265-275 Victoria Avenue Property

Culvert outlet near 285 Victoria Avenue Property

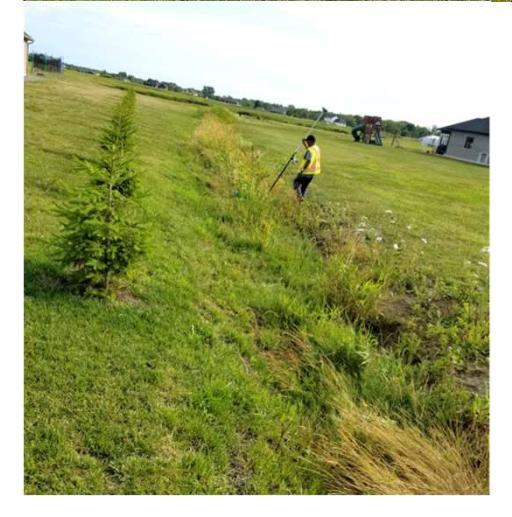
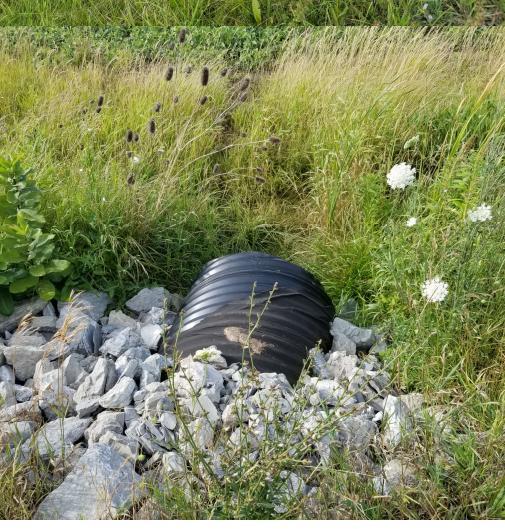
FLOW OBSTRUCTION due to High Vegetation along the Crossings and Open Channels

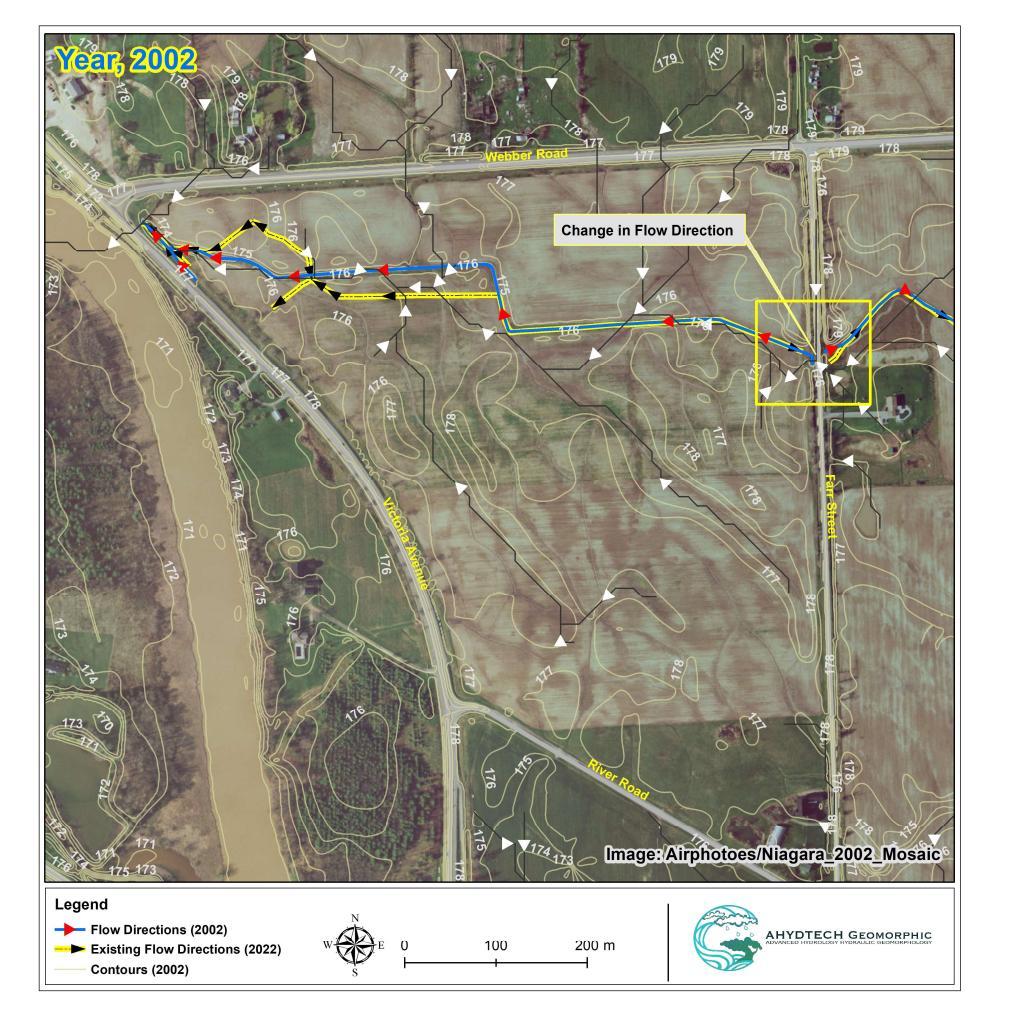
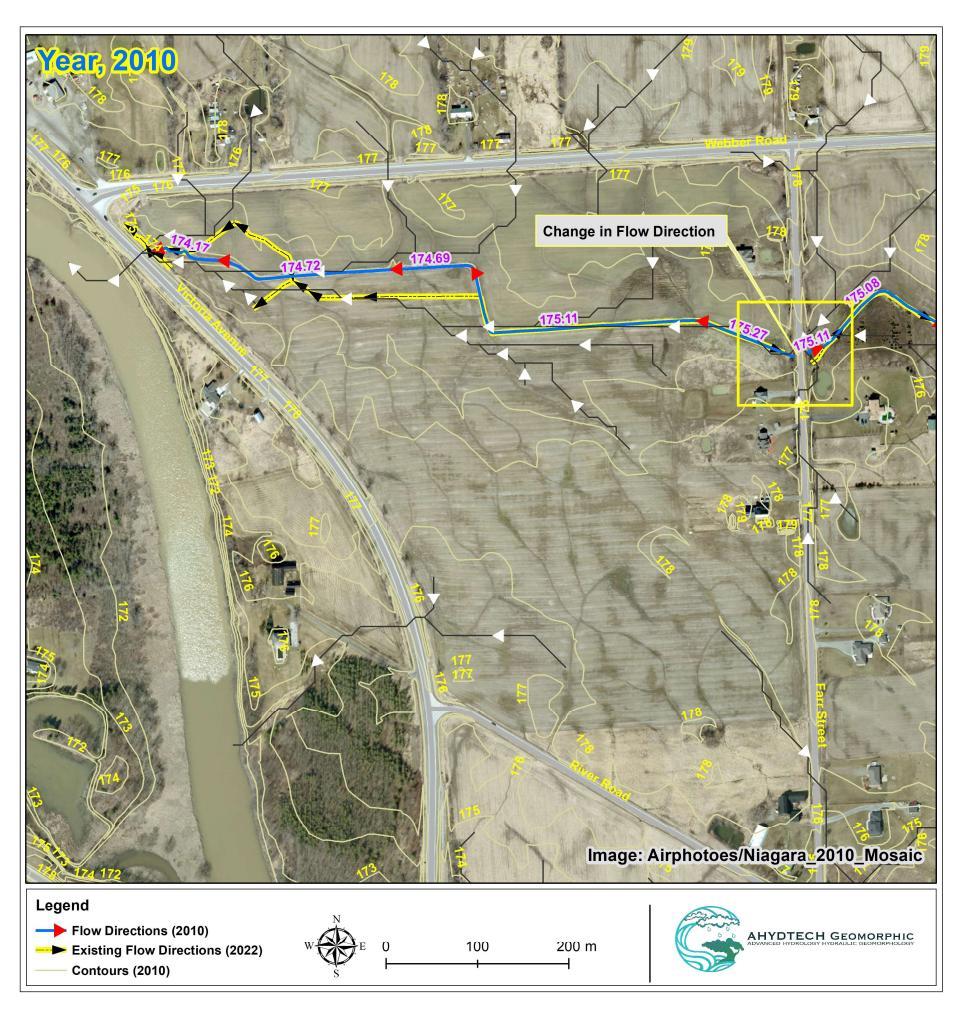
Historical Aerial Image Analysis (2002 and 2010)

2002 and 2010 shows almost similar condition where the change of flow directions can be noticed near the Farr road, where one direction of the reach flows towards the west and the other towards the east.

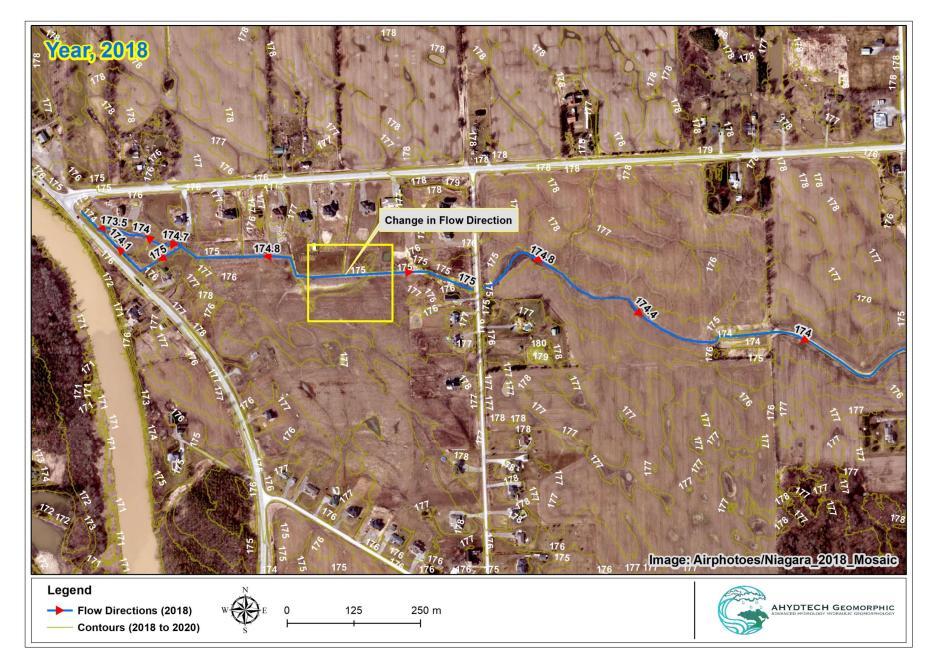
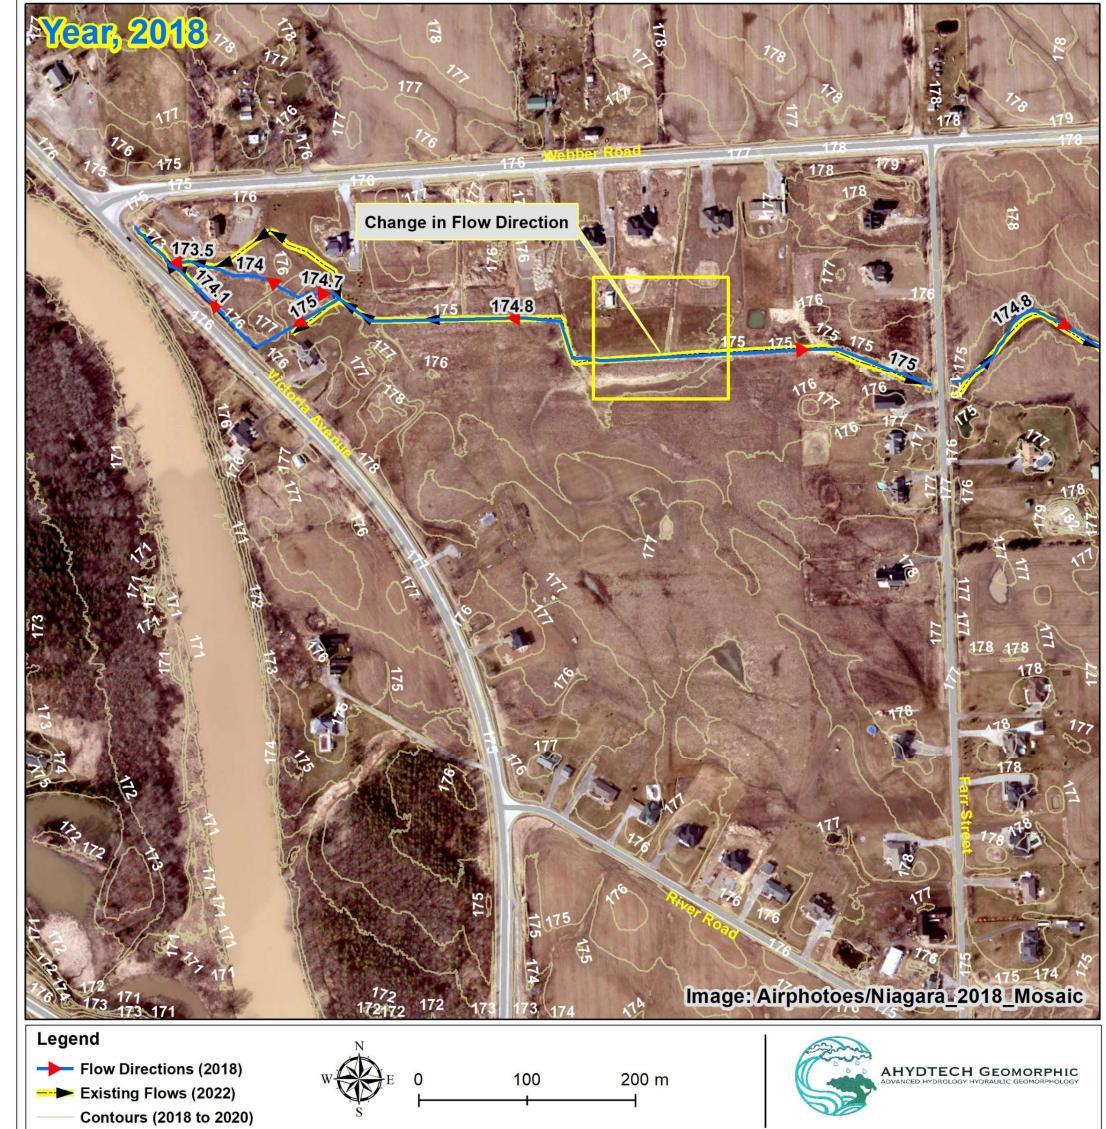
Historical Aerial Image Analysis (2018)

2018 shows the change in flow direction location shifted towards the west of Farr Road. Development through residential houses took place within the area compared to 2010. An additional channel is seen between two properties at the Victoria Avenue properties which turns at an angle of 90 degree (approx.)

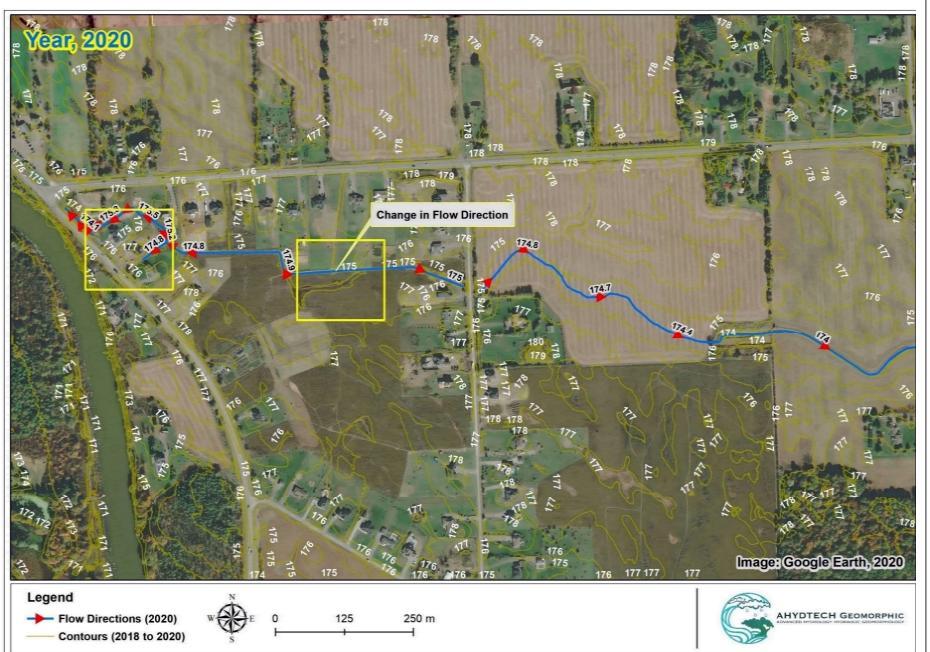
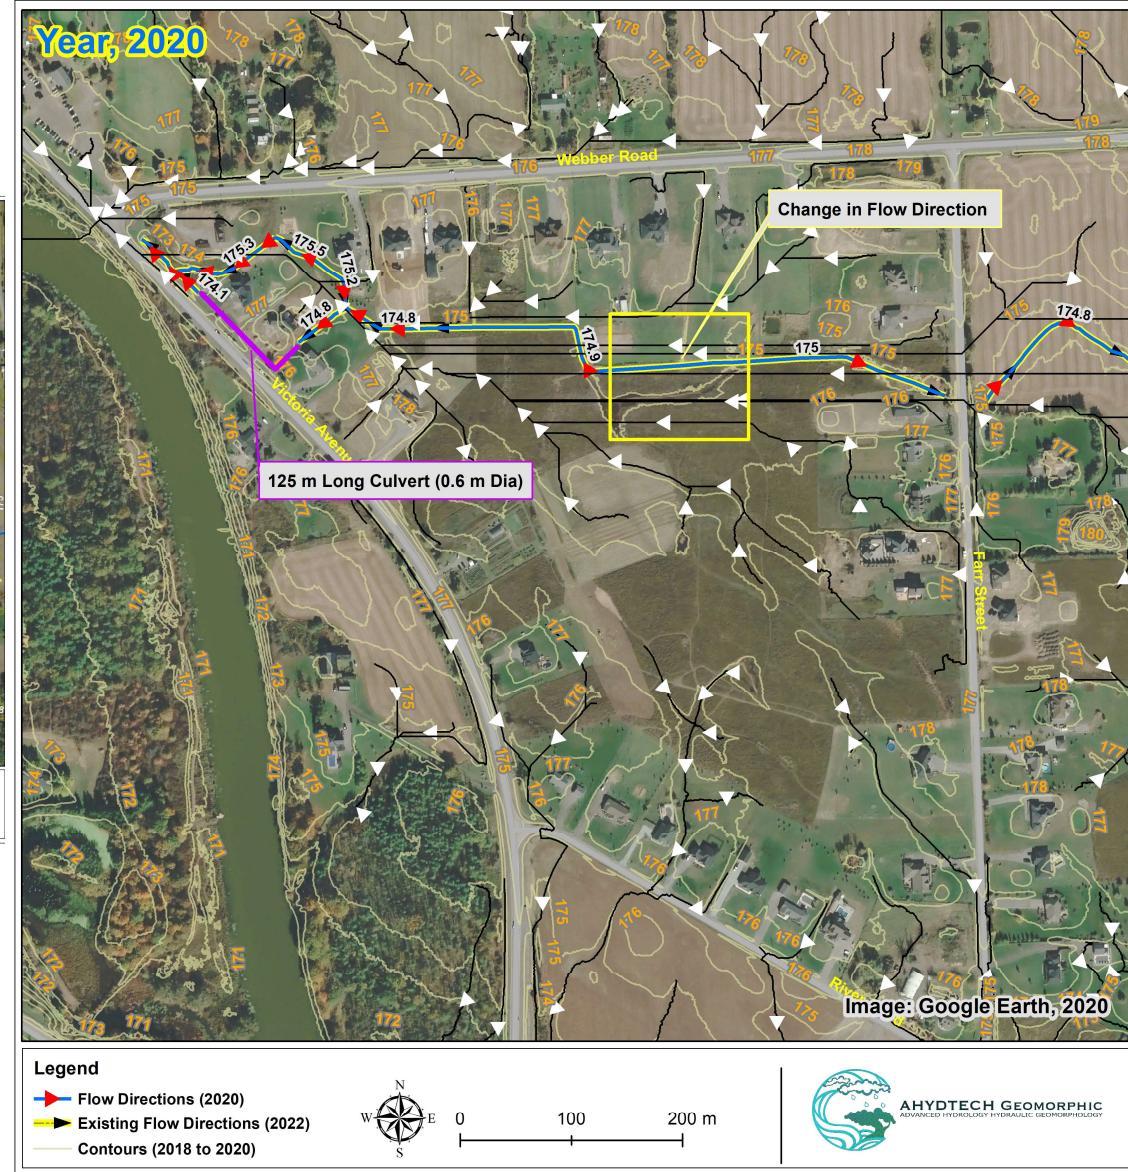
Historical Aerial Image Analysis (2020)

2020 shows the flow direction location change location like 2018. In the West channel, a 0.6m diameter and 125m long culvert runs in between 275 Victoria Avenue and 285 Victoria Avenue properties which runs 35m in between the two properties and then turns 90 degrees under the ditch along Victoria Avenue and the West Channel downstream.

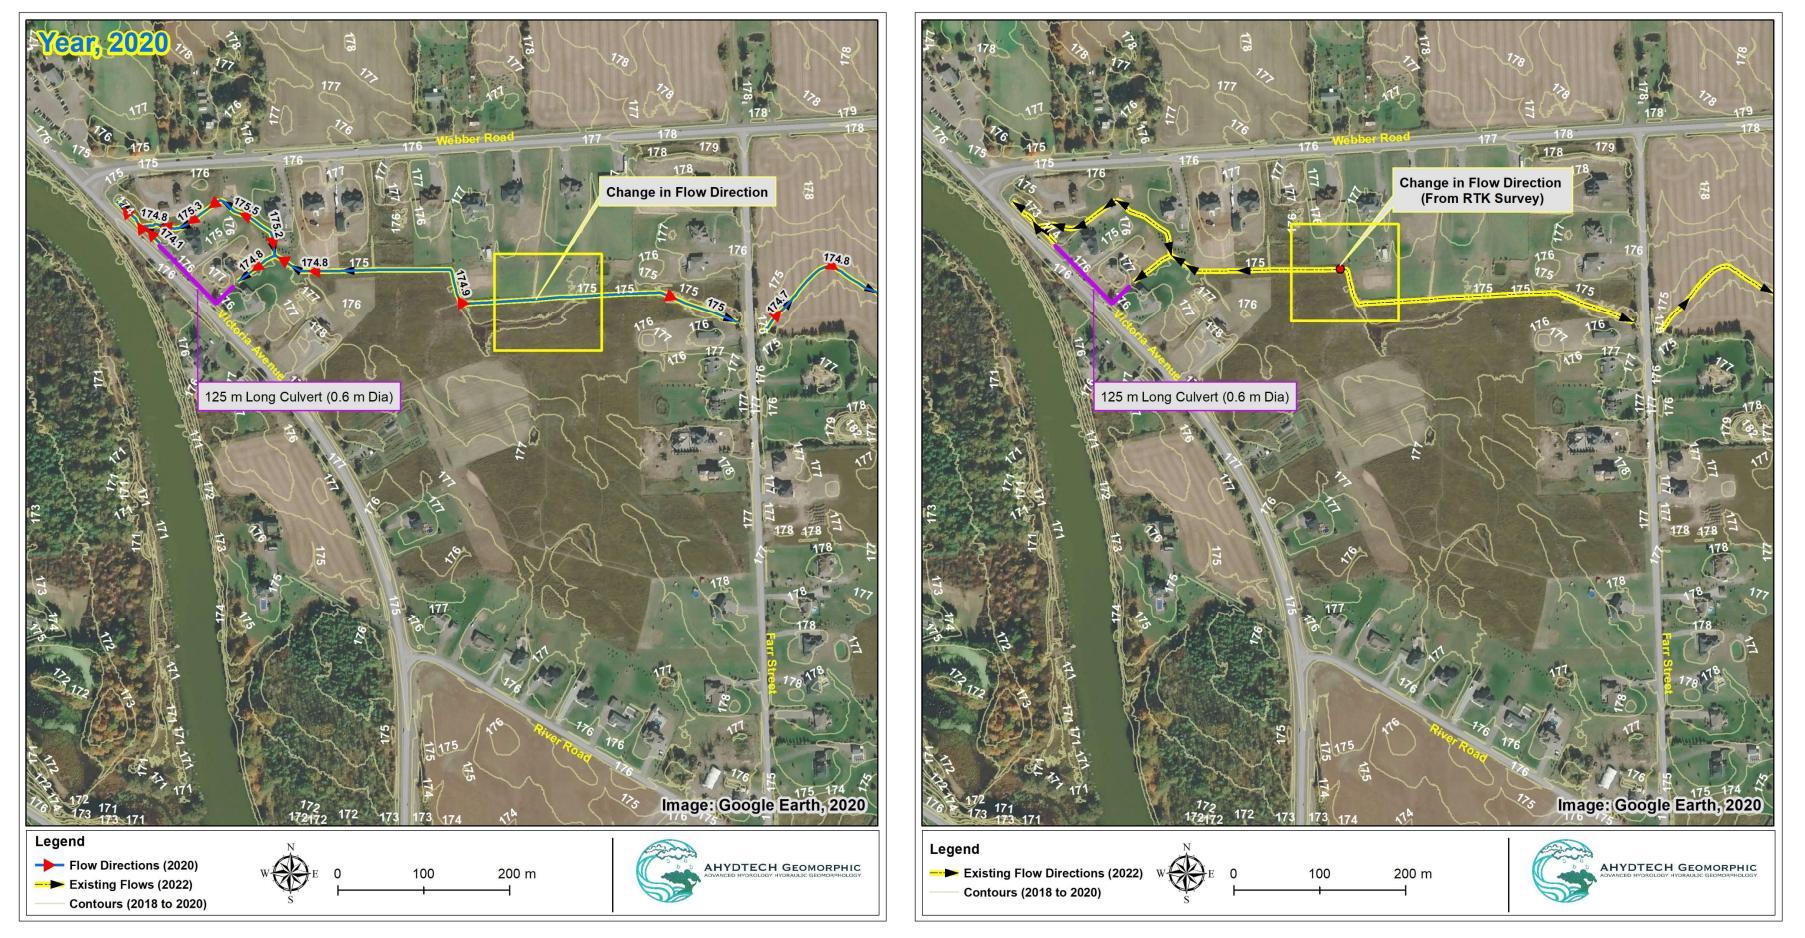
Existing Condition at the Study Area

The change in flow location obtained from the topographic survey conducted (in 2022) (*right side image*) shows the shifting of the changed location more towards west due to land filling issues.

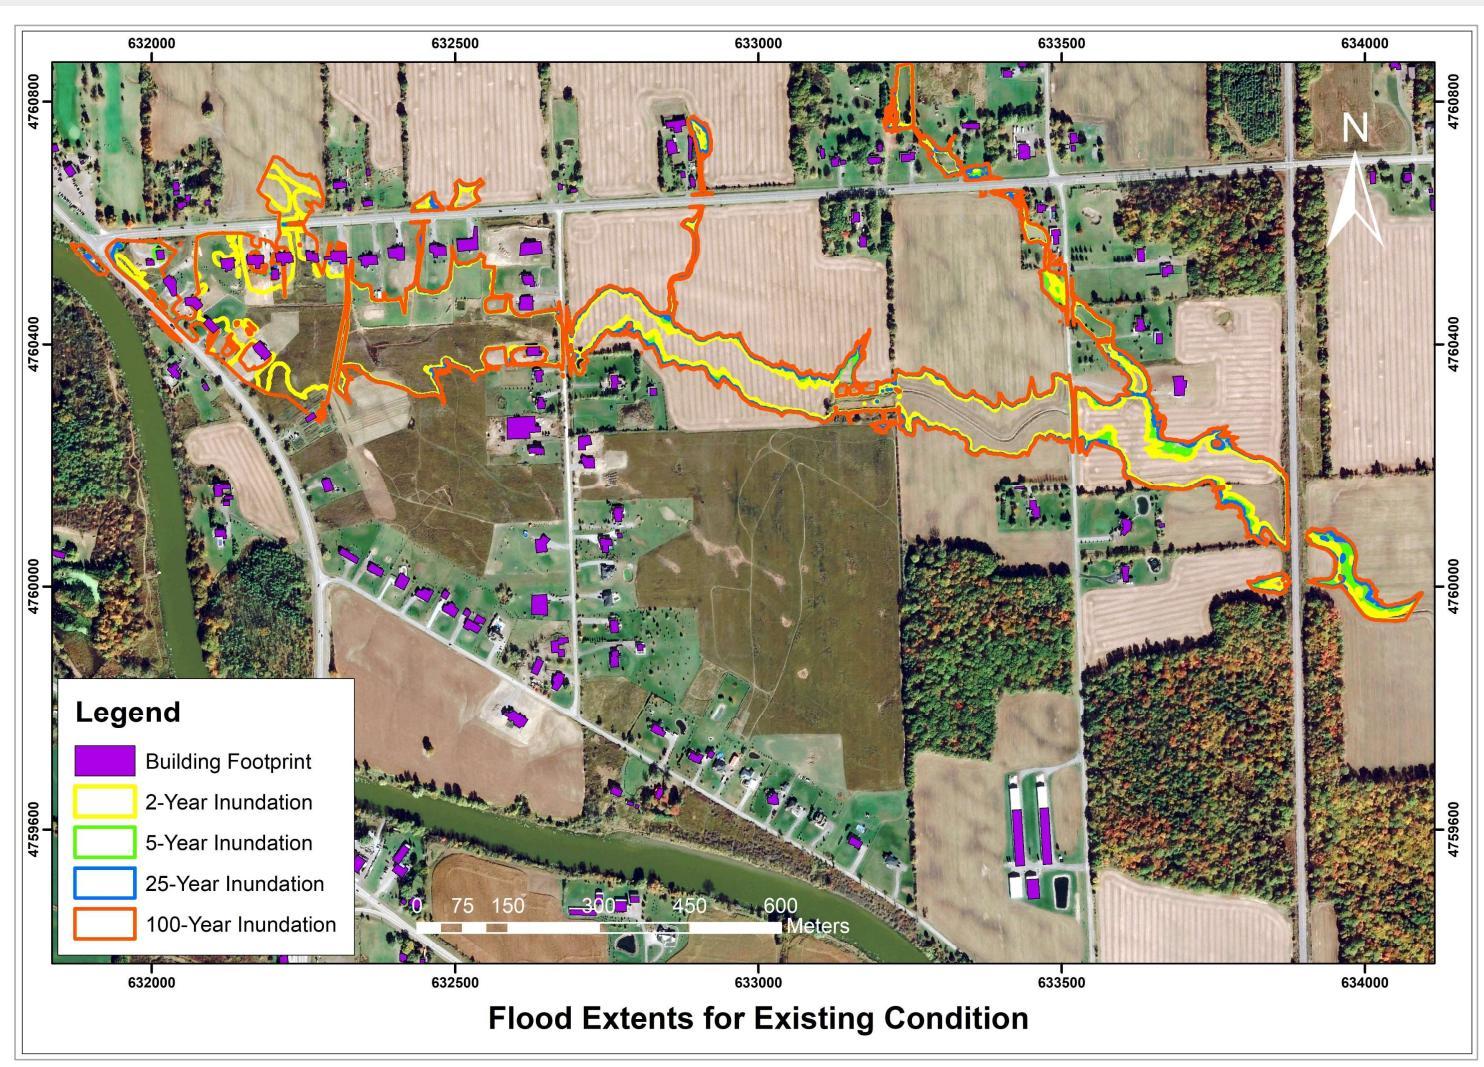
Flood Inundation Extent Map

- Near the Victoria Road and Webber Road, the extent of inundation appears to be higher.
- High inundation has also been observed near the Farr Road.
- The extent of flooding near the Church Street appears to be moderate.
- At the east side of the Webber Road, there seems to be a minimal degree of inundation.

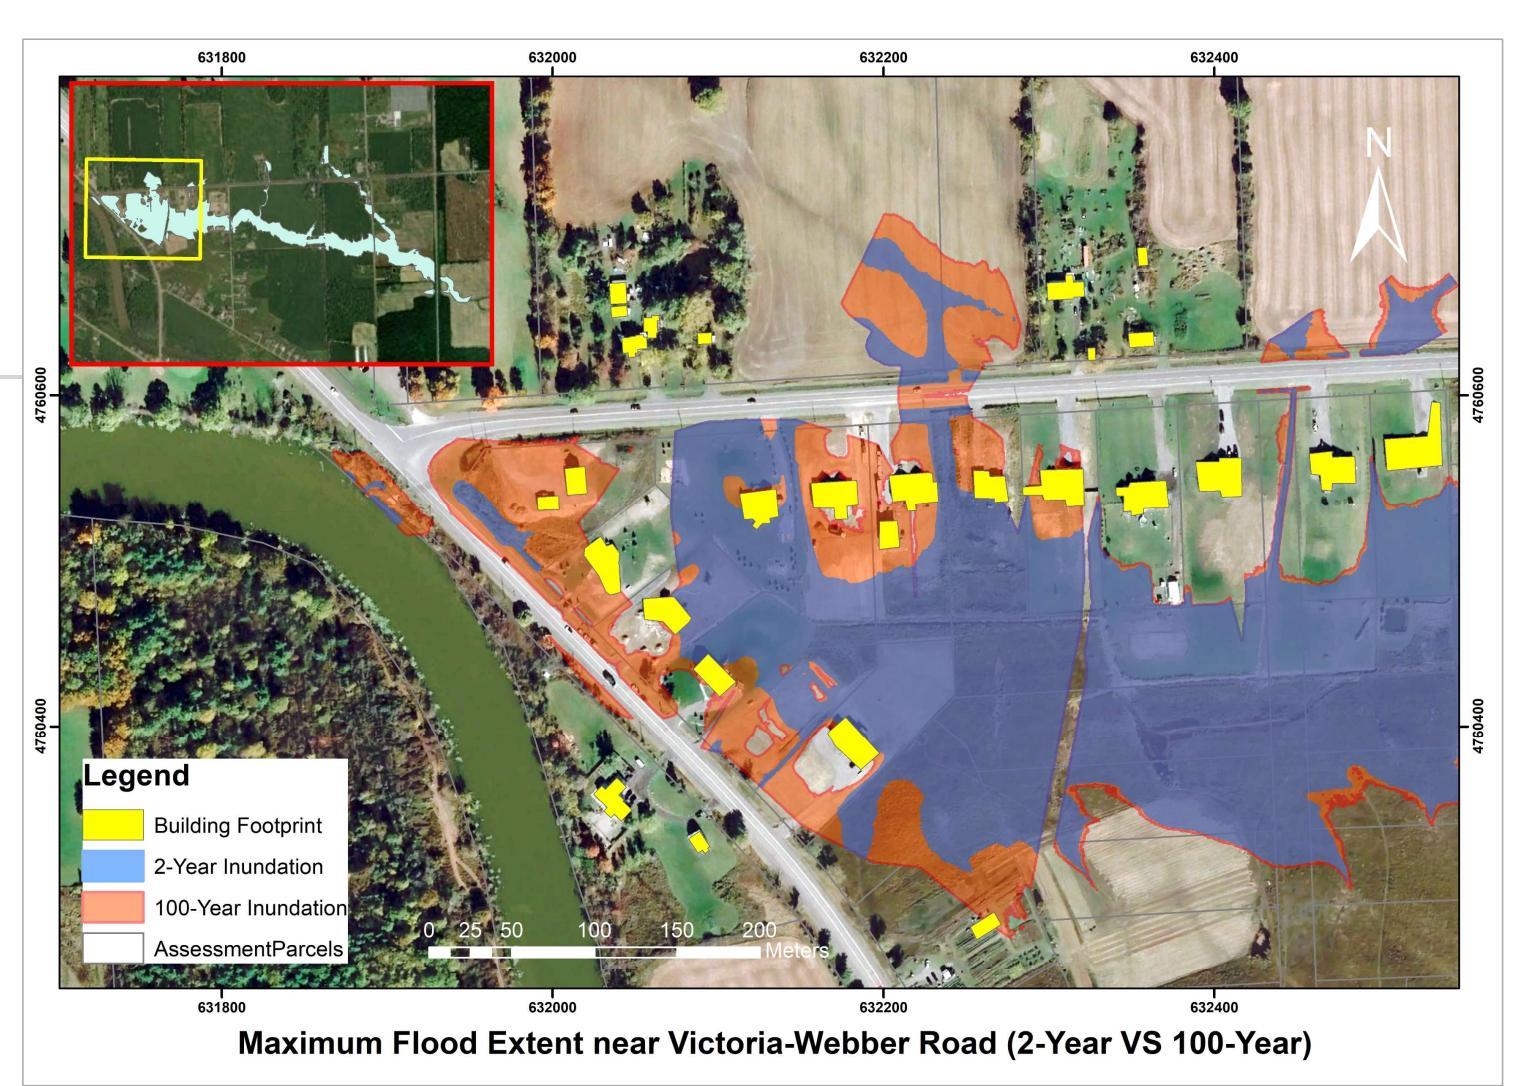
Maximum Inundation

- In the West channel, a 0.6m diameter and 125m long culvert runs in between 265 Victoria Avenue and 275 Victoria Avenue properties which runs 35m in between the two properties and then turns 90 degrees under the ditch along Victoria Avenue and the West Channel downstream.
- This under sized culvert provides backwater effect even for the 2-year flow and flooding in both sides of the watercourse in the West channel.

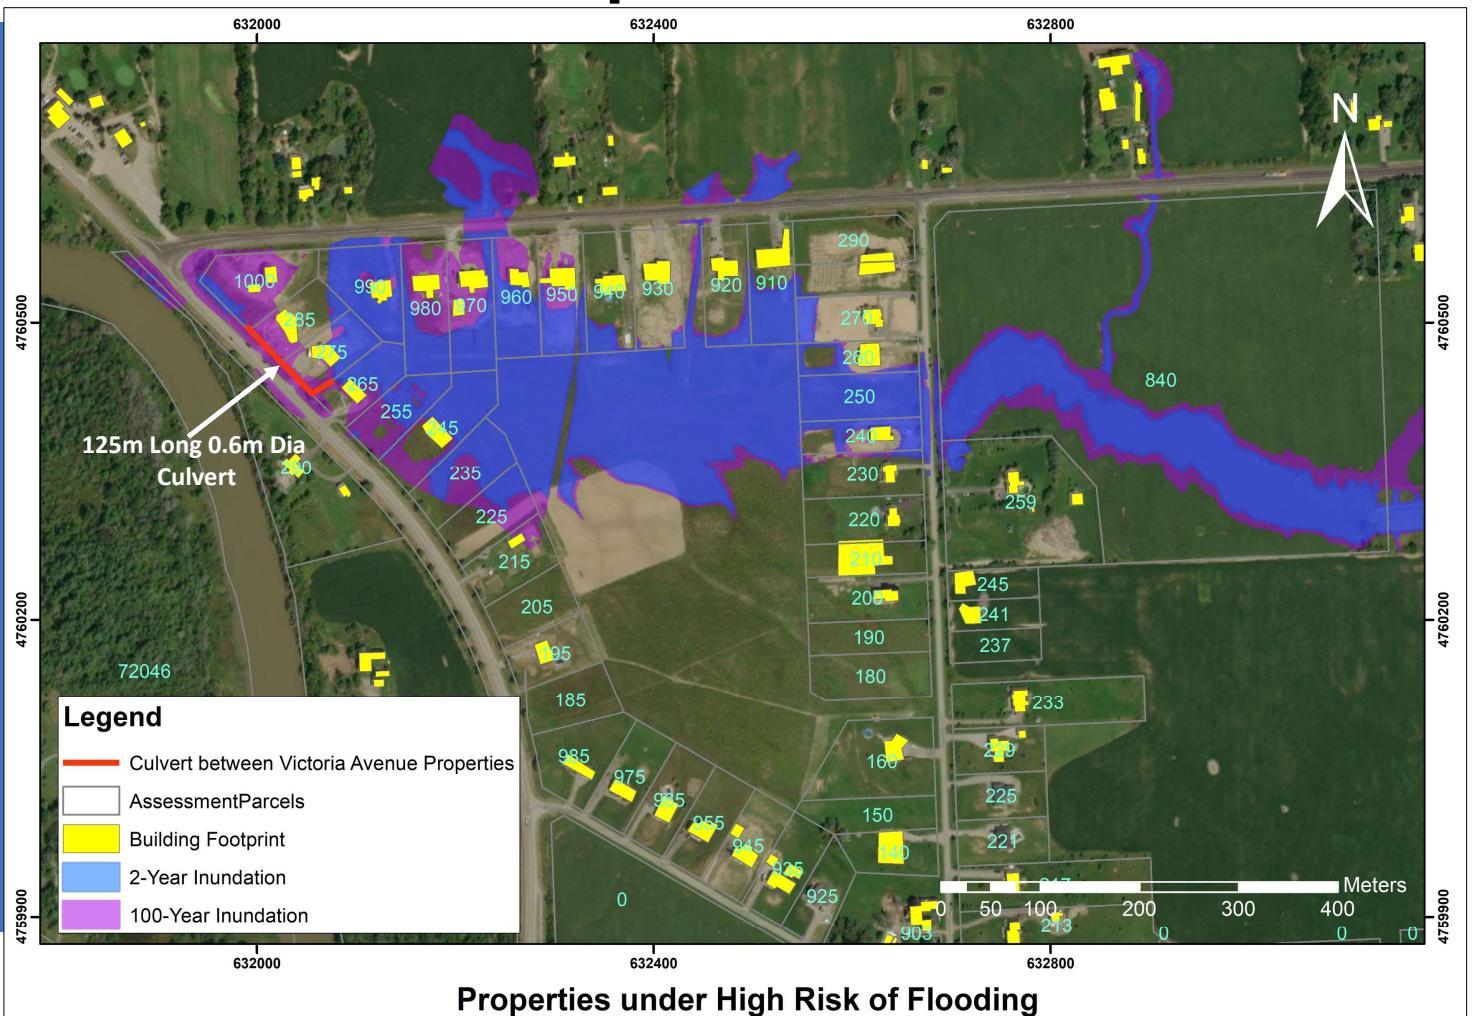
Buildings within the Floodplain

The bounding area of Farr, Webber, Victoria, and River Road has the maximum extent of flooding and inundated water surface elevation compared to the other segments of the study area.

A considerable number of properties (i.e. 950-990,1000 Webber Road properties, 225-285 Vitoria Avenue properties) fall within the area of extreme flooding.

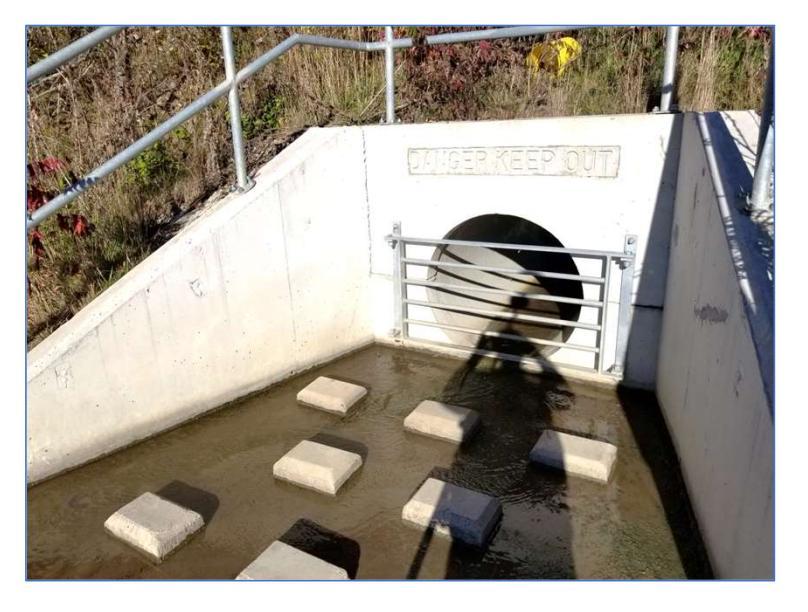
- Existing diameter of the culvert at inlet was found to be 0.5m and hydraulic analysis shows that the culvert has the capacity to convey up to 25-year return period flood events.
- Different culvert diameter (0.6m, 0.8m and 1m) were used in the hydraulic model to check and assess the flooding extents.
- When the size of the culvert has been increased to <u>1m diameter, no flow stagnation and inundation</u> <u>occurs in the properties which had been flooded</u> <u>previously.</u>

Figure : Existing undersized Culvert under Victoria Road

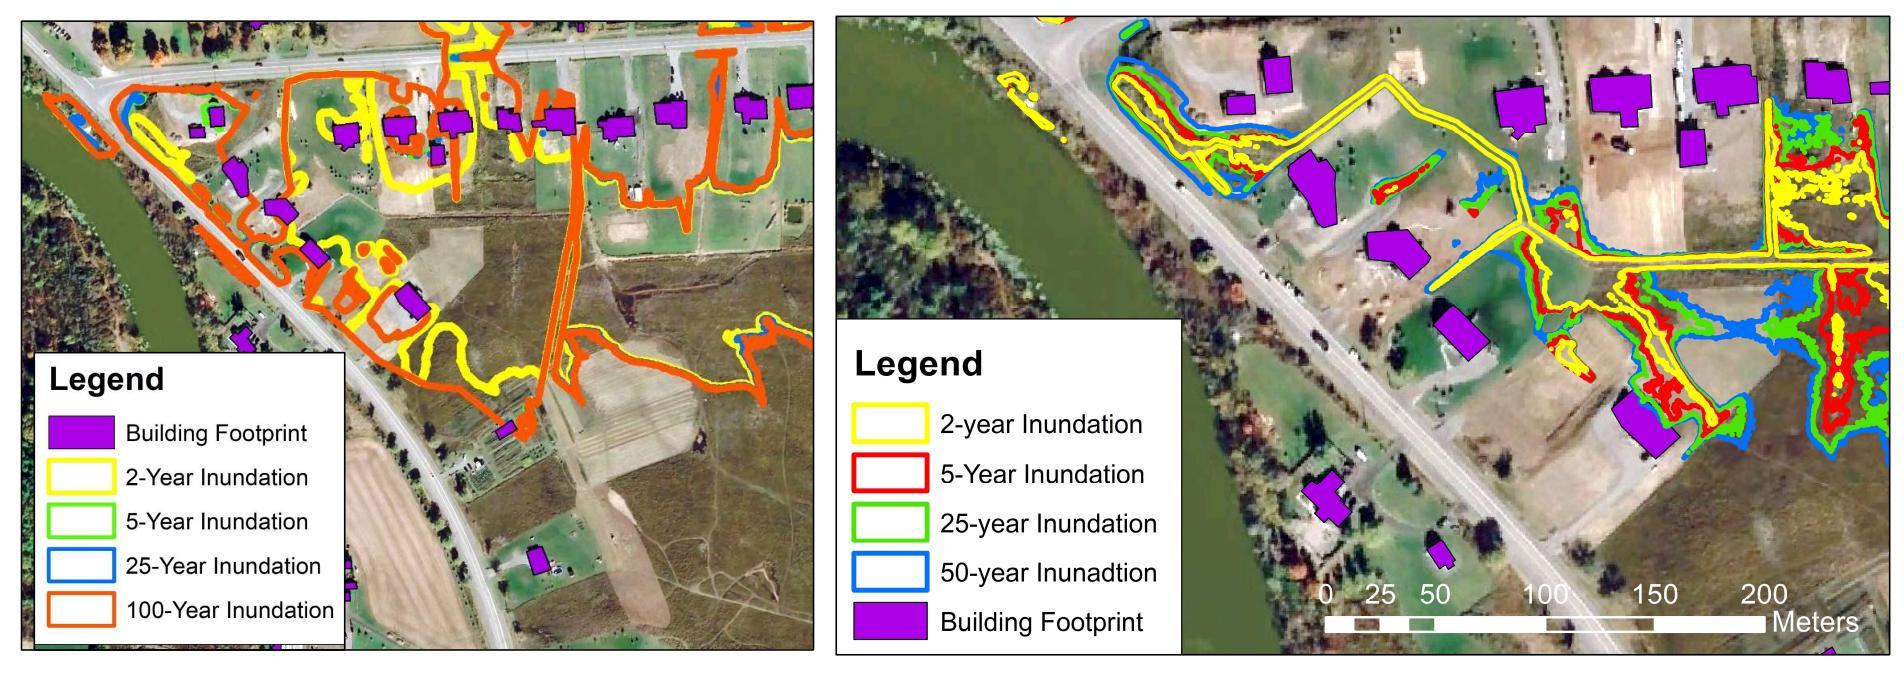
Figure : Flooding extent with the existing 0.5m diameter Culvert under Victoria Road

Figure : Flooding extent with the proposed 1m diameter Culvert under Victoria Road along when implemented along with the Alternative Option 2

A substantial reduction in inundation extents can be observed when the diameter of the Victoria Road culvert is increased to 1m.

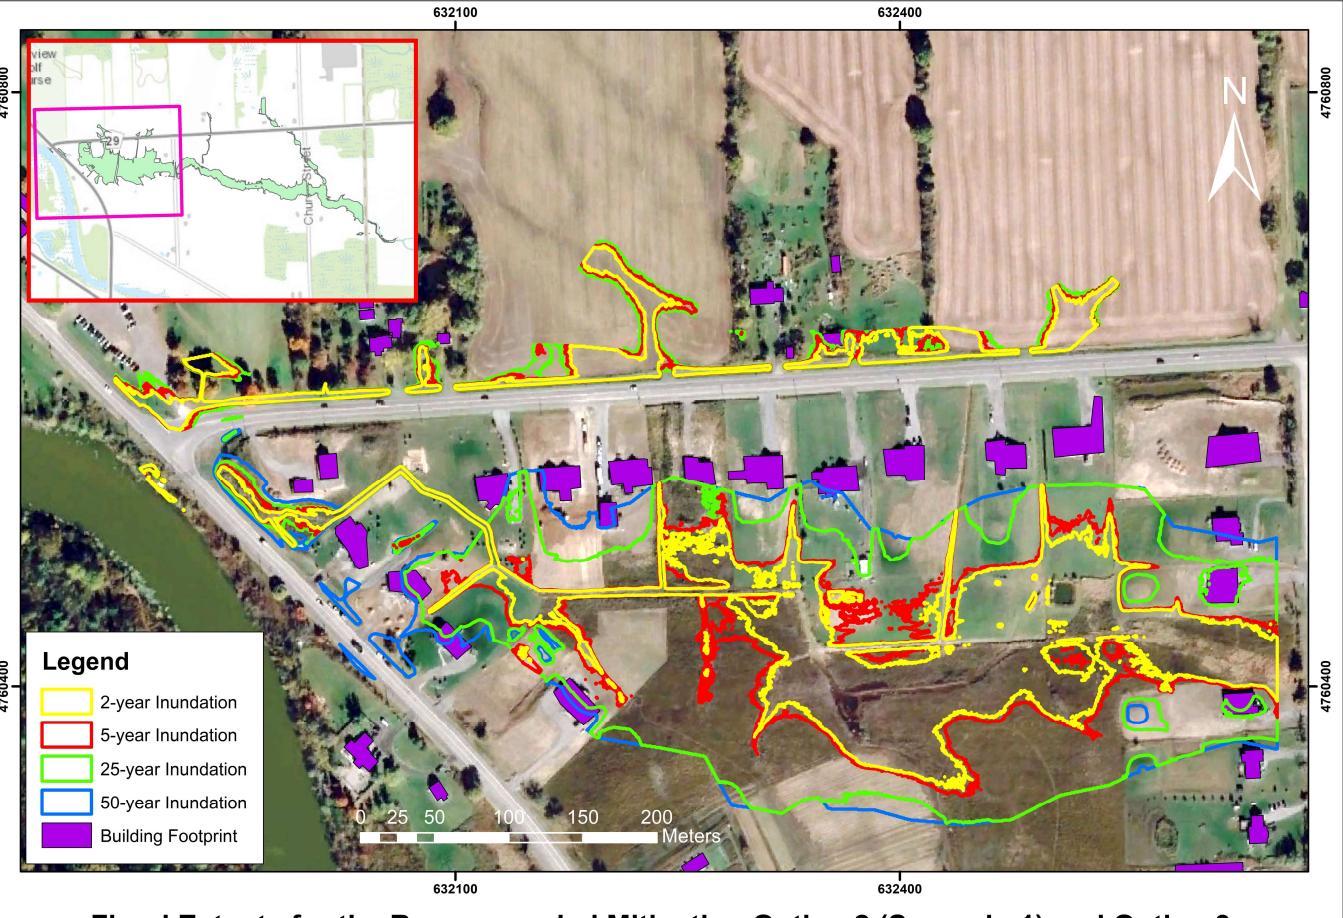
-Model results show that the 125m culvert can successfully convey 20% of the flow generated by 2-year and 5-Year Return Period floods to the Welland river without causing any inundation.

-The 125m culvert cannot capacitate 20% of the flow generated by 25-year flood event and causes significant backwater for 25 and greater return period's floods.

Flood Extents for the Recommended Mitigation Option 2 (Scenario 1) and Option 3

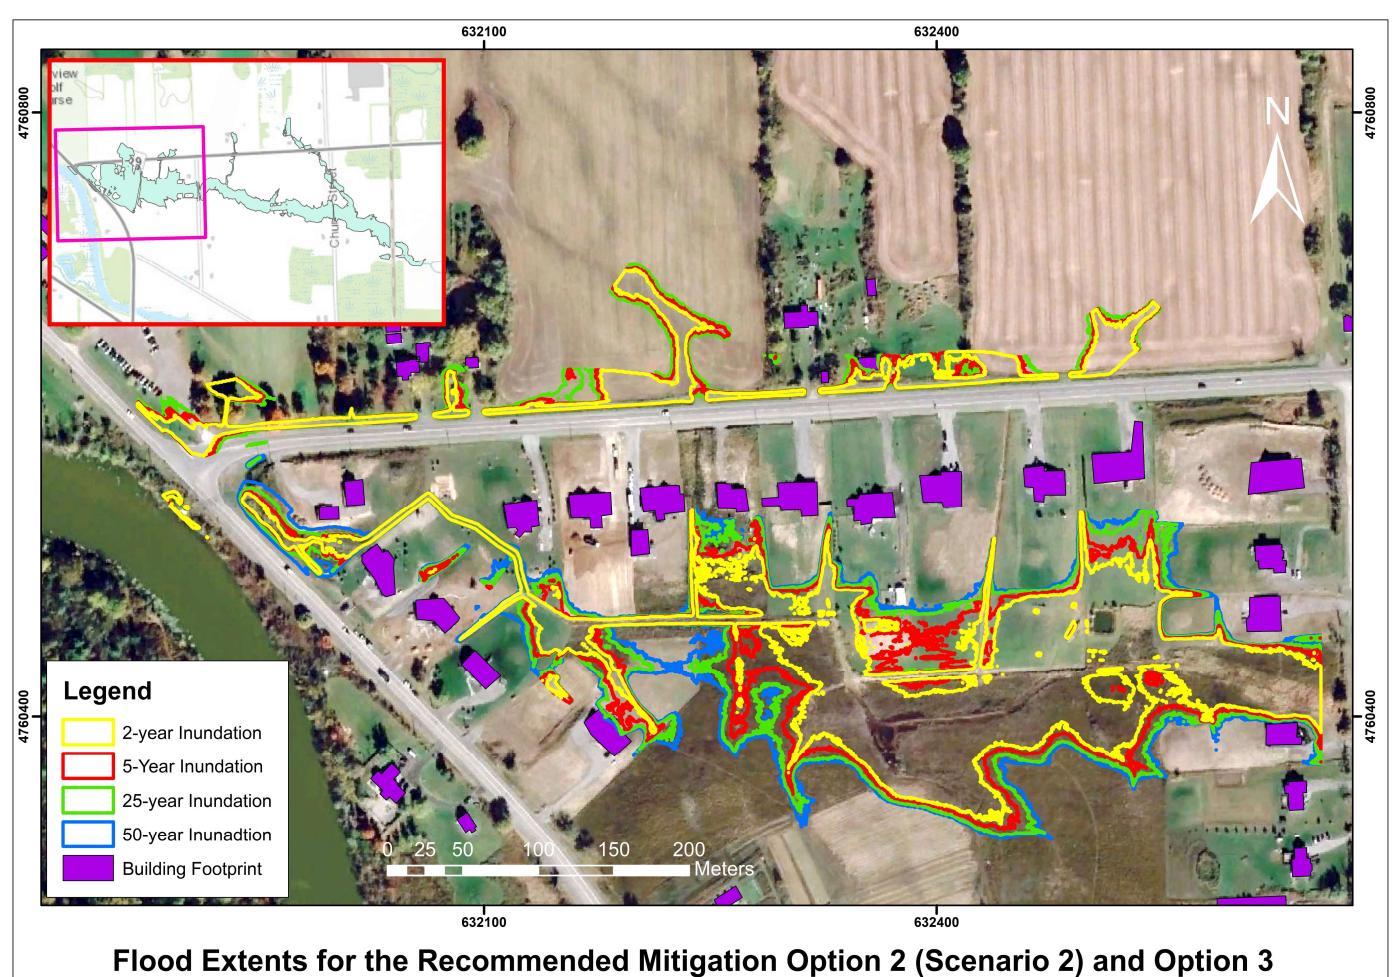
-Model results show that the proposed channel which runs between the properties at 990, 1000 Webber road and 285 Victoria Avenue has the capacity to convey 100% of the flow without causing any flooding issues.

-No inundation occurs within the area for 2, 5, 25 and 50-year flood scenarios.

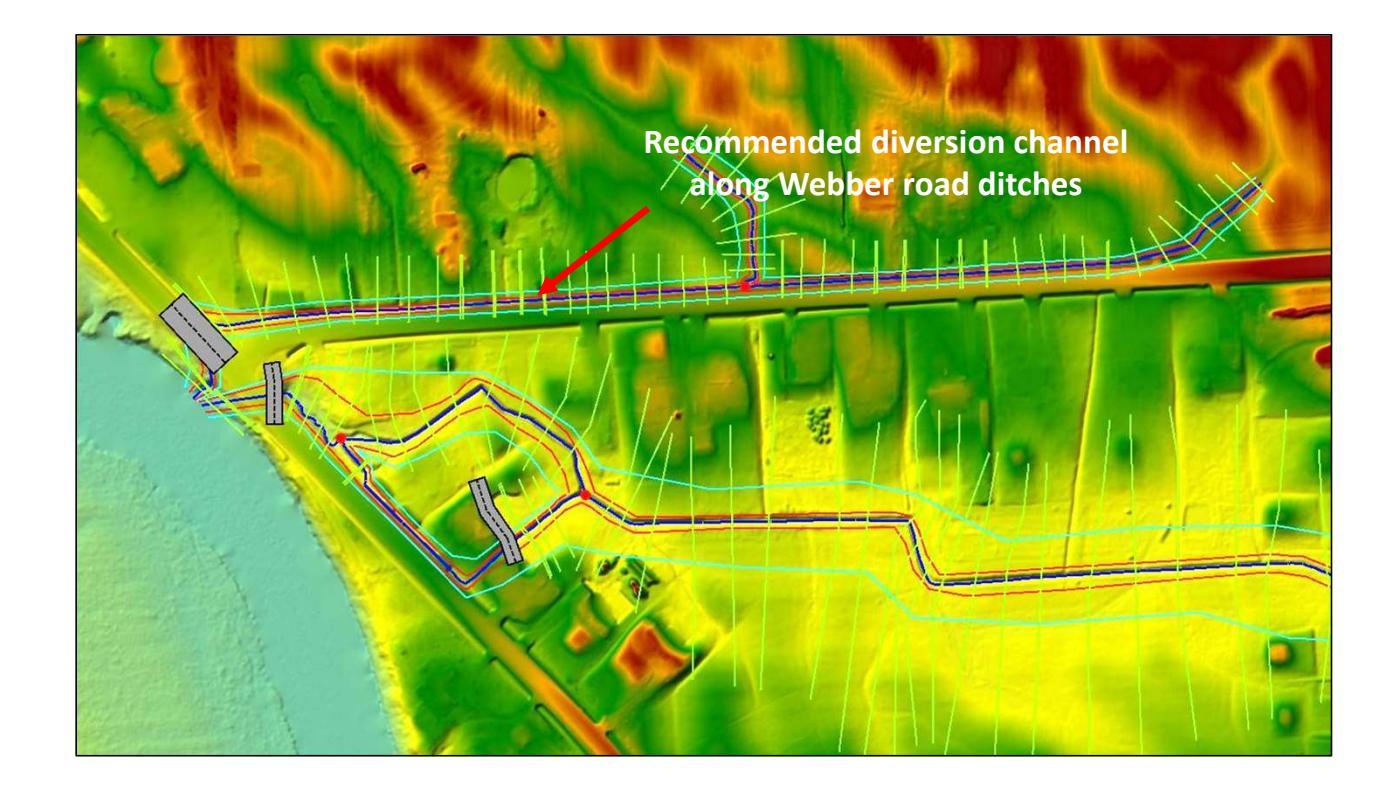
Two of the tributaries which originated from the north of Webber Road and conveyed flow to the main channel south of Webber Road, will be diverted to Welland River through a roadside ditch north of Webber Road.

Model result shows that this diversion channel notably eliminates flooding and reduce the extent of inundation within the project study area when implemented along with the Alternative Option 1 and Alternative Option 2.
