Drainage Study of the Farr, Webber and River Road Area

Town of Pelham Council Meeting

April 19, 2023

Presented by: Dr. Bahar SM

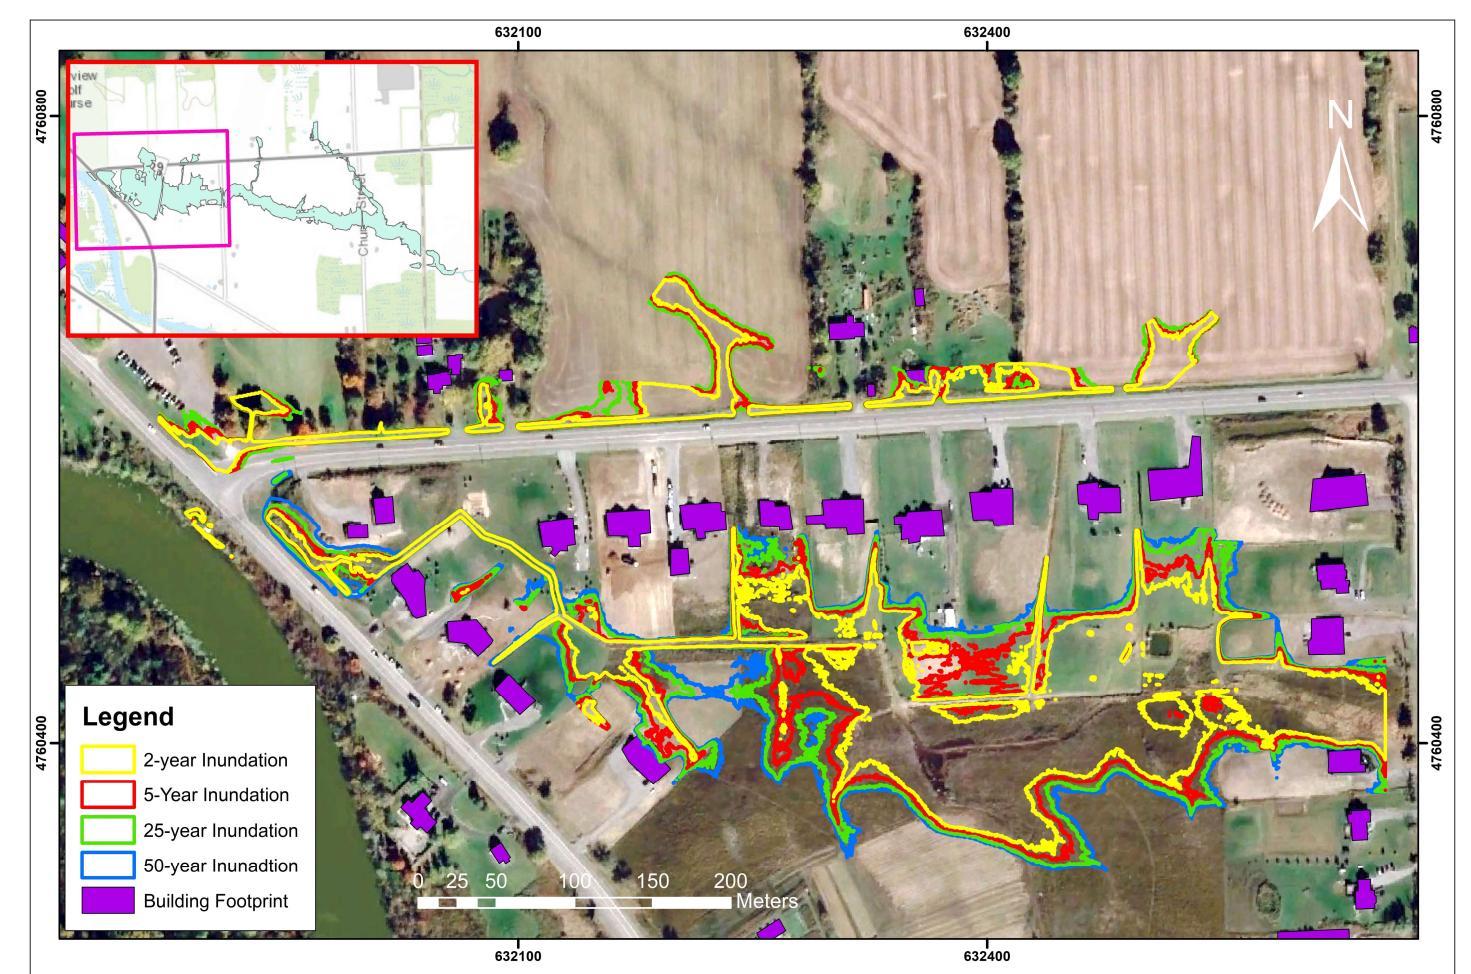
Flood Extents for the proposed Alternative Option 1, Option 2(Scenario 2) and Option 3
