Subject: Wellington Heights Pedestrian Crossing Update**Recommendation:**

BE IT RESOLVED THAT Council receive Report #2023-0182 - Wellington Heights Pedestrian Crossing, for information;

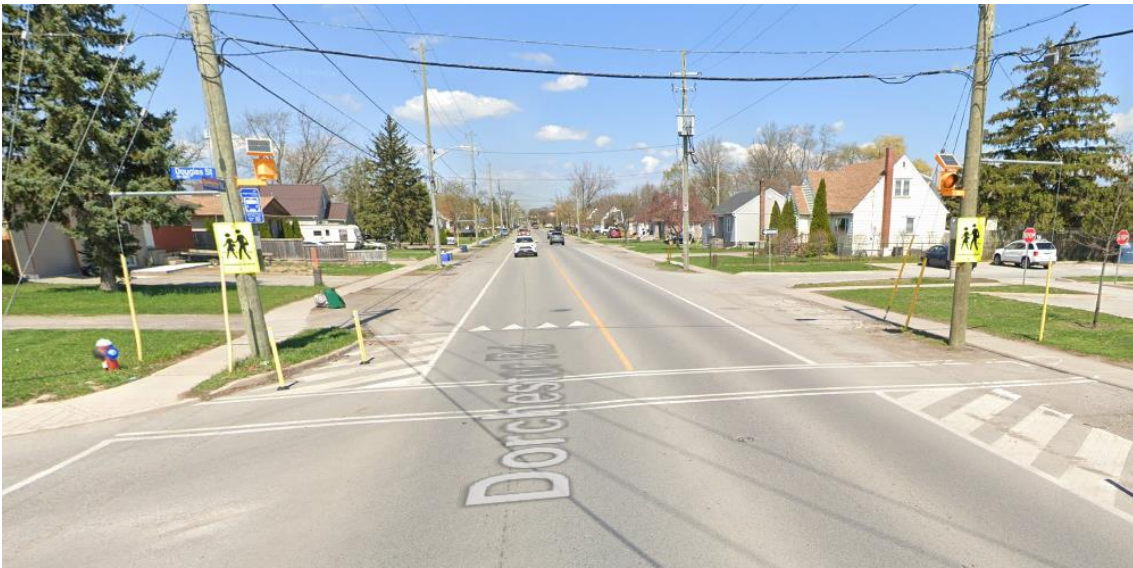
Given all the constraints, Region staff provided the alternative solution of installing a "school crossing" instead. The school crossing would see that signage and solar-

powered flashing lights be installed on the road shoulder on a 6" x 6" wood breakaway post, and the pavement markings be repainted to be more visible. The lights would be set to timers based on the start and end times of the school, with leeway on either end. Region staff install these themselves and anticipate they will be able to have it completed this year. It is also much more cost-effective as there is less work involved. See the below picture for a similar school crossing the Region that has recently been installed.

A school crossing is technically a step down from a Level 2: Type D PXO crossing as it is legally considered an uncontrolled crossing. The lights will only be activated during the times they are programmed for. Unless a school crossing guard is present, vehicles have the right of way through the crossing. Therefore, to make it a controlled crossing, the school crossing will need a crossing guard. Staff are not in favour of this option as a Crossing Guard Warrant Study was prepared by Fire and Protection Services staff in 2019 which identified that a crossing guard is not warranted. A school crossing would also mean that pedestrians would only have the right-of-way when a crossing guard is present, instead of all the time as per current conditions.
