2024 BRIDGE AND CULVERT INSPECTION PROGRAM

REHABILITATION/REPLACEMENT NEEDS

June 2024

TOWN OF PELHAM

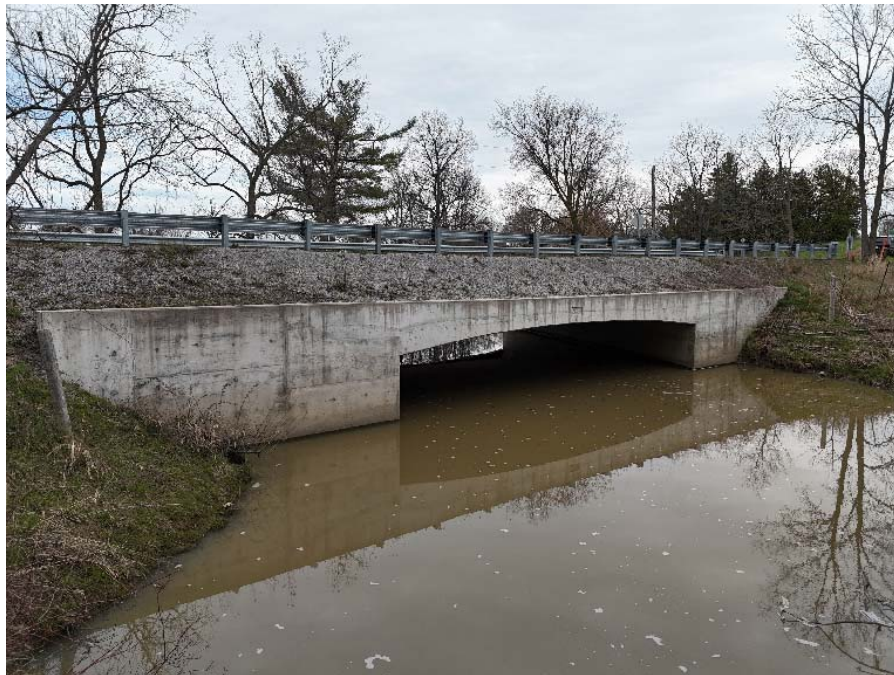
Photograph No. 2: DJI_0059: South elevation.

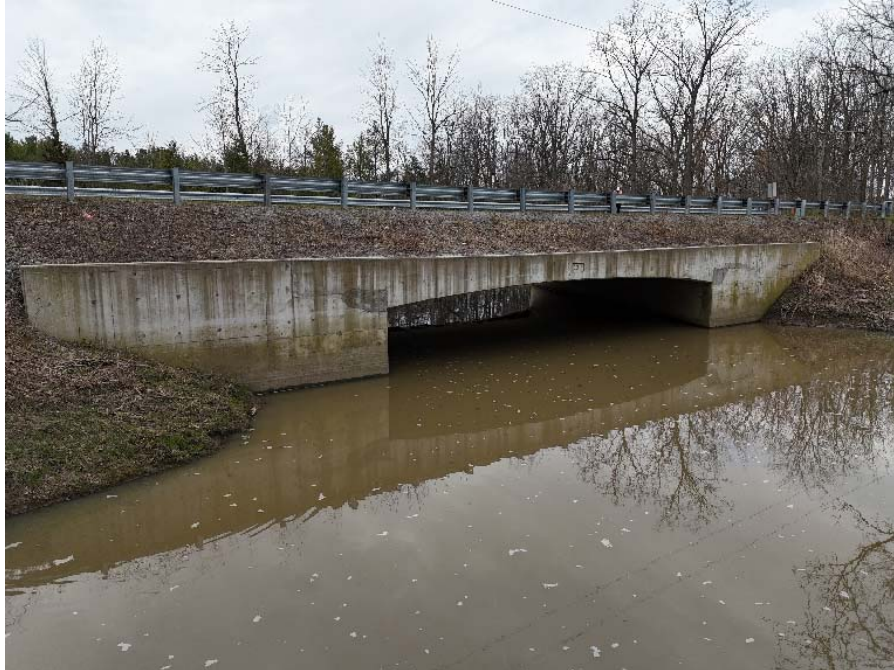
Photograph No. 3: DJI_0075: North elevation.

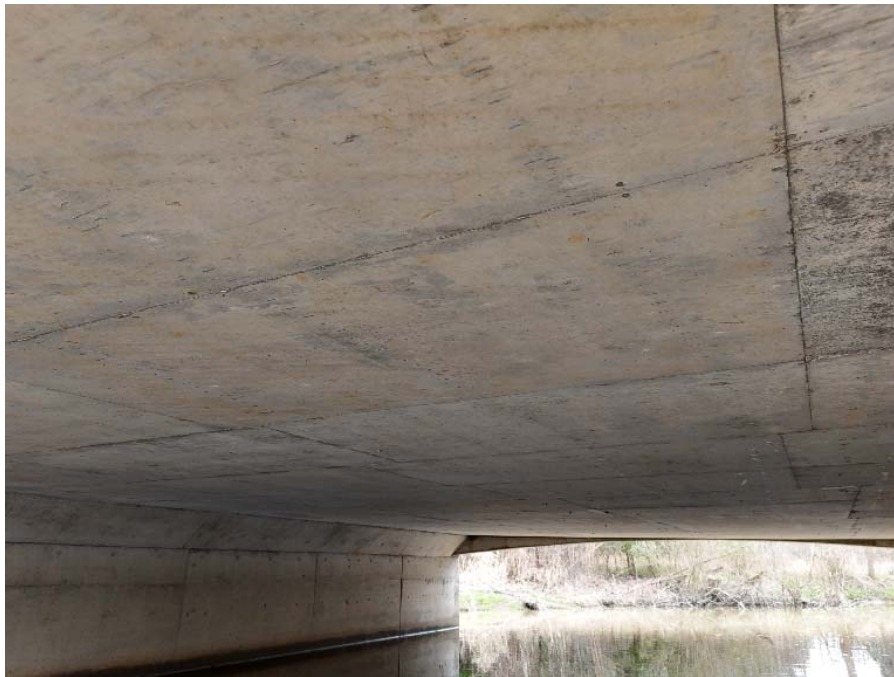
Photograph No. 4: DJI_0088: Underside of structure looking southeast.

The surface treated roadway is generally in fair condition with settlement, cracking, and medium disintegration along the edges of the roadway. There is a medium longitudinal crack in the center of the roadway. The steel beam guide rails over the structure are in fair condition with vehicular damage on the east side at the structure. There is a leaving end terminal at the southwest corner. The other three corners are turned down and buried. The timber posts exhibit light to medium wood rot throughout and isolated areas of severe wood rot. The two-span rigid frame structure is in good condition with light concrete cracking, efflorescent staining, and light concrete disintegration at the four corners at the wingwalls. There are narrow vertical cracks in the center of the abutment sidewalls. There is light leakage from the fascias onto the bridge deck soffit. There are isolated areas of light segregation in the soffit and abutment sidewall of the south cell at the west end of the structure. There is an isolated small spall at the location of the segregation in the south cell in the soffit with exposed corroded reinforcing steel.

We recommend replacing the steel beam guiderail in 6-10 Years.

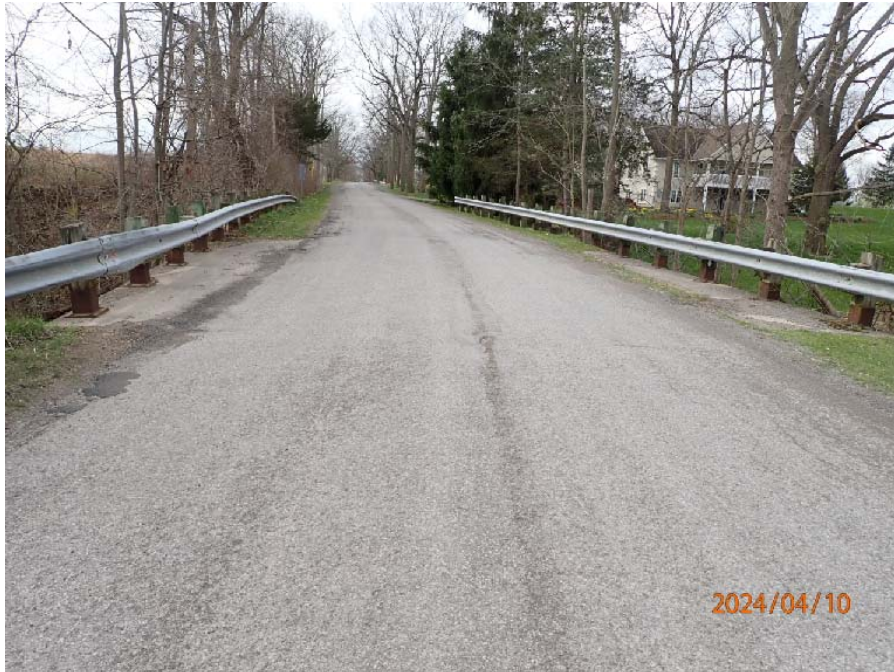
Photograph No. 1: 0134: Roadway looking south.

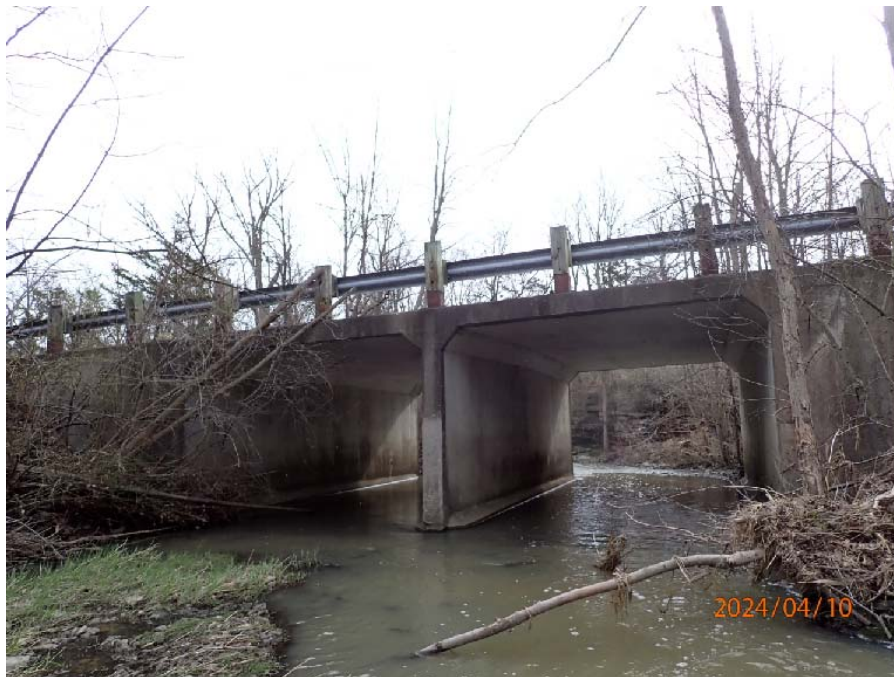
Photograph No. 2: 0176: West elevation.

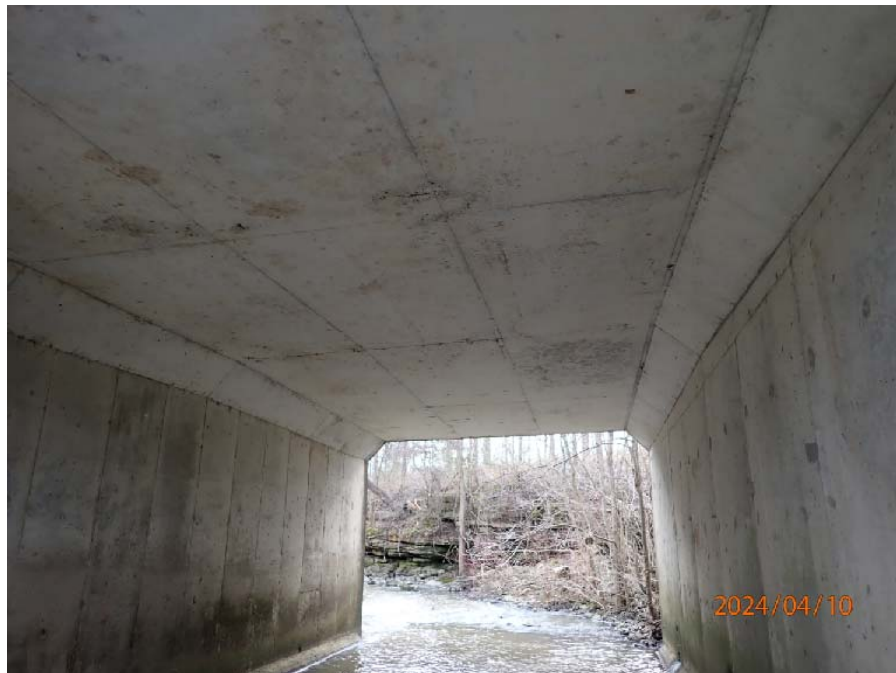
Photograph No. 3: 0190: Underside of south cell looking east.

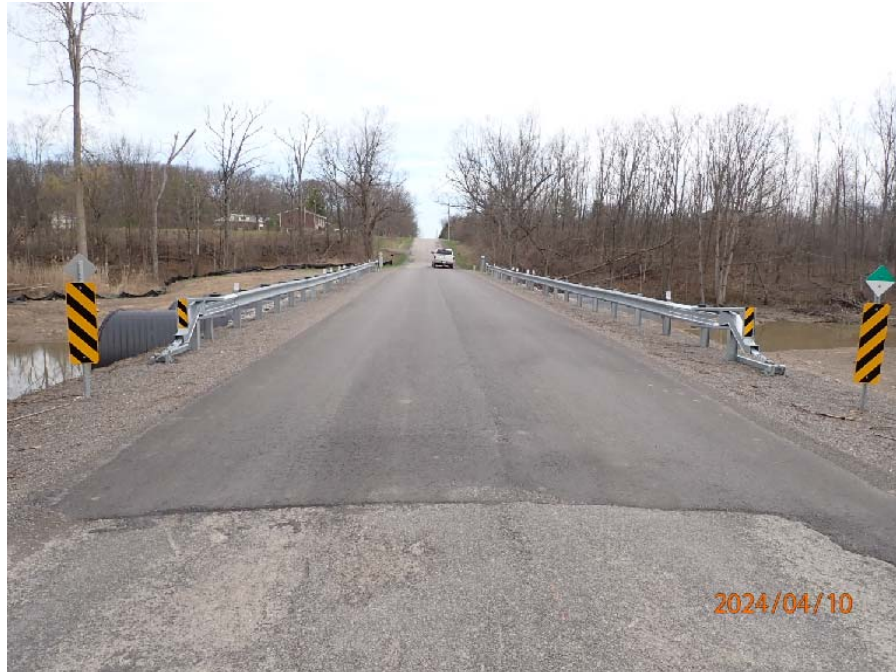
Photograph No. 1: 0005: Roadway looking north.

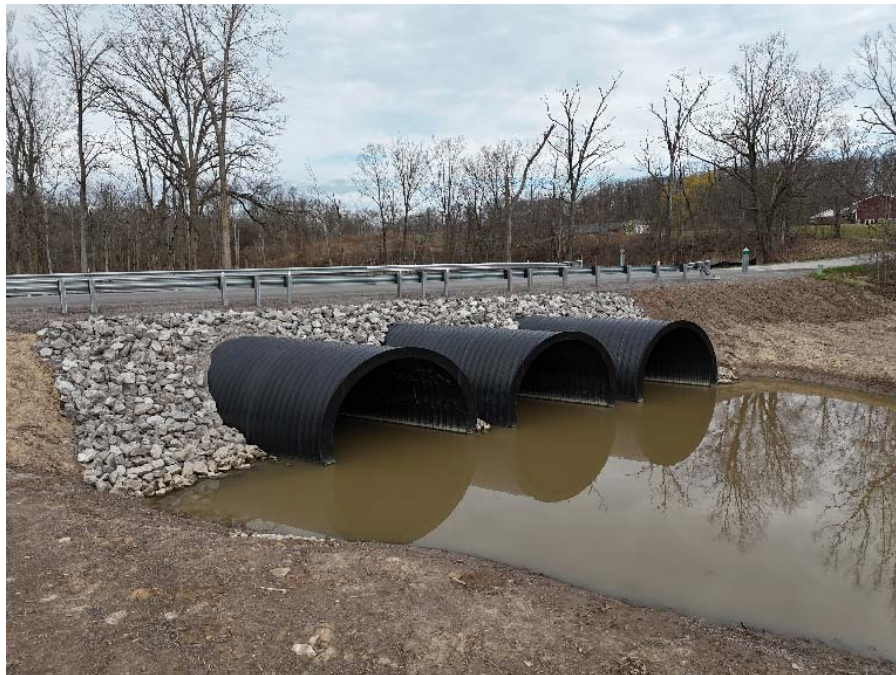
Photograph No. 2: DJI_0021: East elevation.

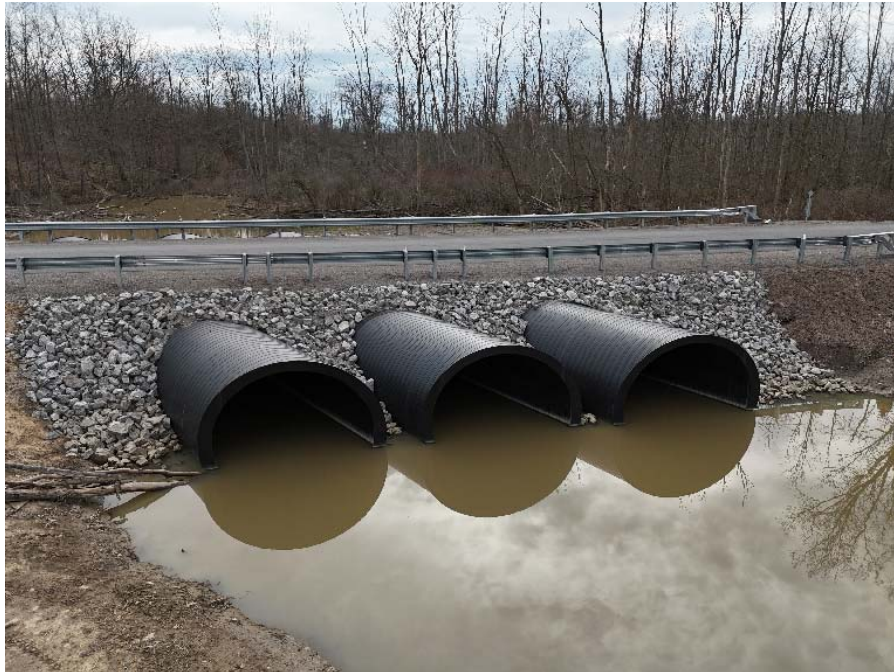
Photograph No. 3: DJI_0022: West elevation.

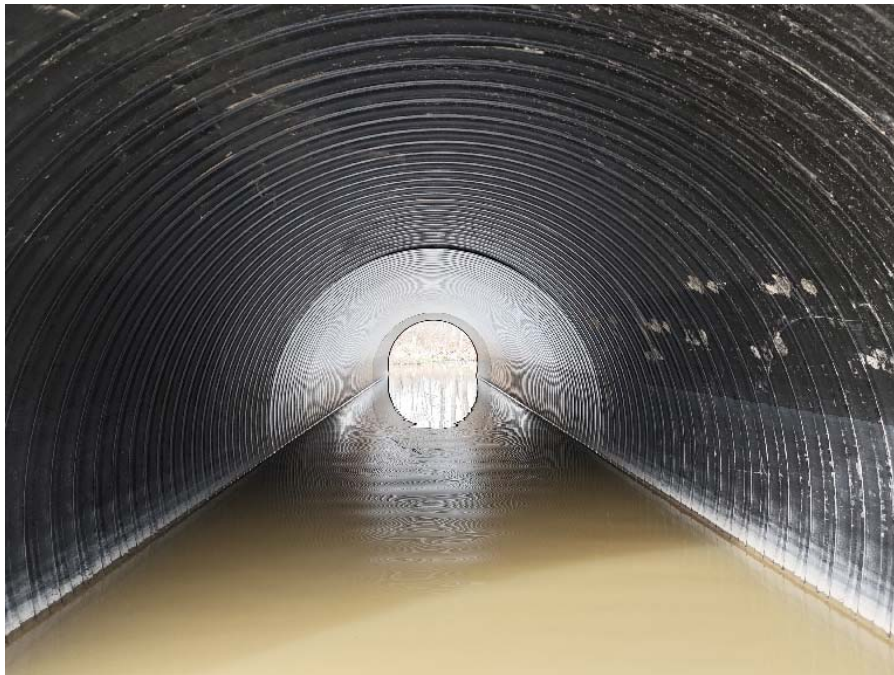
Photograph No. 4: DJI_0044: Interior of north cell, looking west.

The surface treated roadway is in very good condition. There are no hazard markers or barrier at this location. The twin corrugated steel pipes are in poor condition with severe corrosion and perforations below the waterline. There is a severe deformation at the south end of the east cell where the west side of the steel multi-plate is deformed inward. There are deformations in the crowns of both cells, possibly due to minimal fill over the structure. Light erosion is evident with holes forming between the mortared rip rap on the slope protection at the north and south sides of the roadway. There is medium erosion with a large void forming below the mortared rip rap on the slope protection at the south side of the roadway.

We recommend replacing the structure NOW. We understand this structure is scheduled for replacement in 2025.

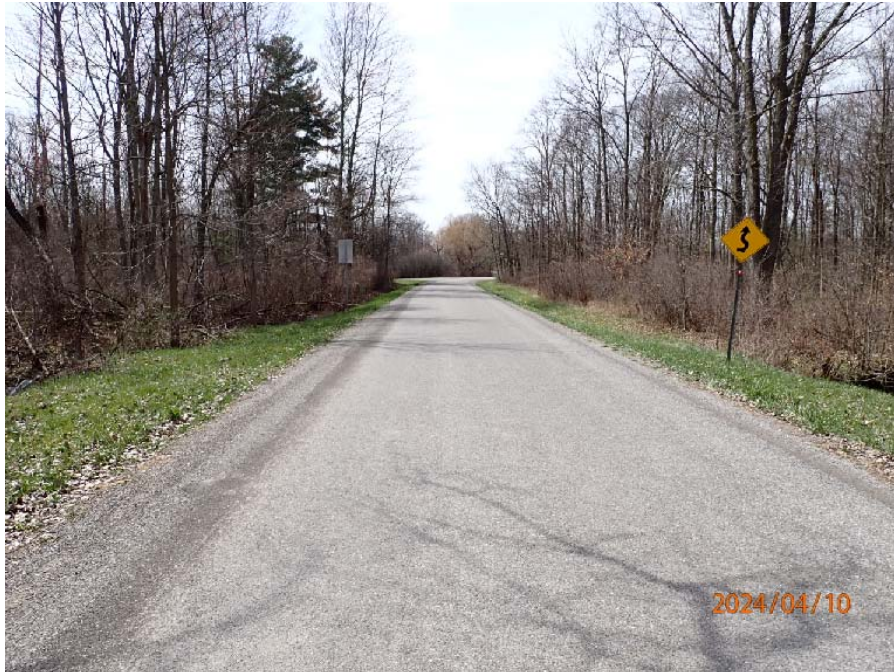
Photograph No. 1: 0769: Roadway looking west.

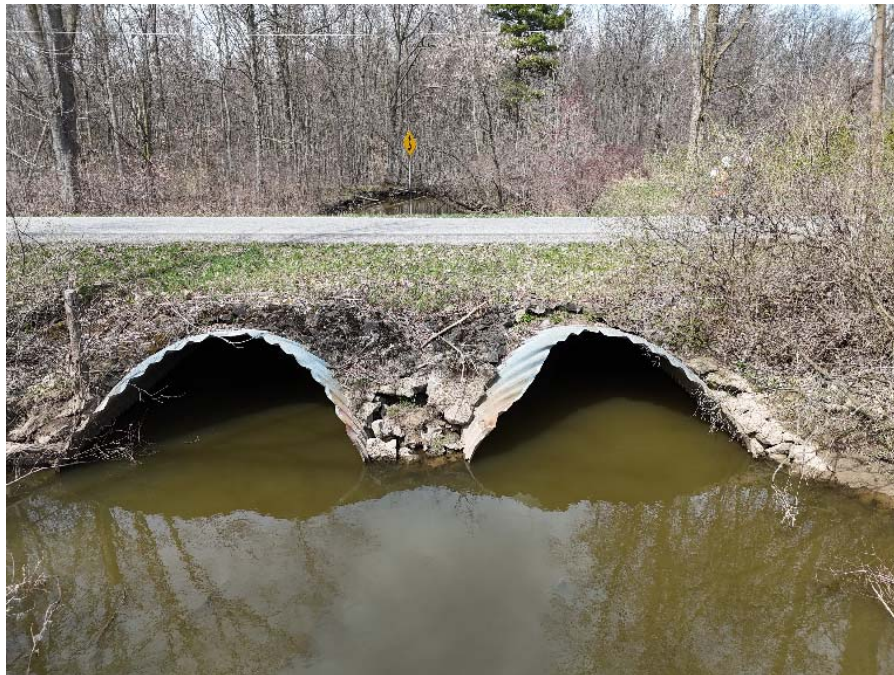
Photograph No. 2: DJI_0136: South elevation.

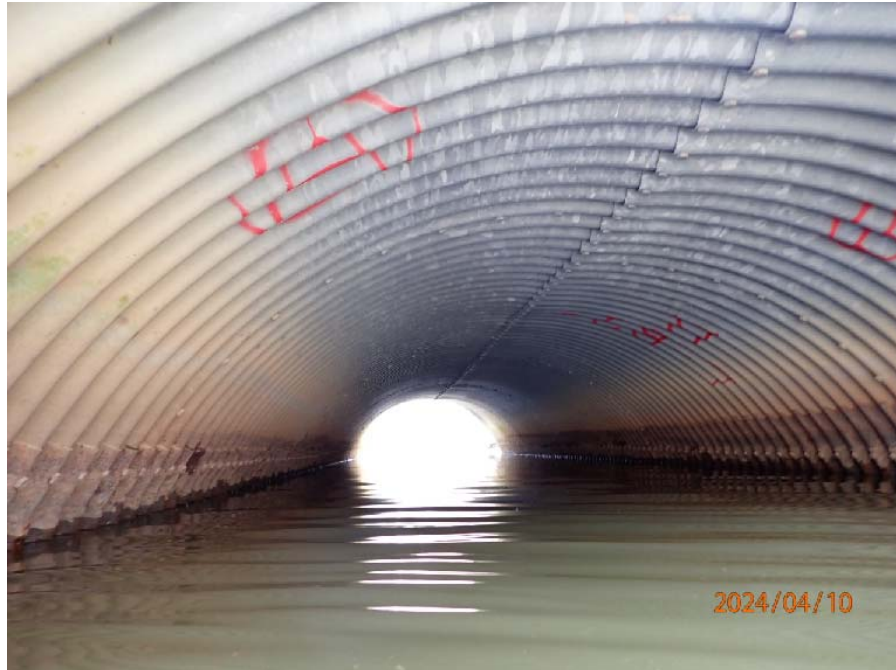
Photograph No. 3: 0811: Interior of west cell looking south.

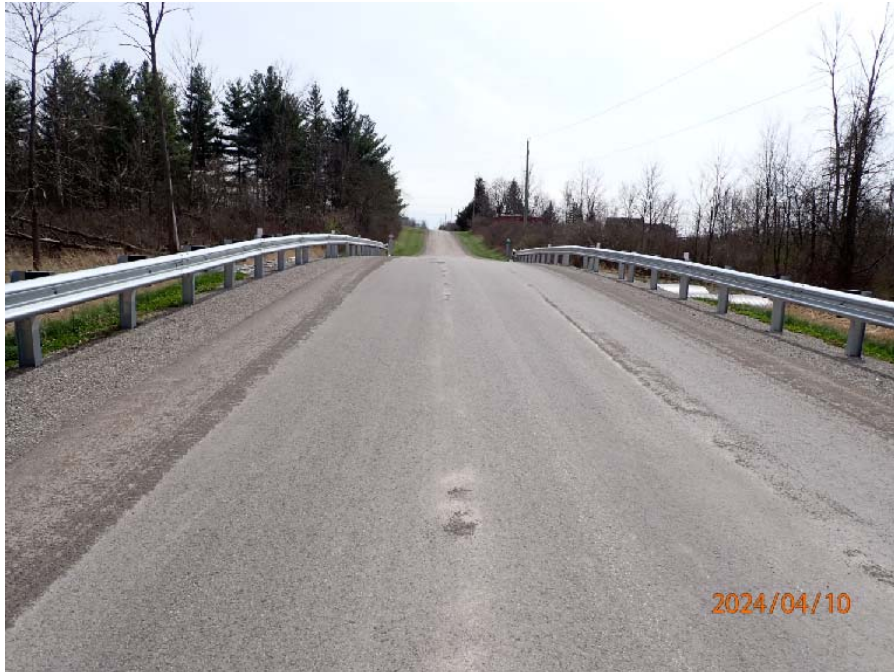
Photograph No. 1: 0737: Roadway looking south.

The surface treated roadway is in fair to poor condition with disintegration along the edges of the roadway. There are small, patched and unpatched potholes along the edges of the roadway. There are no roadside markers or barriers at this location. The exposed ends of the structure are generally in good condition with light scaling. The bridge deck soffit is generally in good condition. The abutment sidewalls are generally in good condition with light scour along the waterline. There is medium to severe erosion at all four corners of the structure. There is a utility attached to the north side

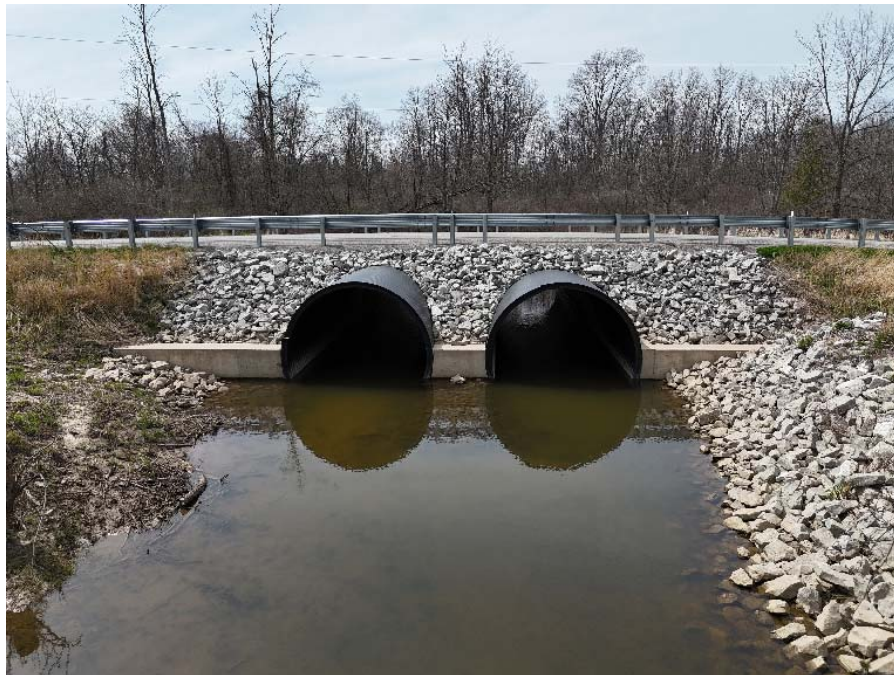
Photograph No. 2: DJI_0110: East elevation.

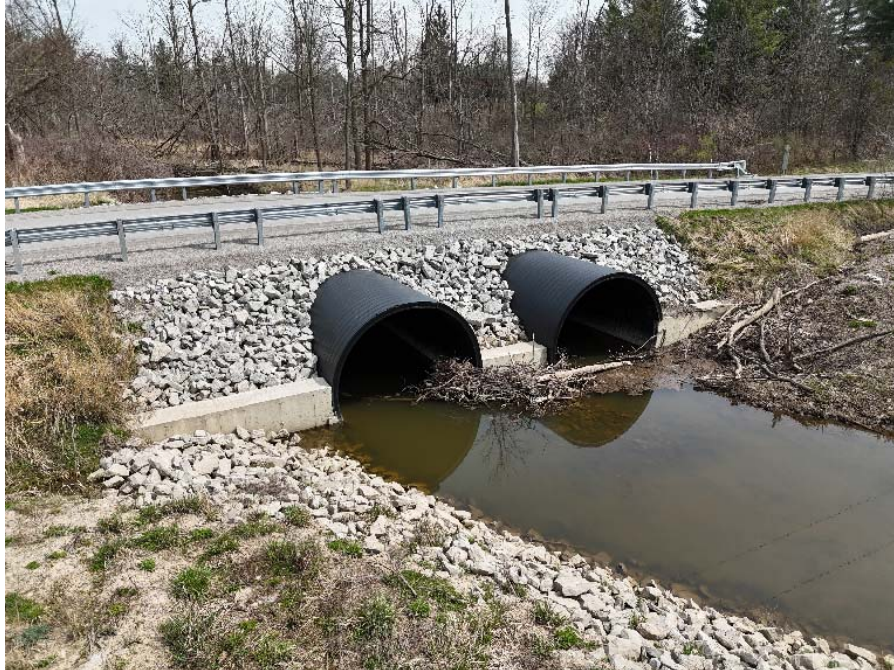
Photograph No. 3: DJI_0113: West elevation.

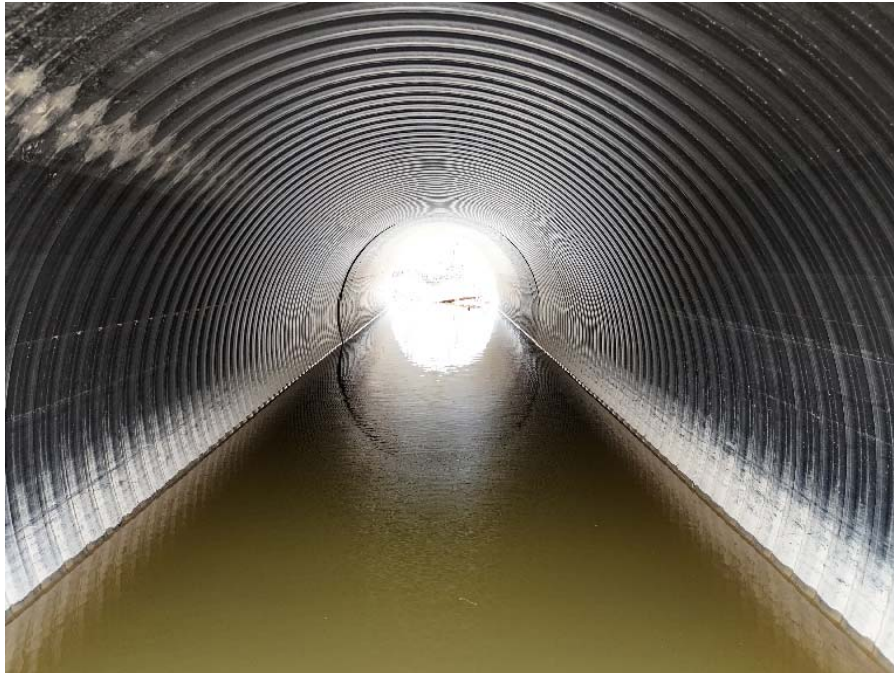
Photograph No. 4: DJI_0127: Interior of north cell, looking west.

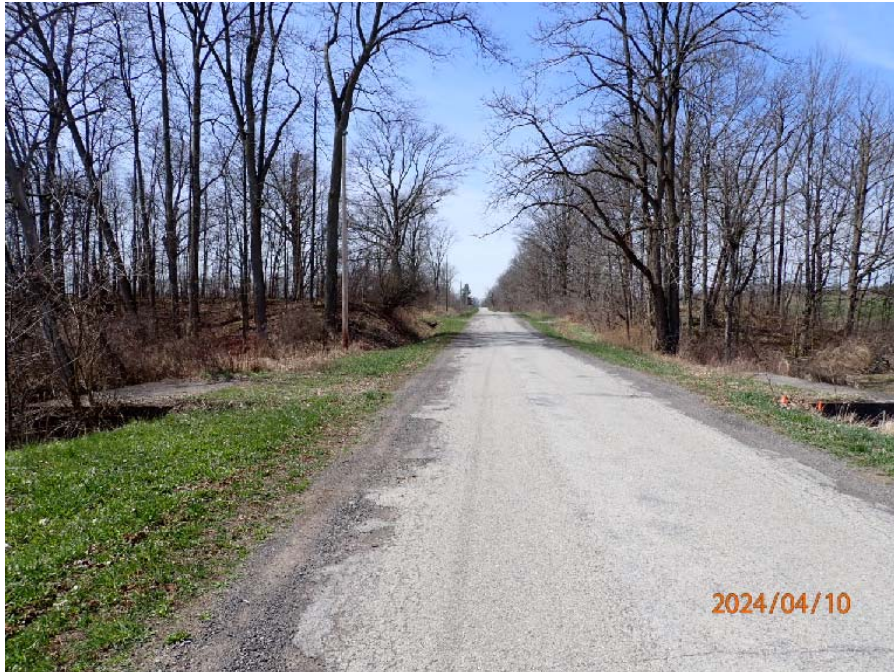
Photograph No. 1: 0543: Roadway looking west.

The surface treated roadway is in fair to poor condition with medium settlement, rutting, map cracking, and asphalt padding either side of the structure, especially at the south side. There are no roadside markers or barriers at this location. The exposed ends of the structure are generally in good condition with light scaling. The bridge deck soffit is in good condition. There is evidence of narrow cracking in the soffit at the north end, at approximately mid span. The abutment sidewalls are in good condition with light scour along the waterline. The footings are exposed at isolated locations, up to 100mm. There is light erosion of the side slopes adjacent to the structure at the south end. There is medium to severe erosion at all four corners of the structure.

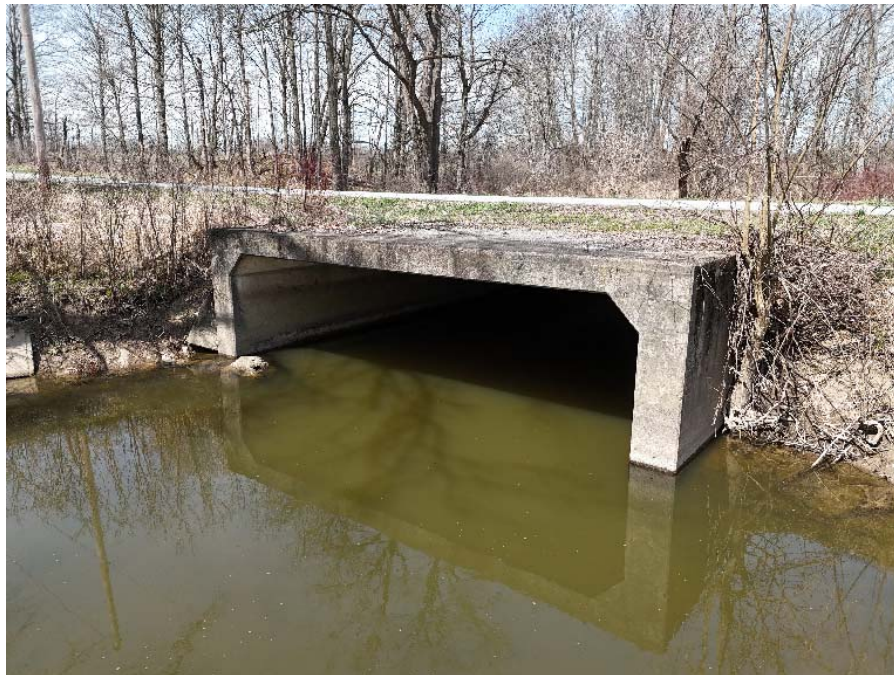
Photograph No. 2: DJI_0094: South elevation.

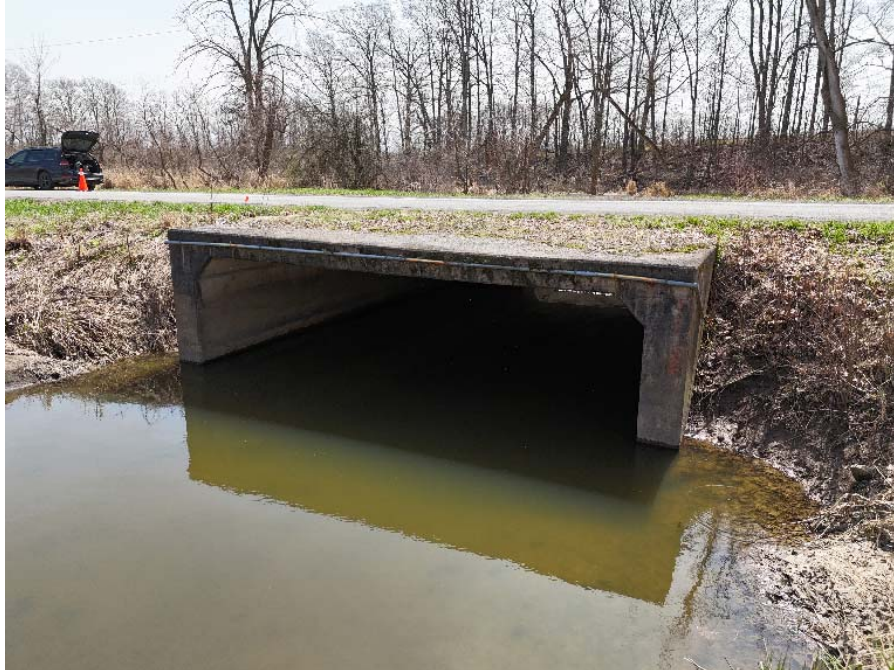
Photograph No. 3: DJI_0101: North elevation.

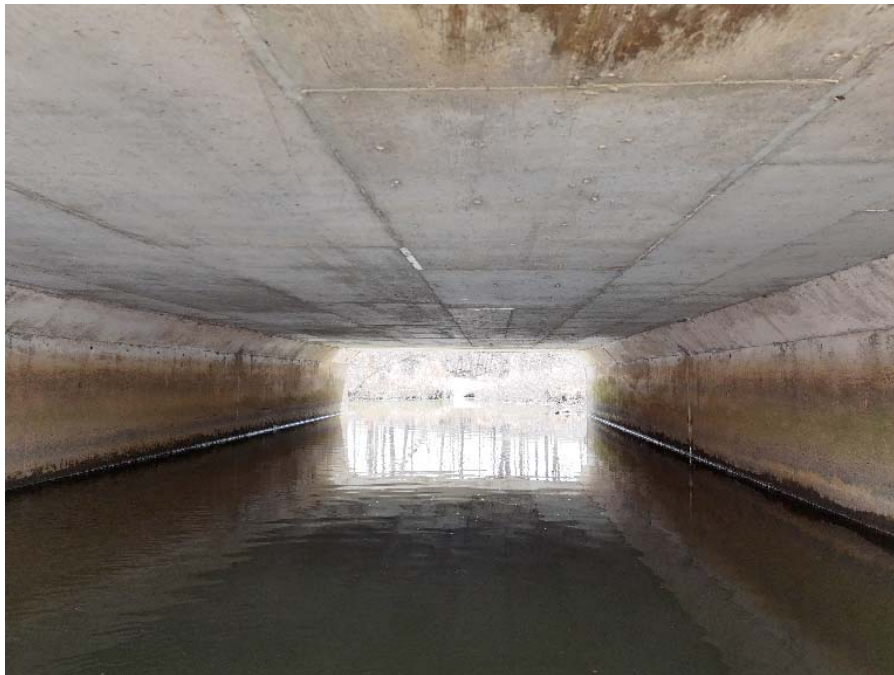
Photograph No. 4: DJI_0108: Interior of structure looking south.

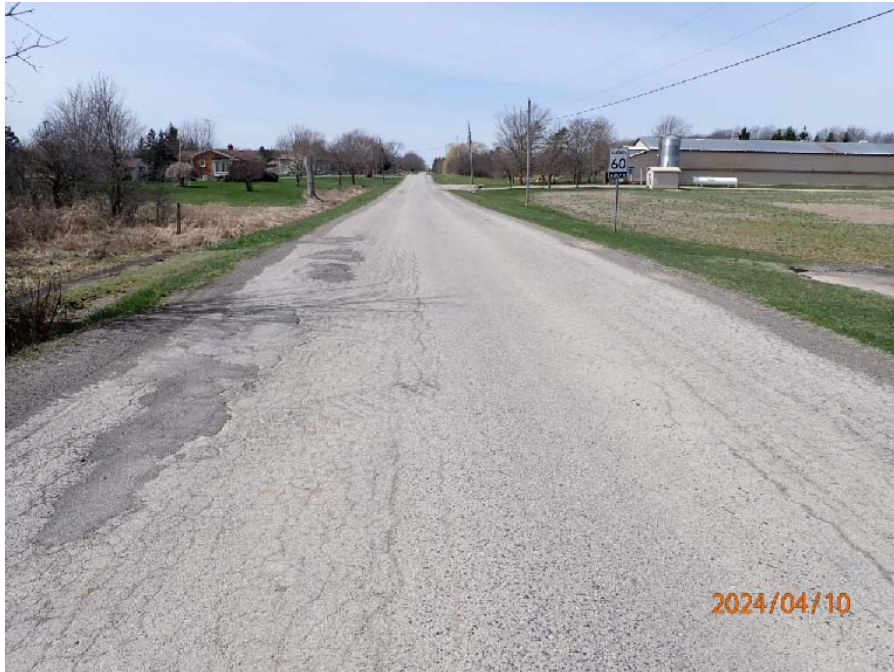
Photograph No. 1: 0494: Roadway looking west.

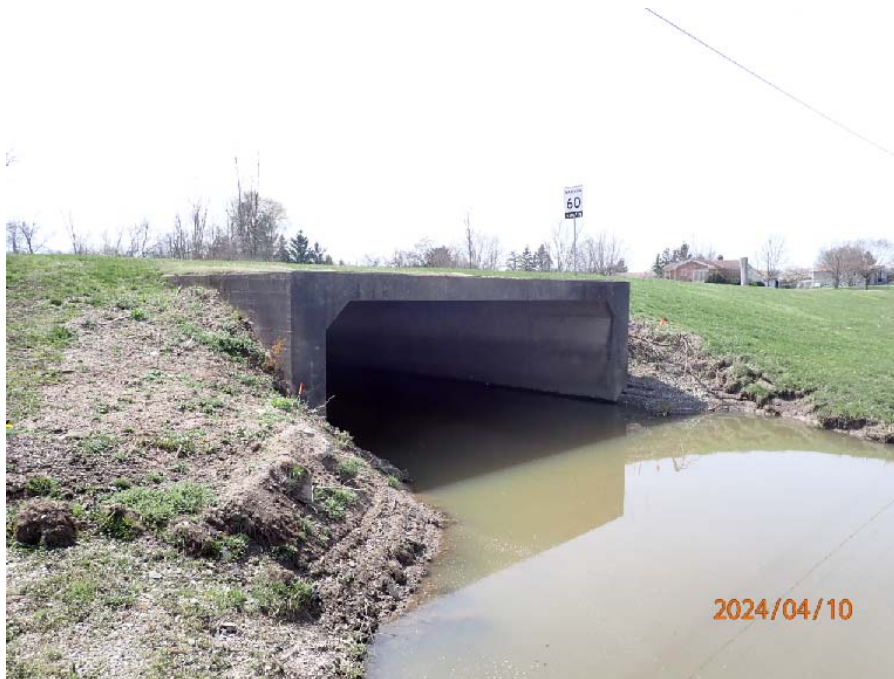
Photograph No. 2: 0515: North elevation.

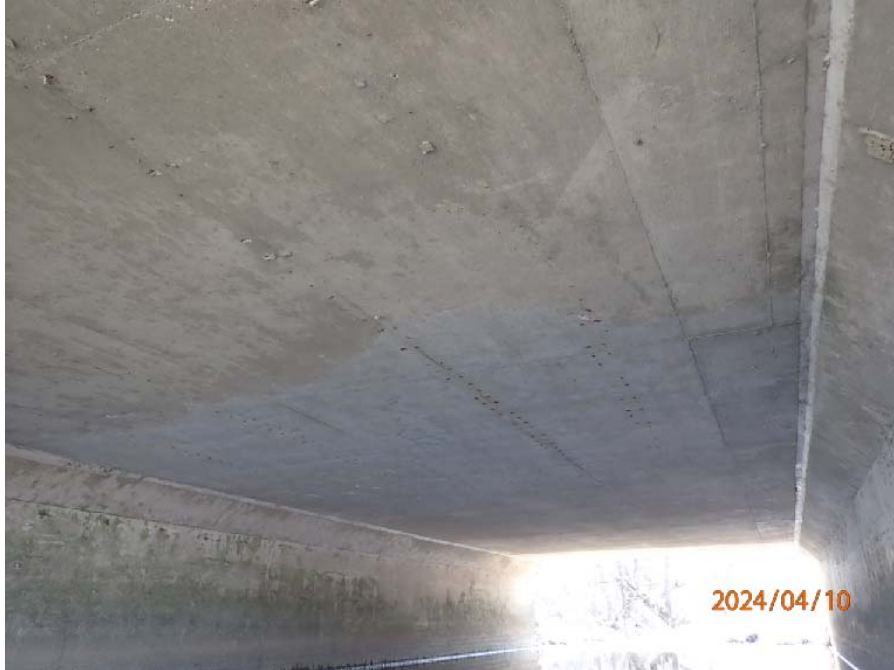
Photograph No. 3: 0525: Interior of structure looking north.

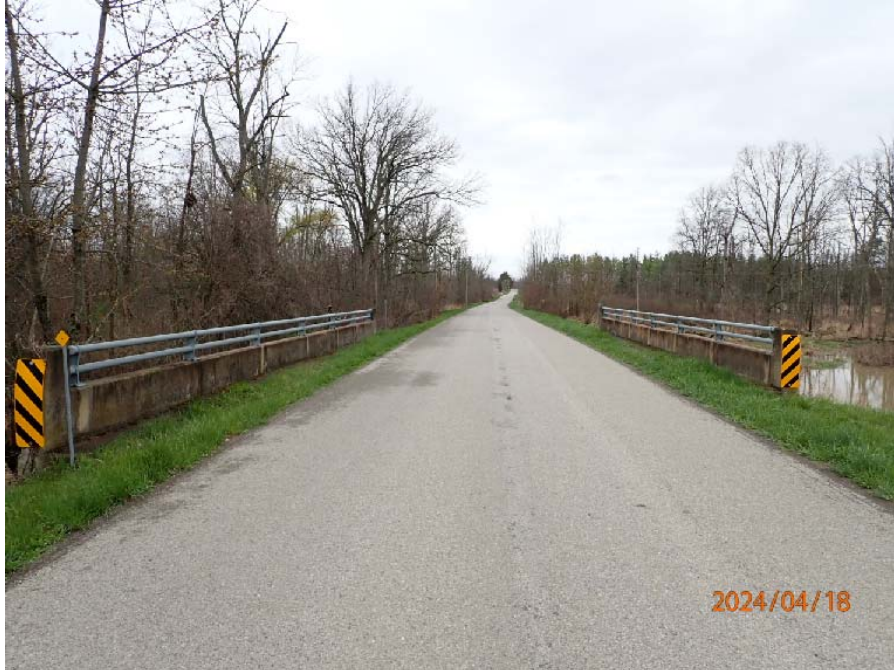
Photograph No. 1: 0123: Roadway looking north.

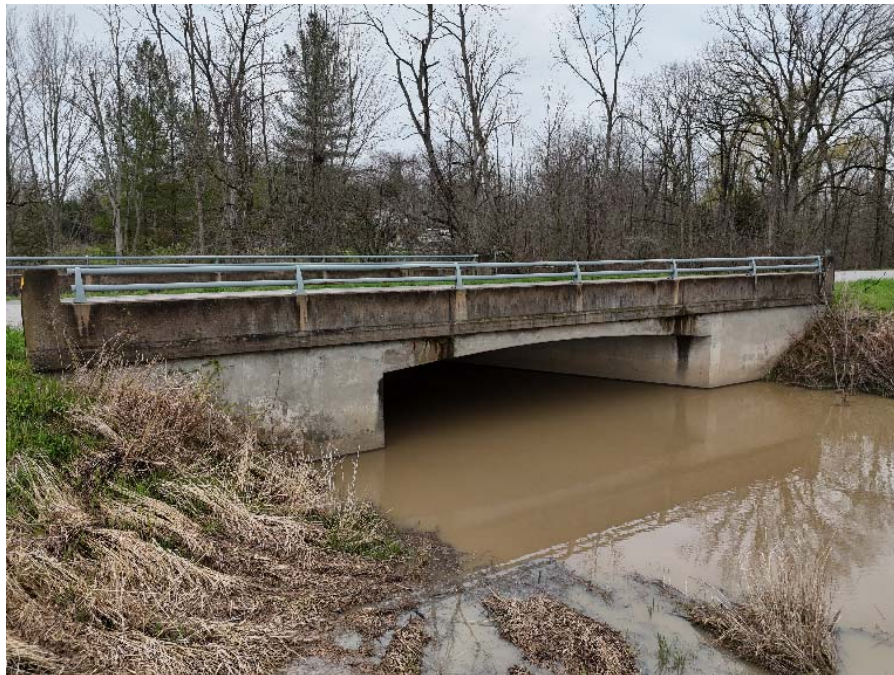
Photograph No. 2: DJI_0005: East elevation.

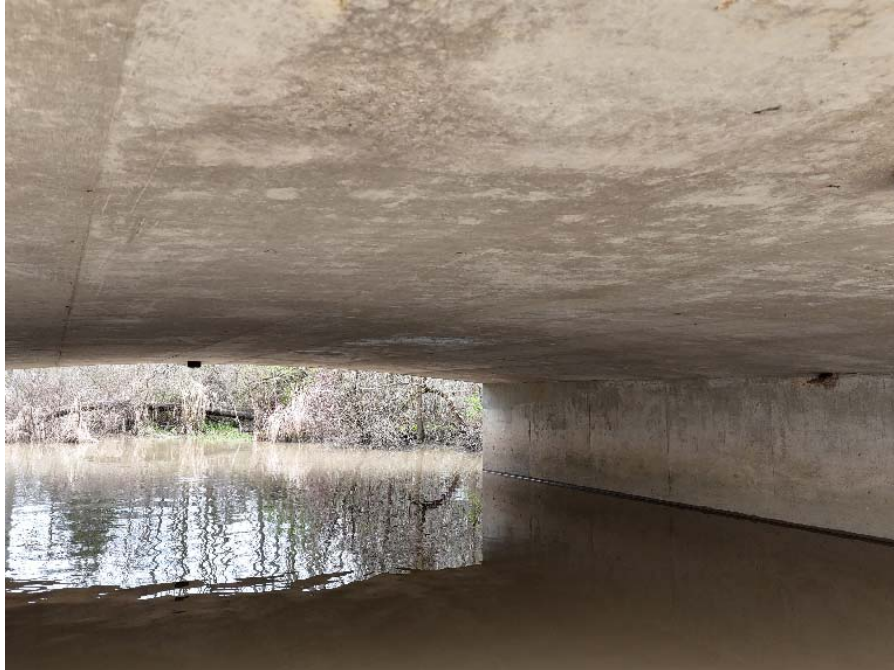
Photograph No. 3: DJI_0017: Underside of structure looking northwest.

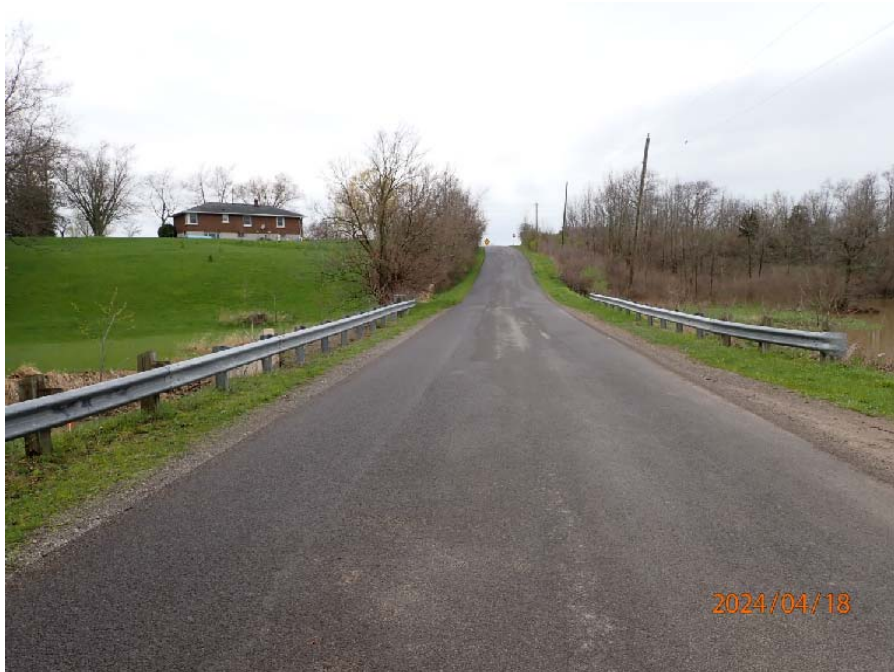
Photograph No. 1: 0002: Roadway looking north.

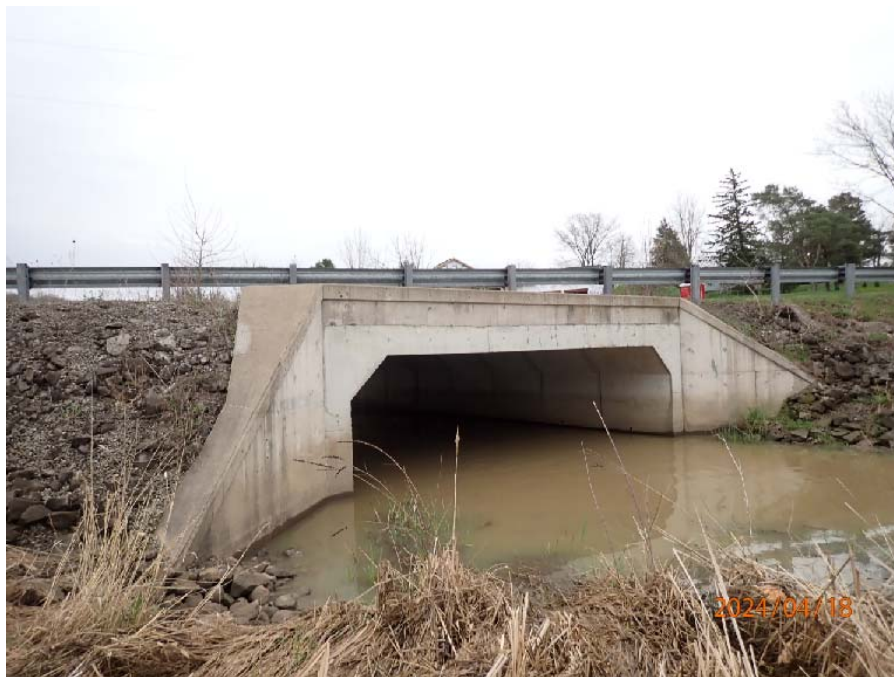
Photograph No. 2: 0042: West elevation.

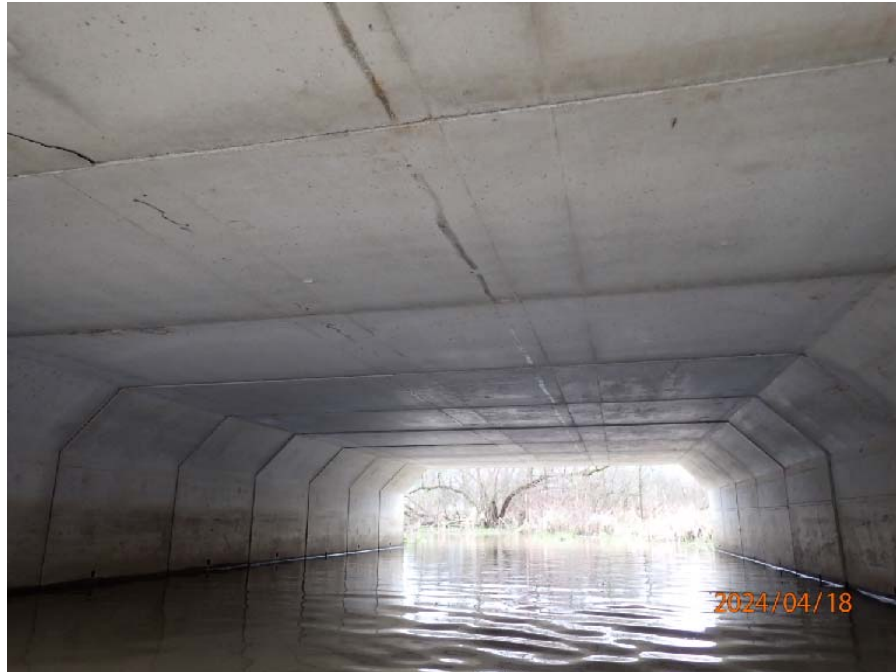
Photograph No. 3: 0029: Interior of structure looking west.

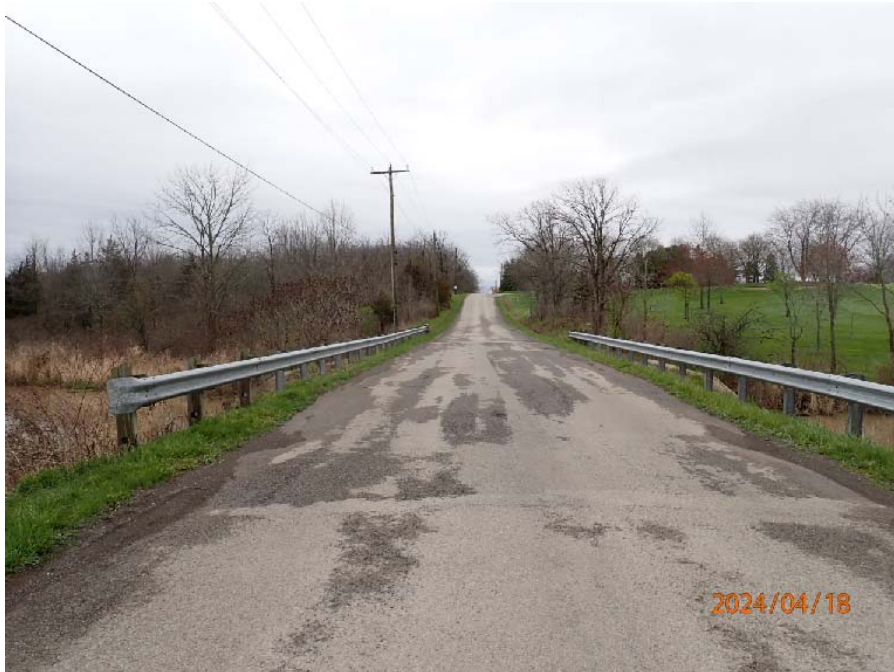
Photograph No. 1: 0058: Roadway looking east.

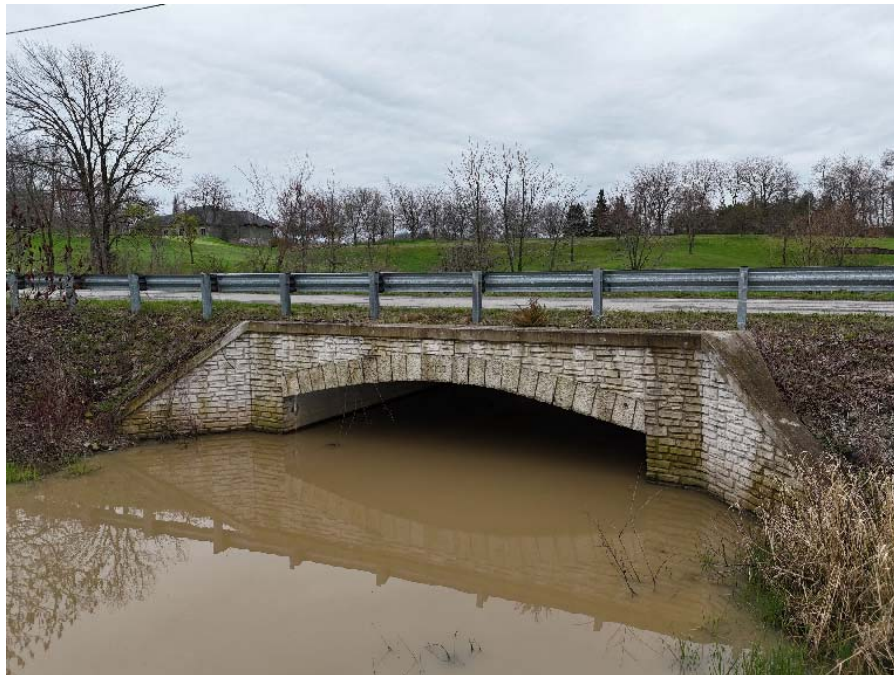
Photograph No. 2: DJI_0001: North elevation.

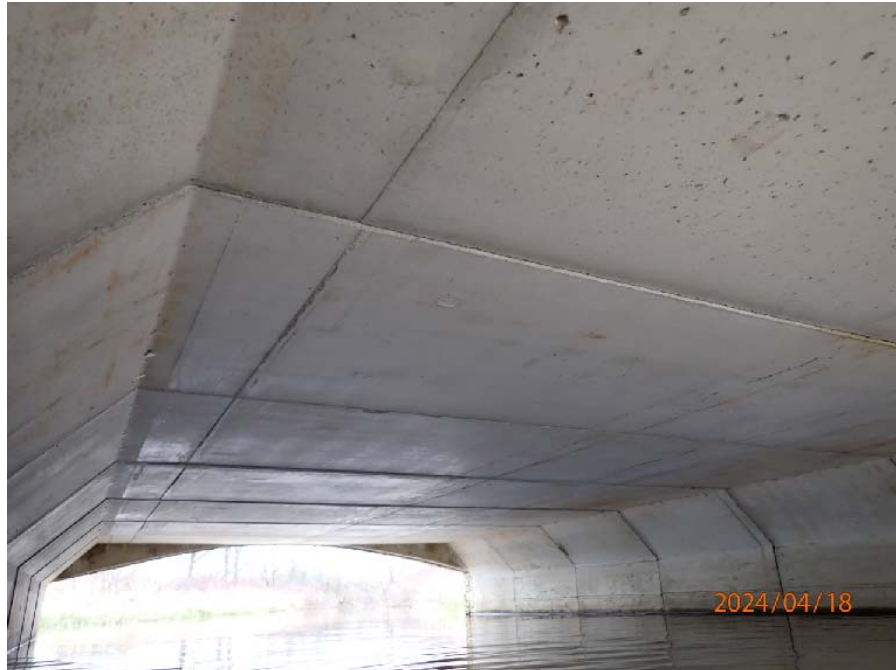
Photograph No. 3: 0109: Interior of structure looking north.

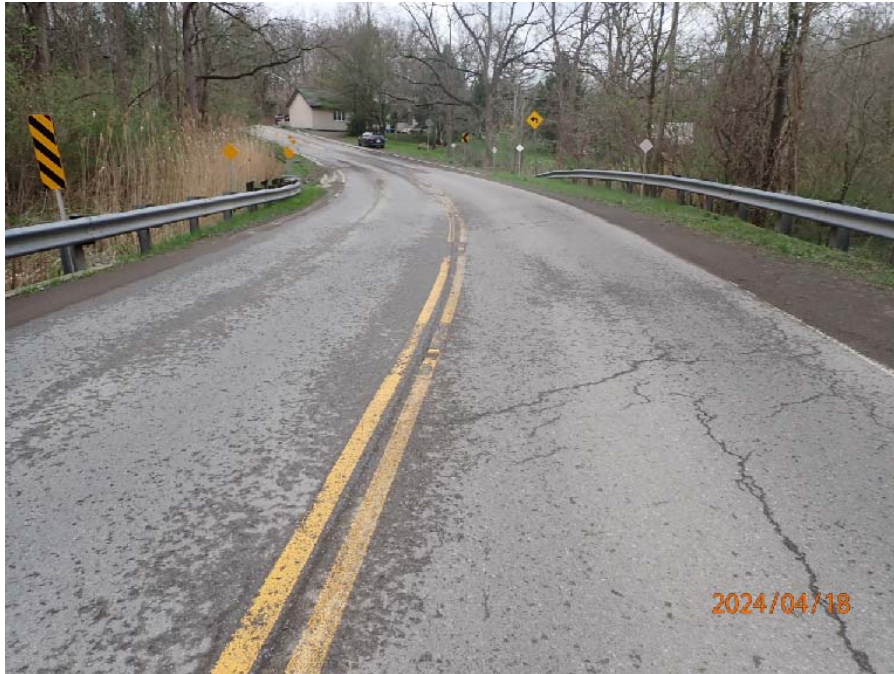
Photograph No. 1: 0274: Roadway looking north.

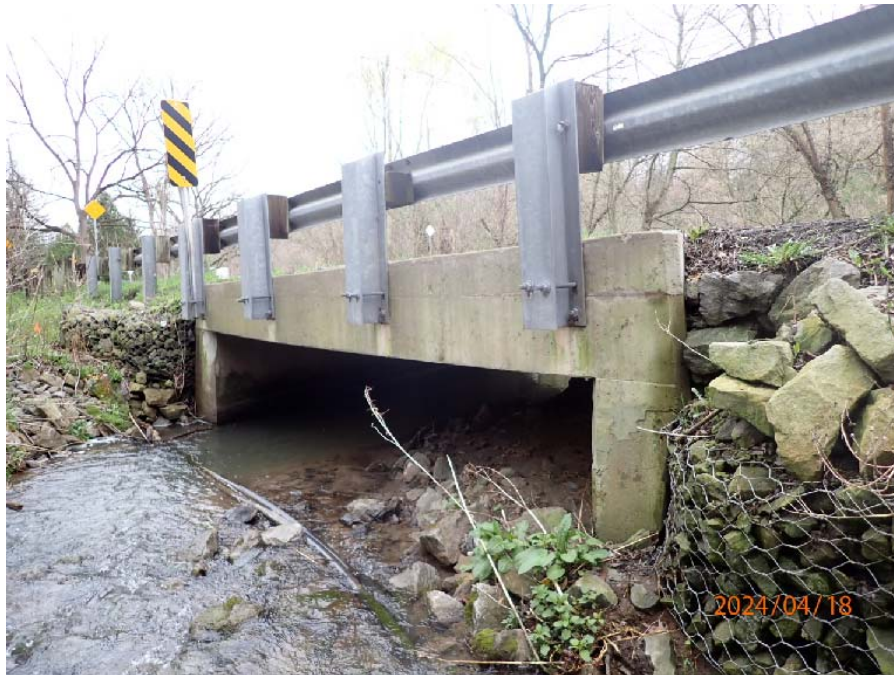
Photograph No. 2: 0298: West elevation.

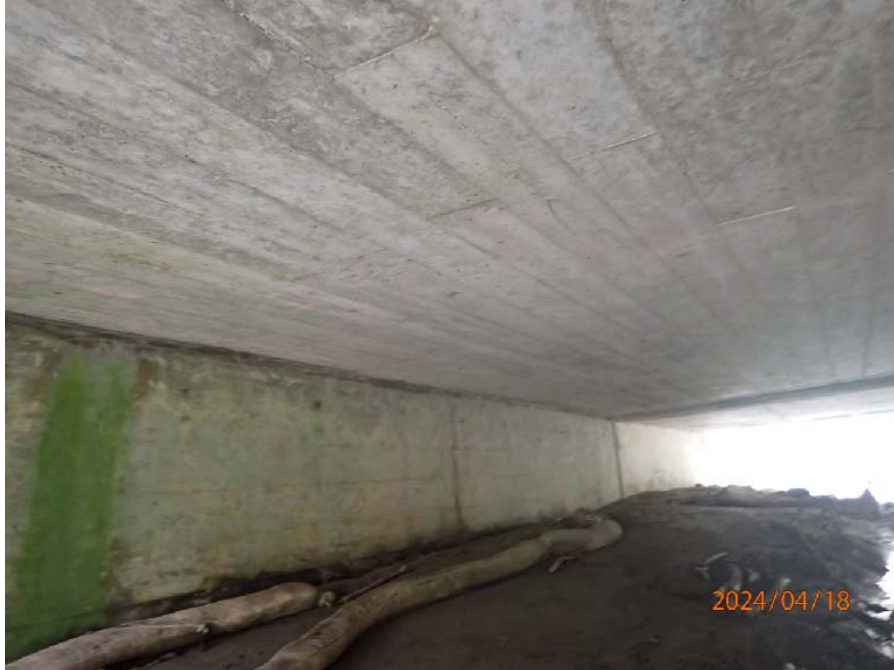
Photograph No. 3: 0331: Interior of structure looking southwest.
