2024 BRIDGE AND CULVERT INSPECTION PROGRAM

REHABILITATION/REPLACEMENT NEEDS

June 2024

TOWN OF PELHAM

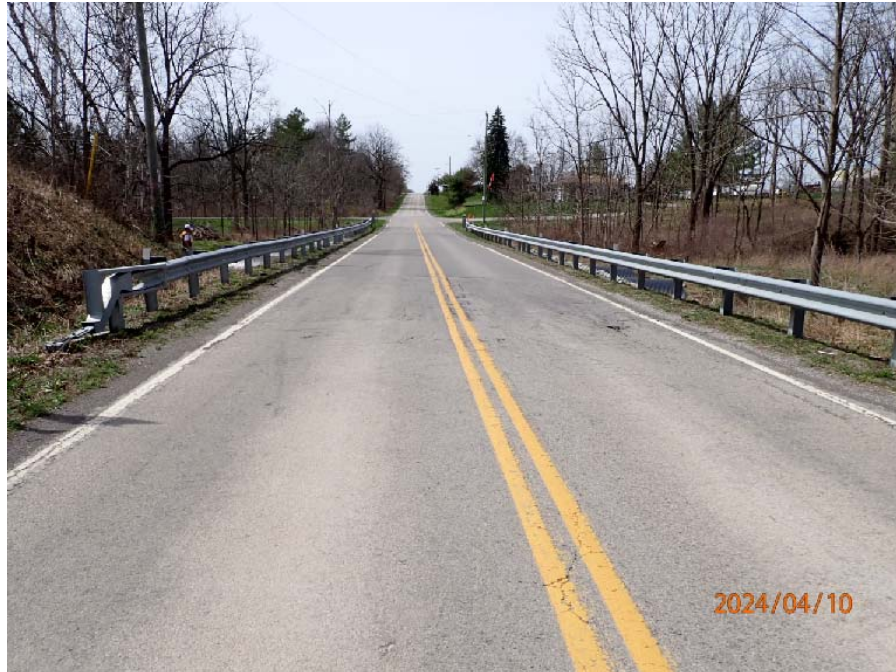
Photograph No. 1: 0658: Roadway looking west.

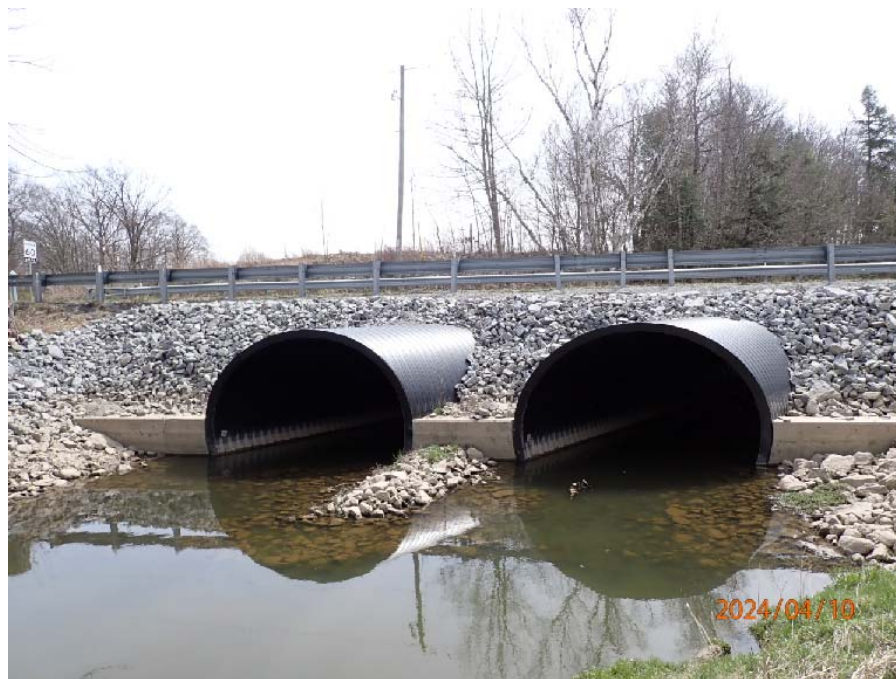
Photograph No. 2: 0715: North elevation.

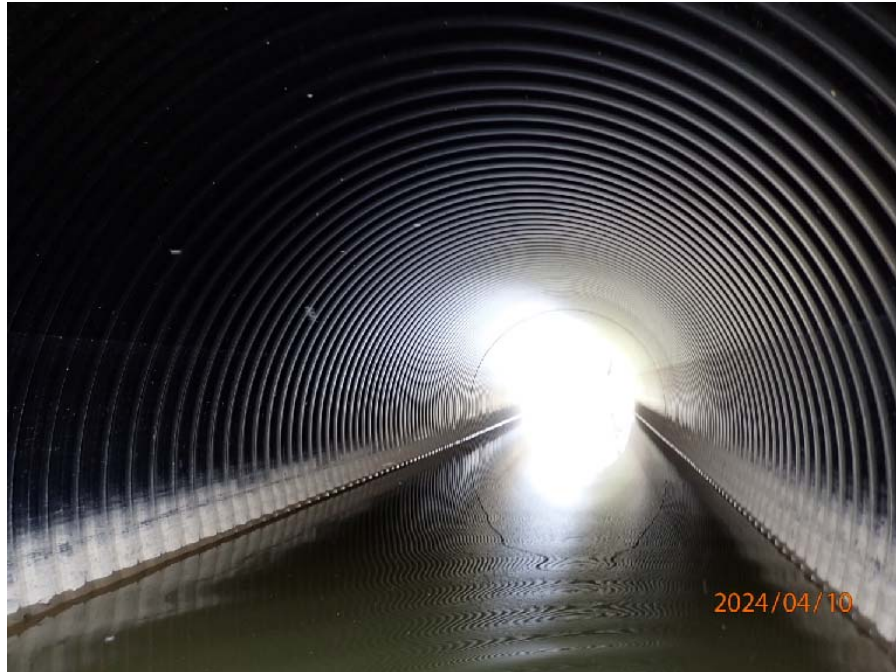
Photograph No. 3: 0728: Interior of east cell looking south.

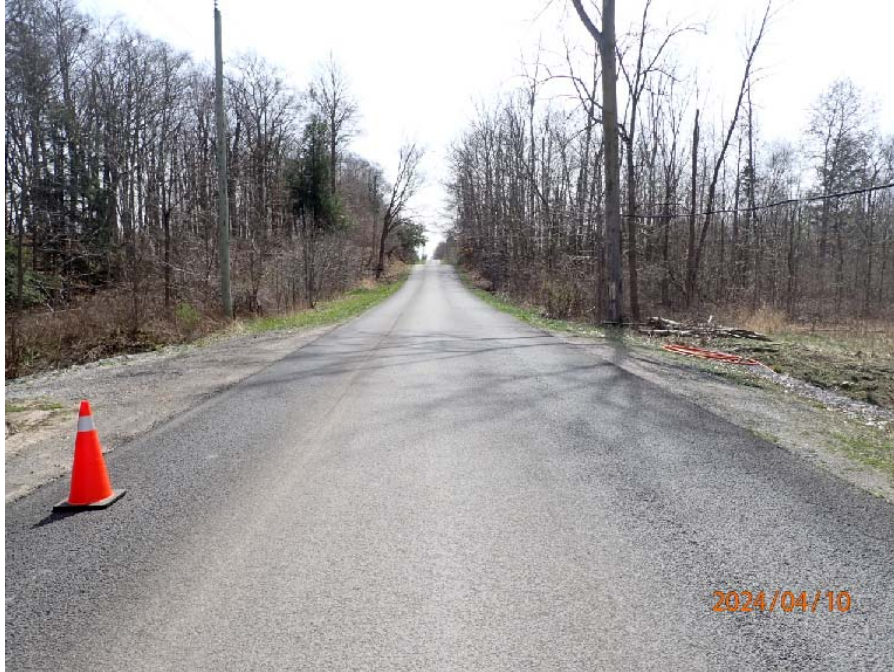
Photograph No. 1: 0564: Roadway looking south.

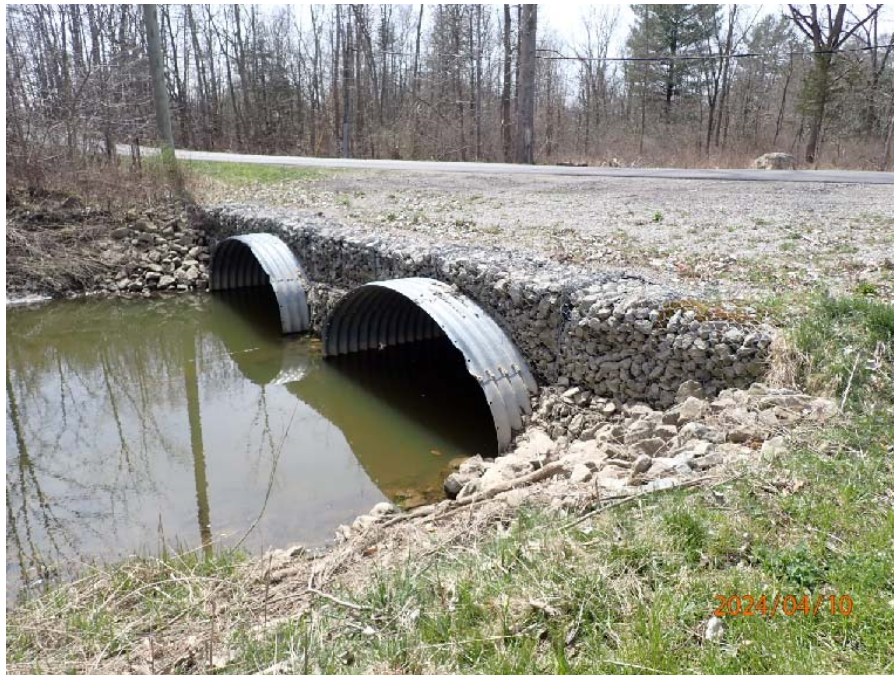
Photograph No. 2: 0579: West elevation.

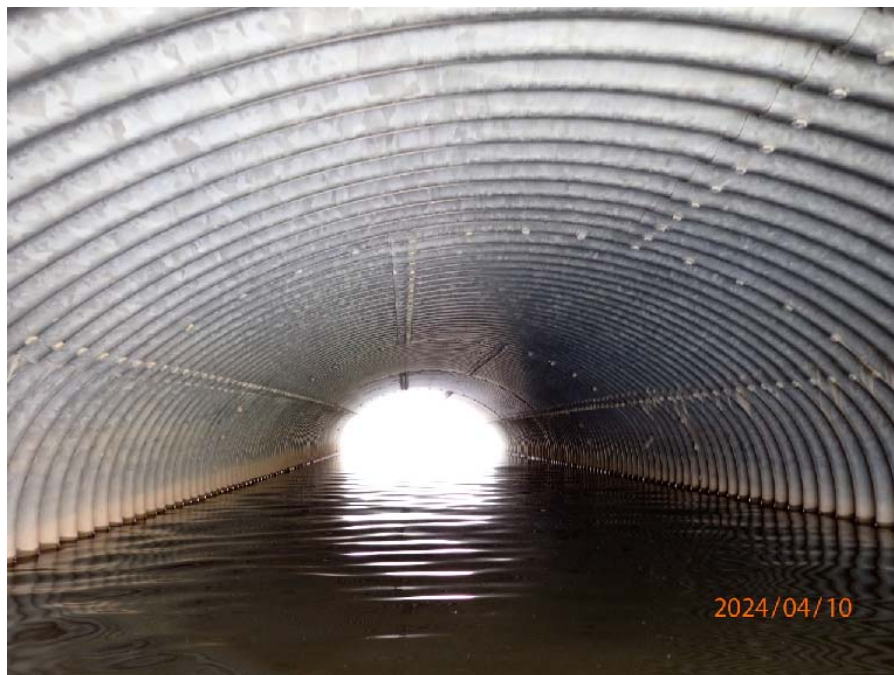
Photograph No. 3: 0585: Interior of north cell looking west.

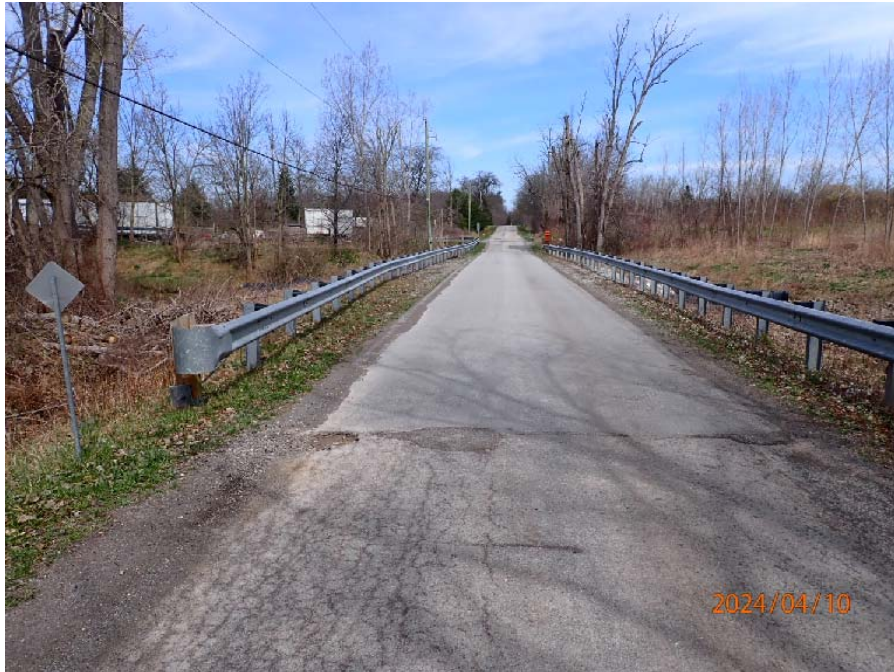
Photograph No. 1: 0380: Roadway looking north.

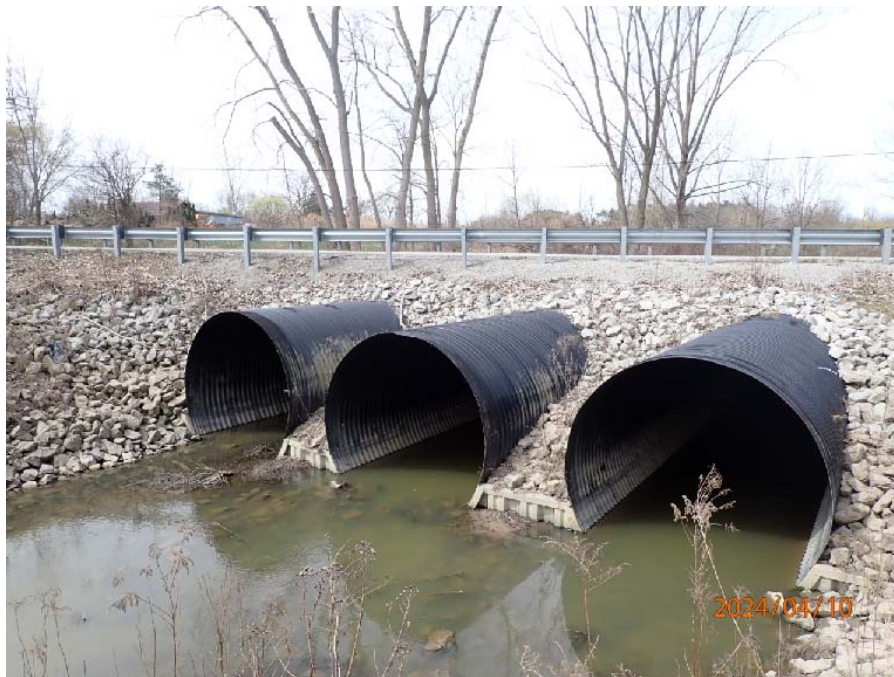
Photograph No. 2: 0429: East elevation.

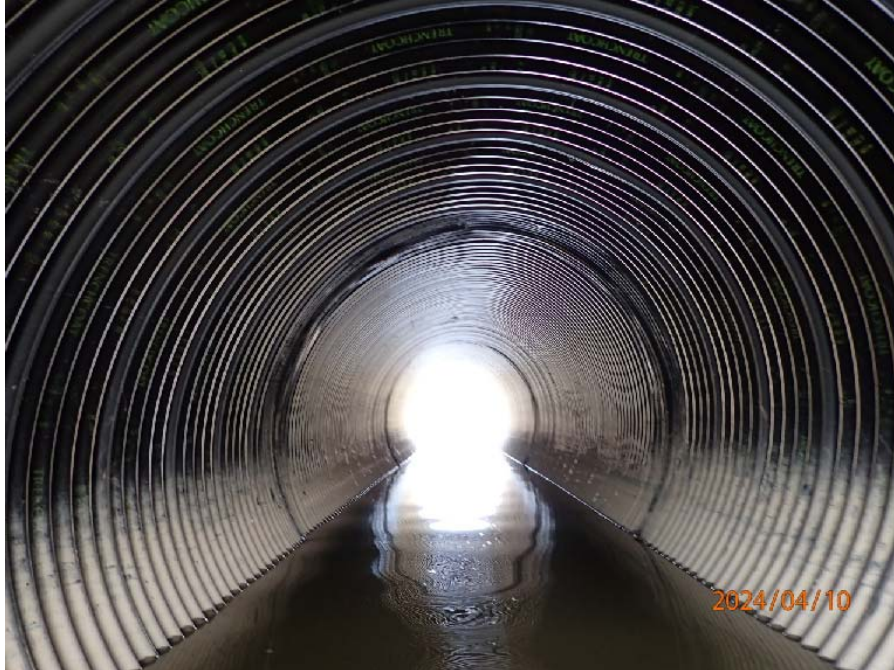
Photograph No. 3: 0446: Interior of centre pipe looking west.

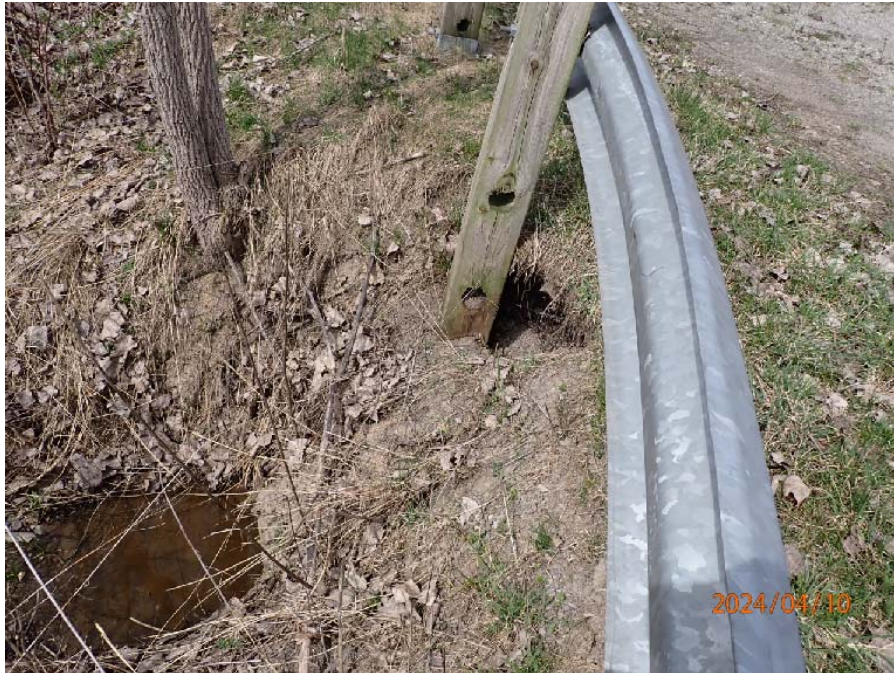
The asphalt paved roadway over the structure is in good condition. The steel beam guiderail over the east and west ends are in good condition. There is an extruder end treatment at the southeast corner. There is a driveway rounding at the northwest corner, and a leaving-end termination at the northeast and southwest corners. There are hazard markers at the southeast, northwest, and northeast corners. There is an area of localized medium erosion at the last timber post at the northwest driveway rounding. The polymer coated corrugated steel pipes are in very good condition. There are two joints in each pipe. The joints are composed of steel plates with a different size of corrugation than the surrounding pipe. The east connection in the middle cell appears to be damaged with a gap of approximately 25mm. There is loss of granular and geotextile filter cloth is visible at this location. There are steel bin retaining walls acting as cut-off walls at both ends of the structure. There is a 75mm gap between the pipe and the steel cut-off wall at the southeast corner. There is rip-rap erosion protection on the side slopes. There is a 300mm HDPE drain that outlets onto the rip-rap side slope at the northwest corner of the structure.

Photograph No. 4: 0402: Sinkhole at driveway rounding at northwest corner.

We recommend placing granular material at the northwest driveway rounding NOW.
